Distribution New Construction
St. Louis, Missouri April 20, 2010
Inspection findings related to Plastic Materials

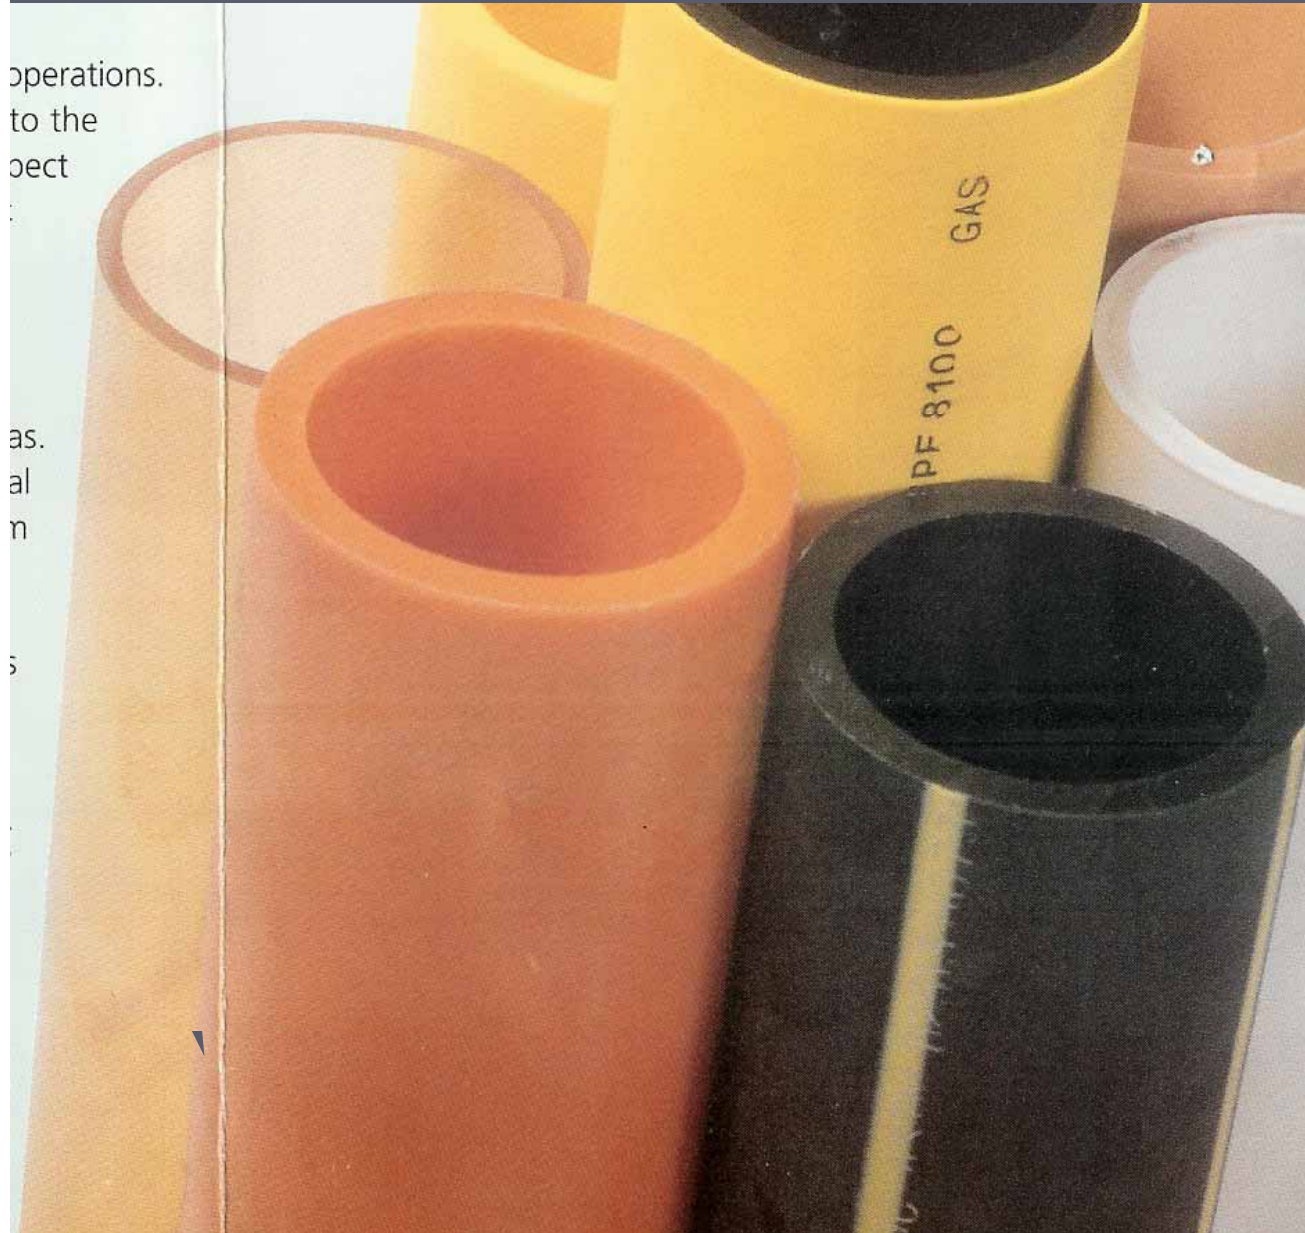
- The Operator installed a 2" ,lastic with a gouge greater than 10% wall loss, the Operator did not know how to measure the defect nor did he have any ,e ,ui, ment to measure the defect.

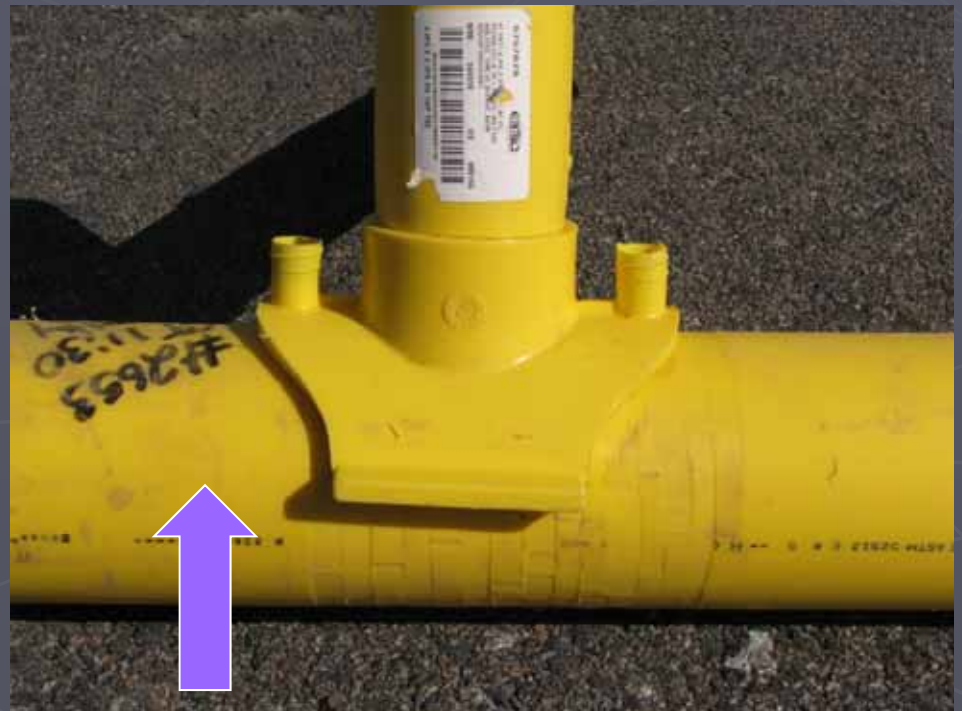
► The tapping tee failed during tapping operations by the contractor. The Operator initiated a Failure Investigation and concluded that the tee failed due to improper preparation and clamping. The manufacturer is redesigning the clamping tool used during the electrofusion process.

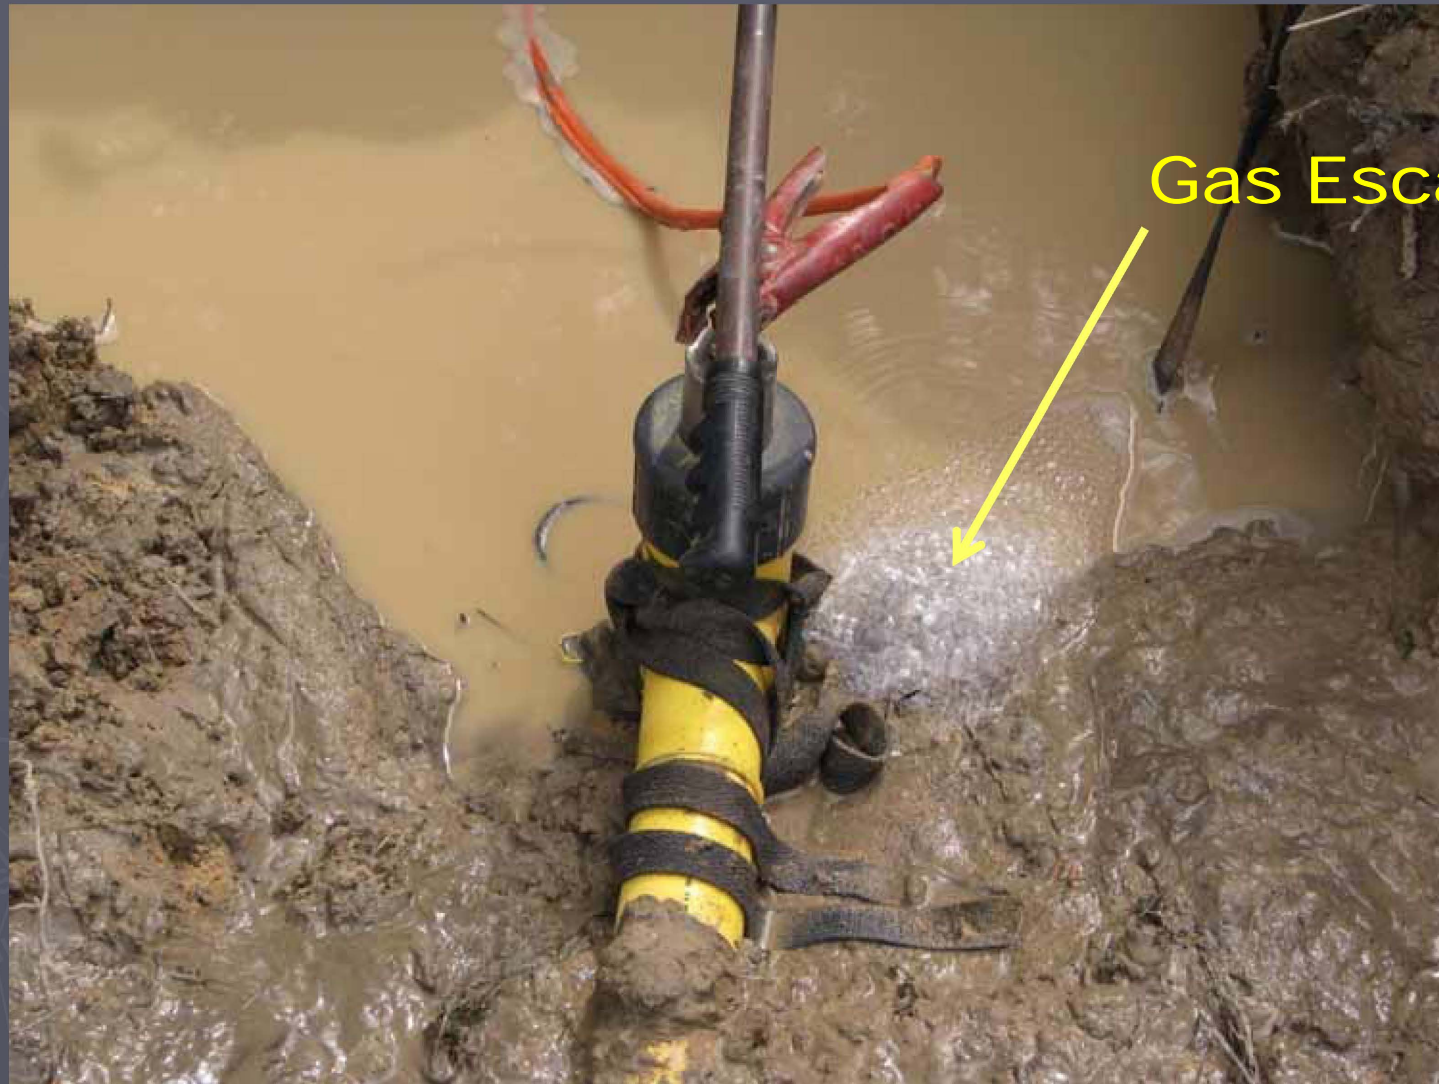
Newly installed high volume tapping tee.

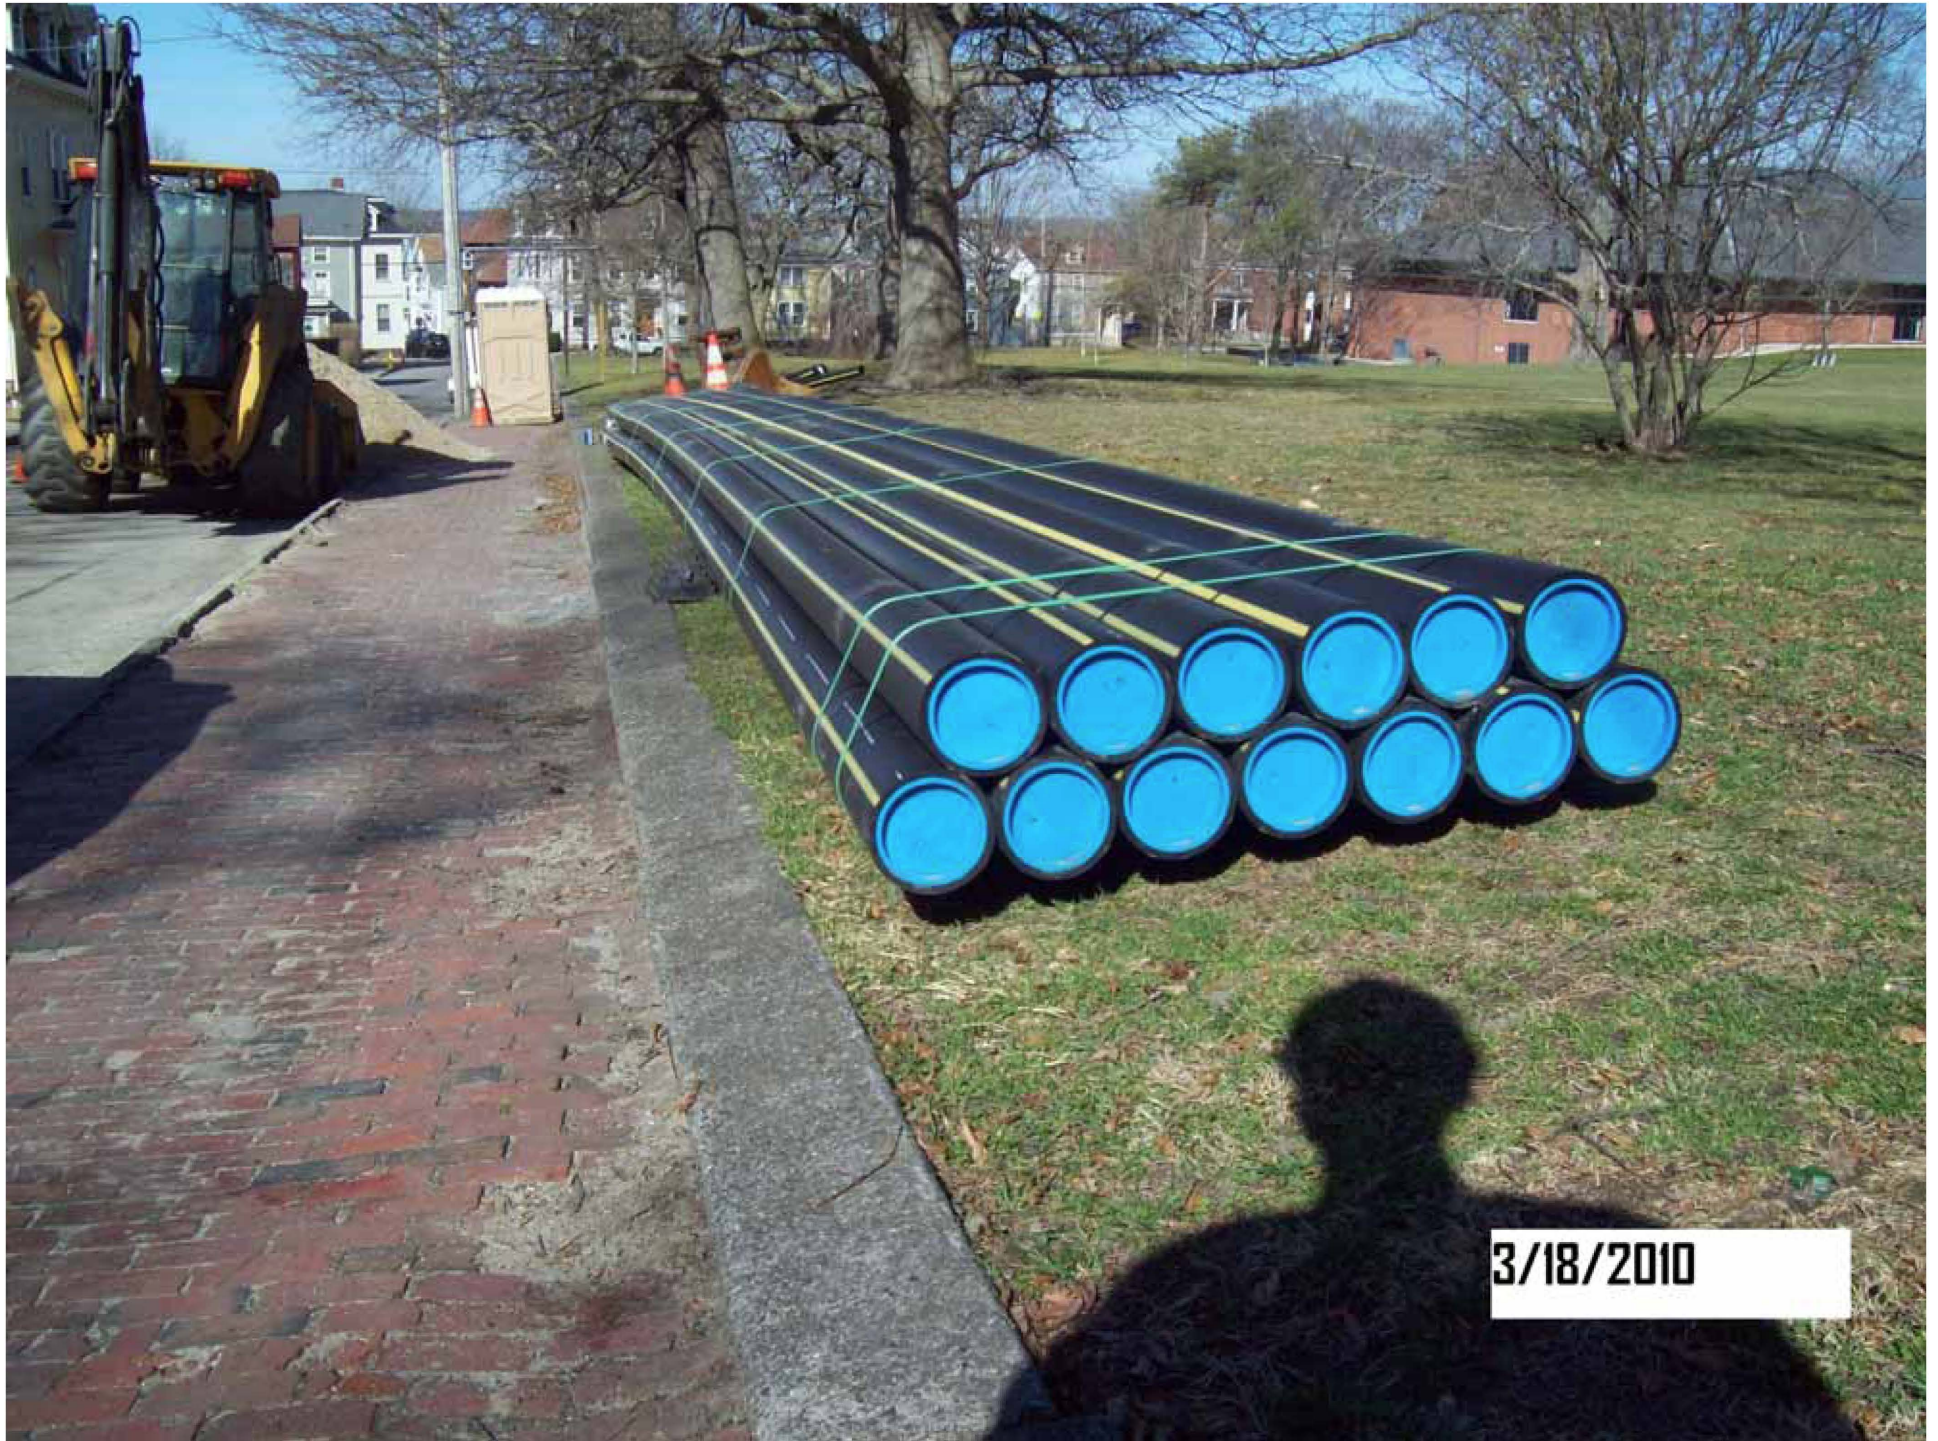
- ▶ The Operator's contractor performing the service installation failed to inspect the manufacturing date on the pipe. Once alerted by the State inspector it was later discovered that 500' of this pipe had already been installed.

Pipe Dated
March 7, 2010

Pipe is 11 days old from the factory?

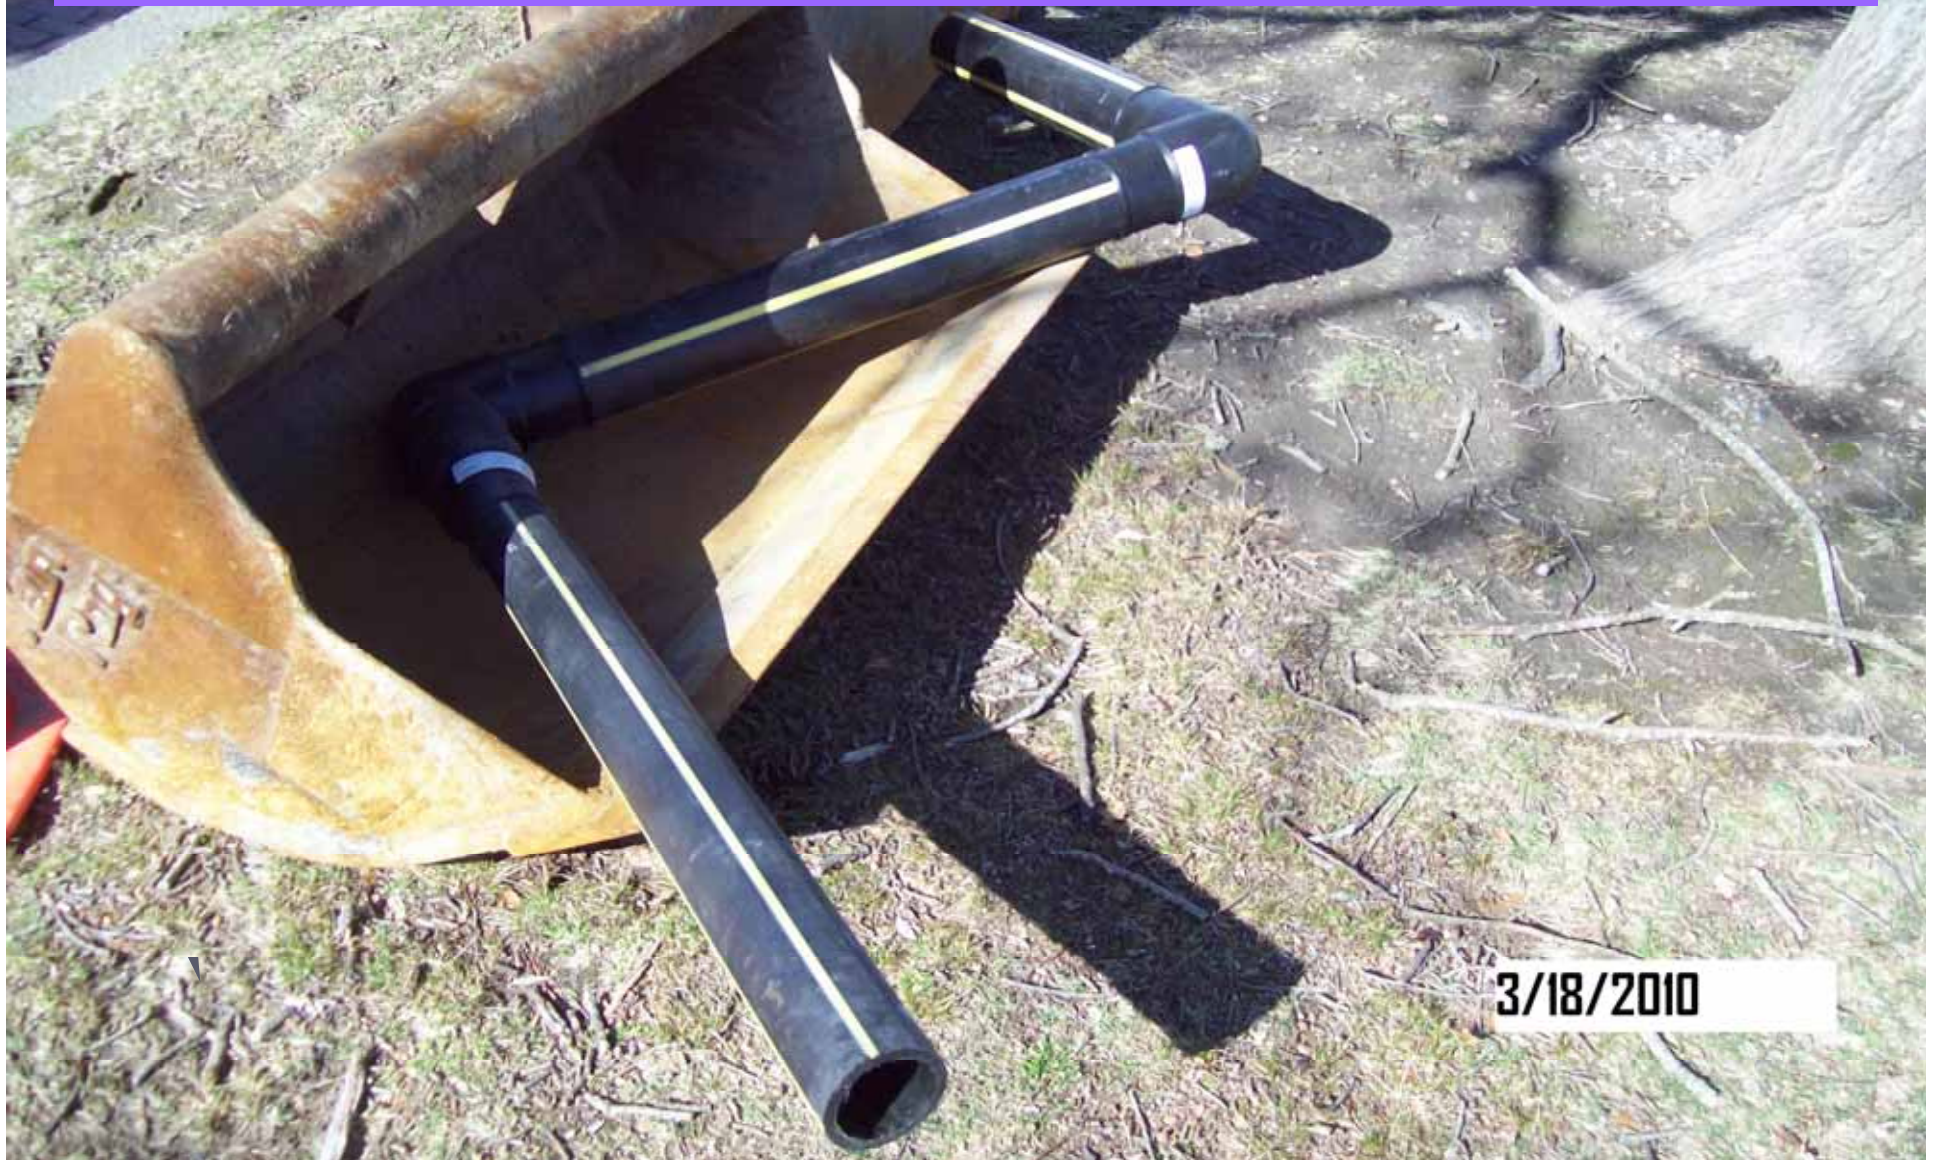
Pipe Dated
Feb. 6, 2008

...Older than 2 years!

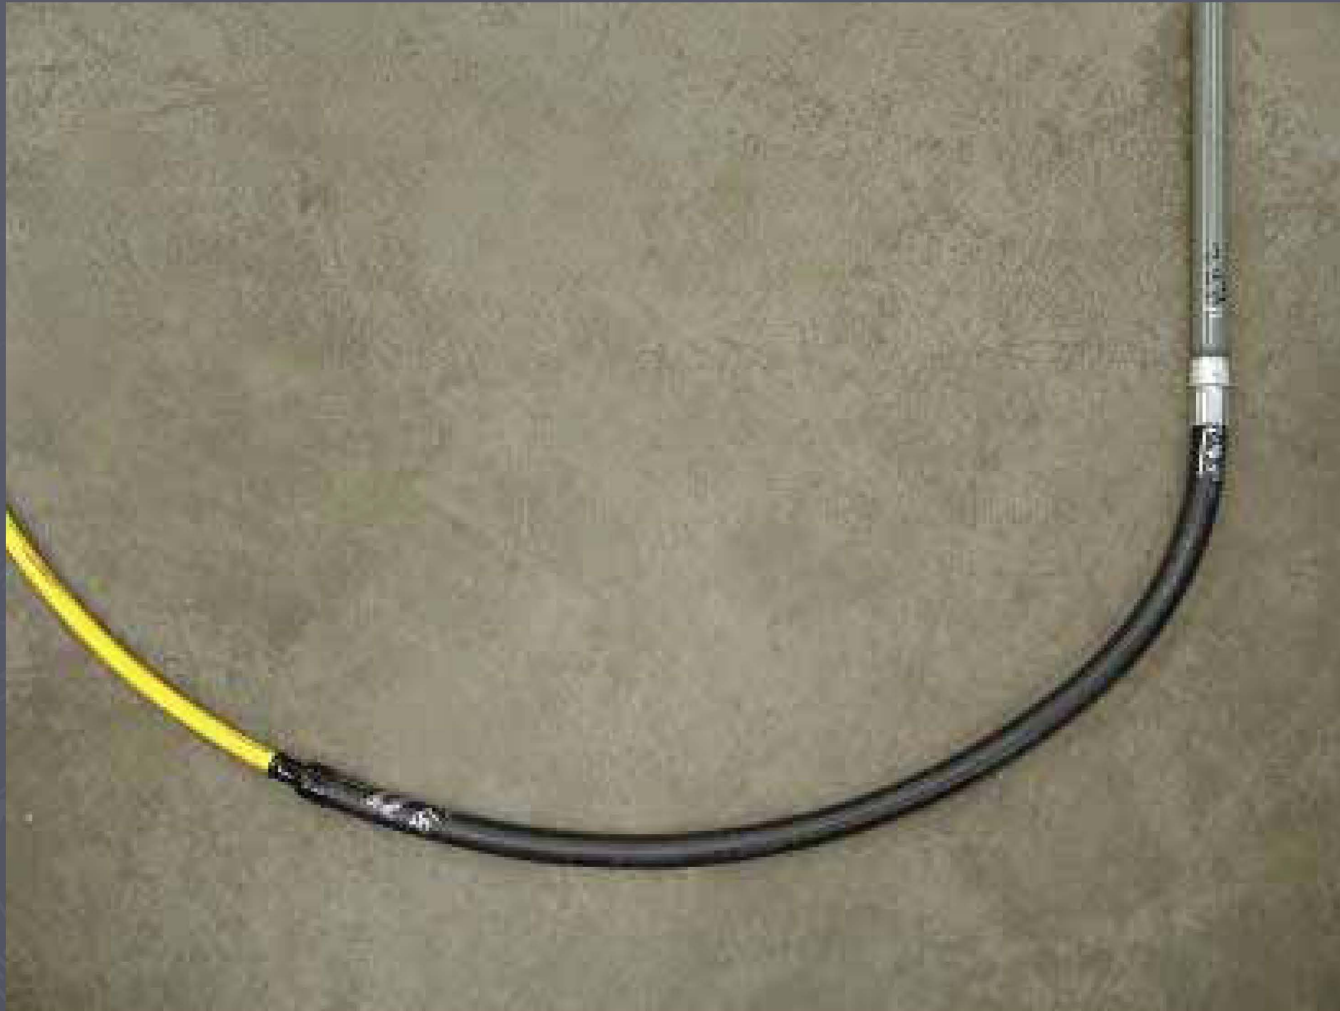
- ▶ The Operator's contractor , performing a branch service installation shortened two anodeless risers. There was no procedure for this activity.

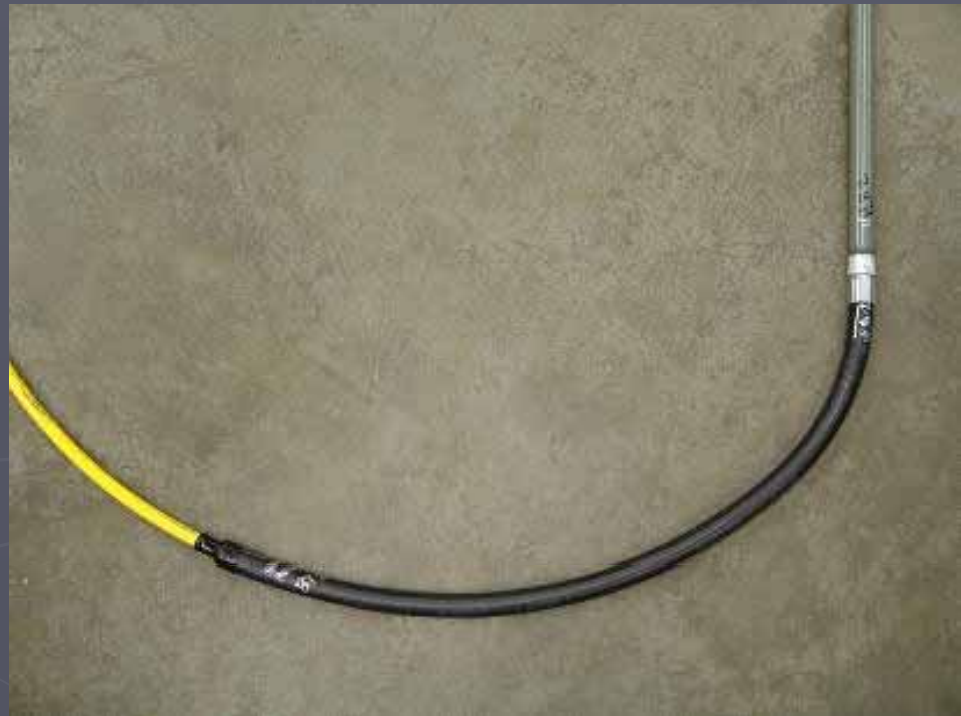
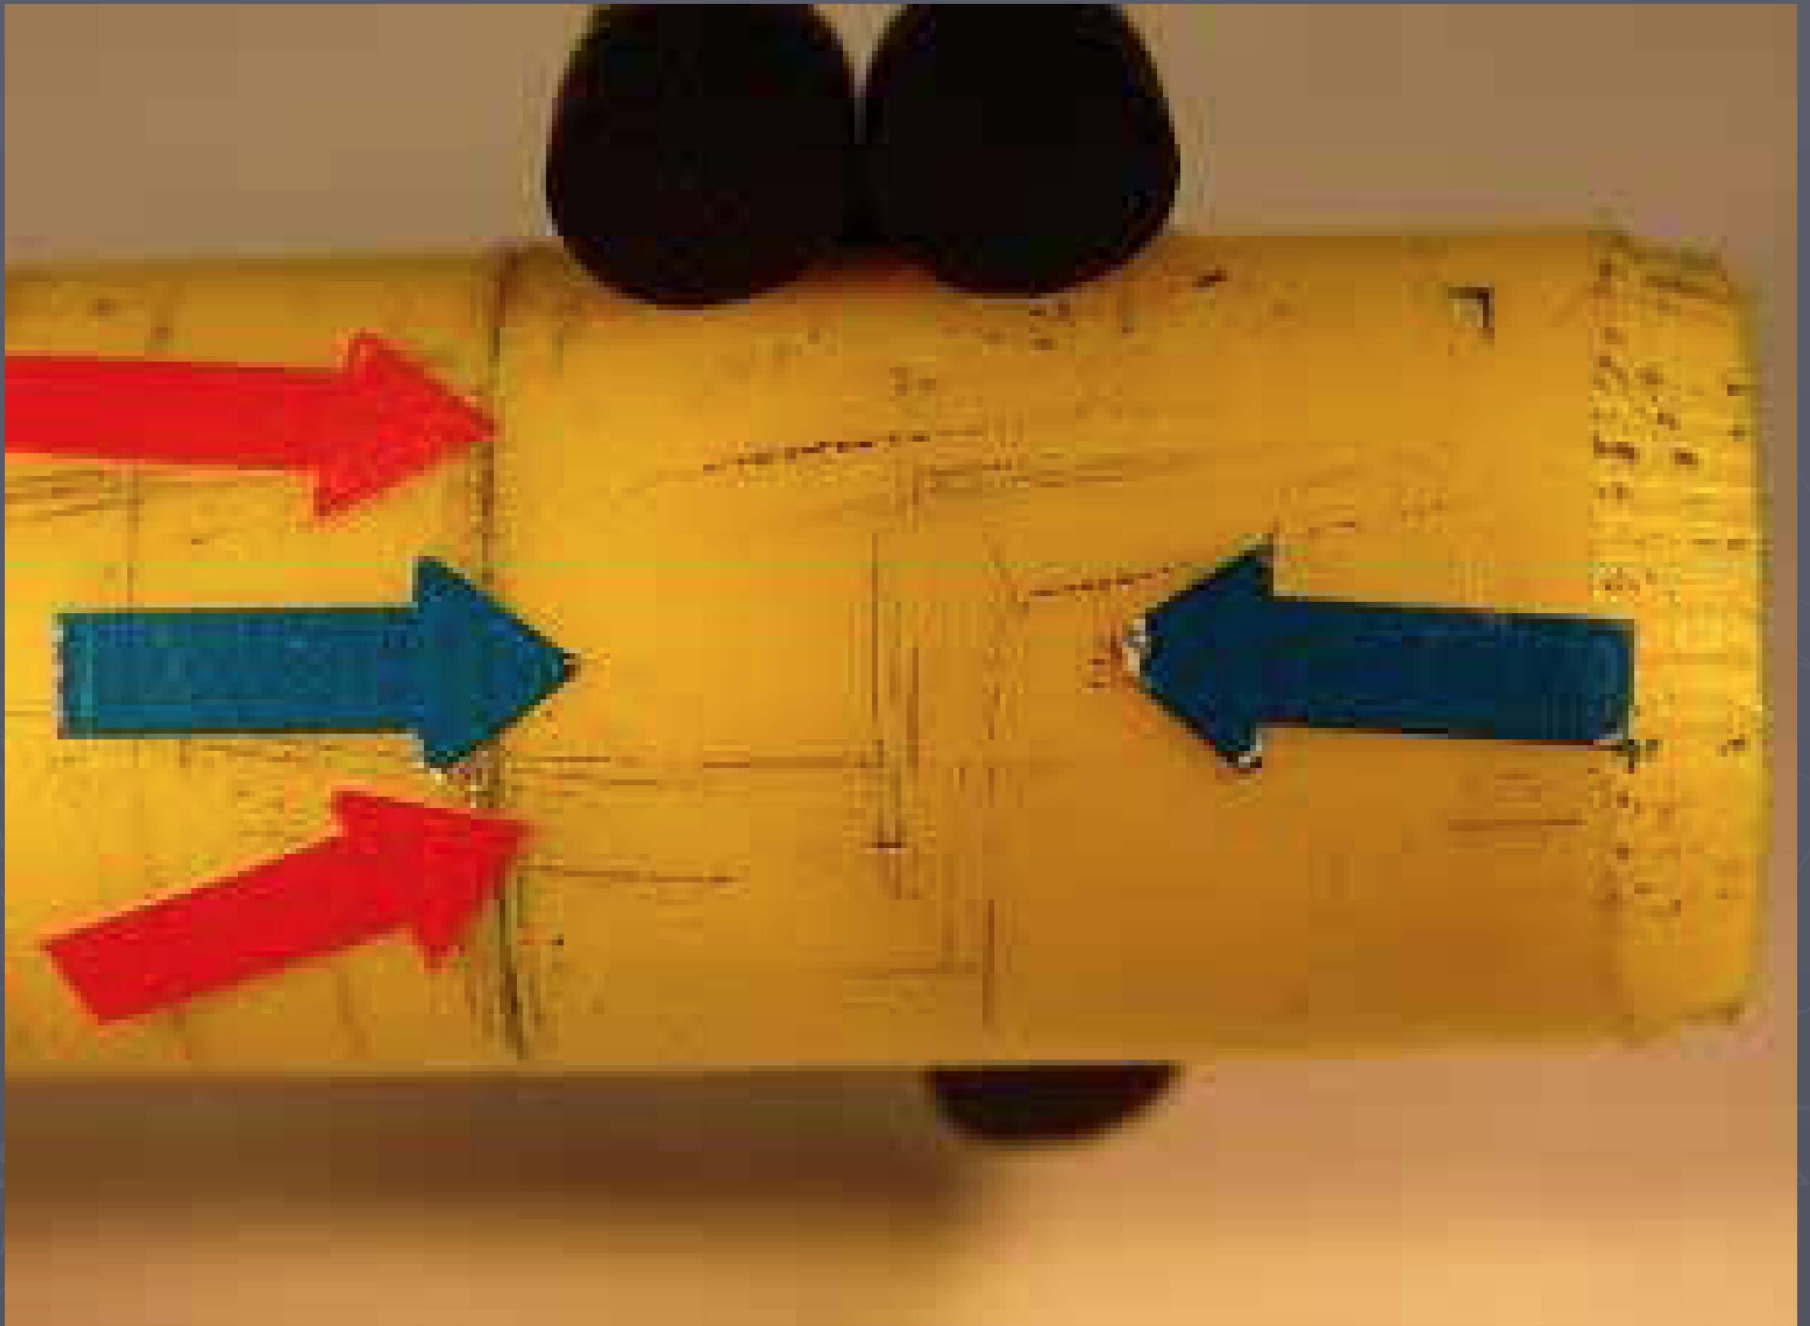
- This time the Operator had a written procedure to assemble anodeless risers but unfortunately the parts supplied were leading to on site failures.

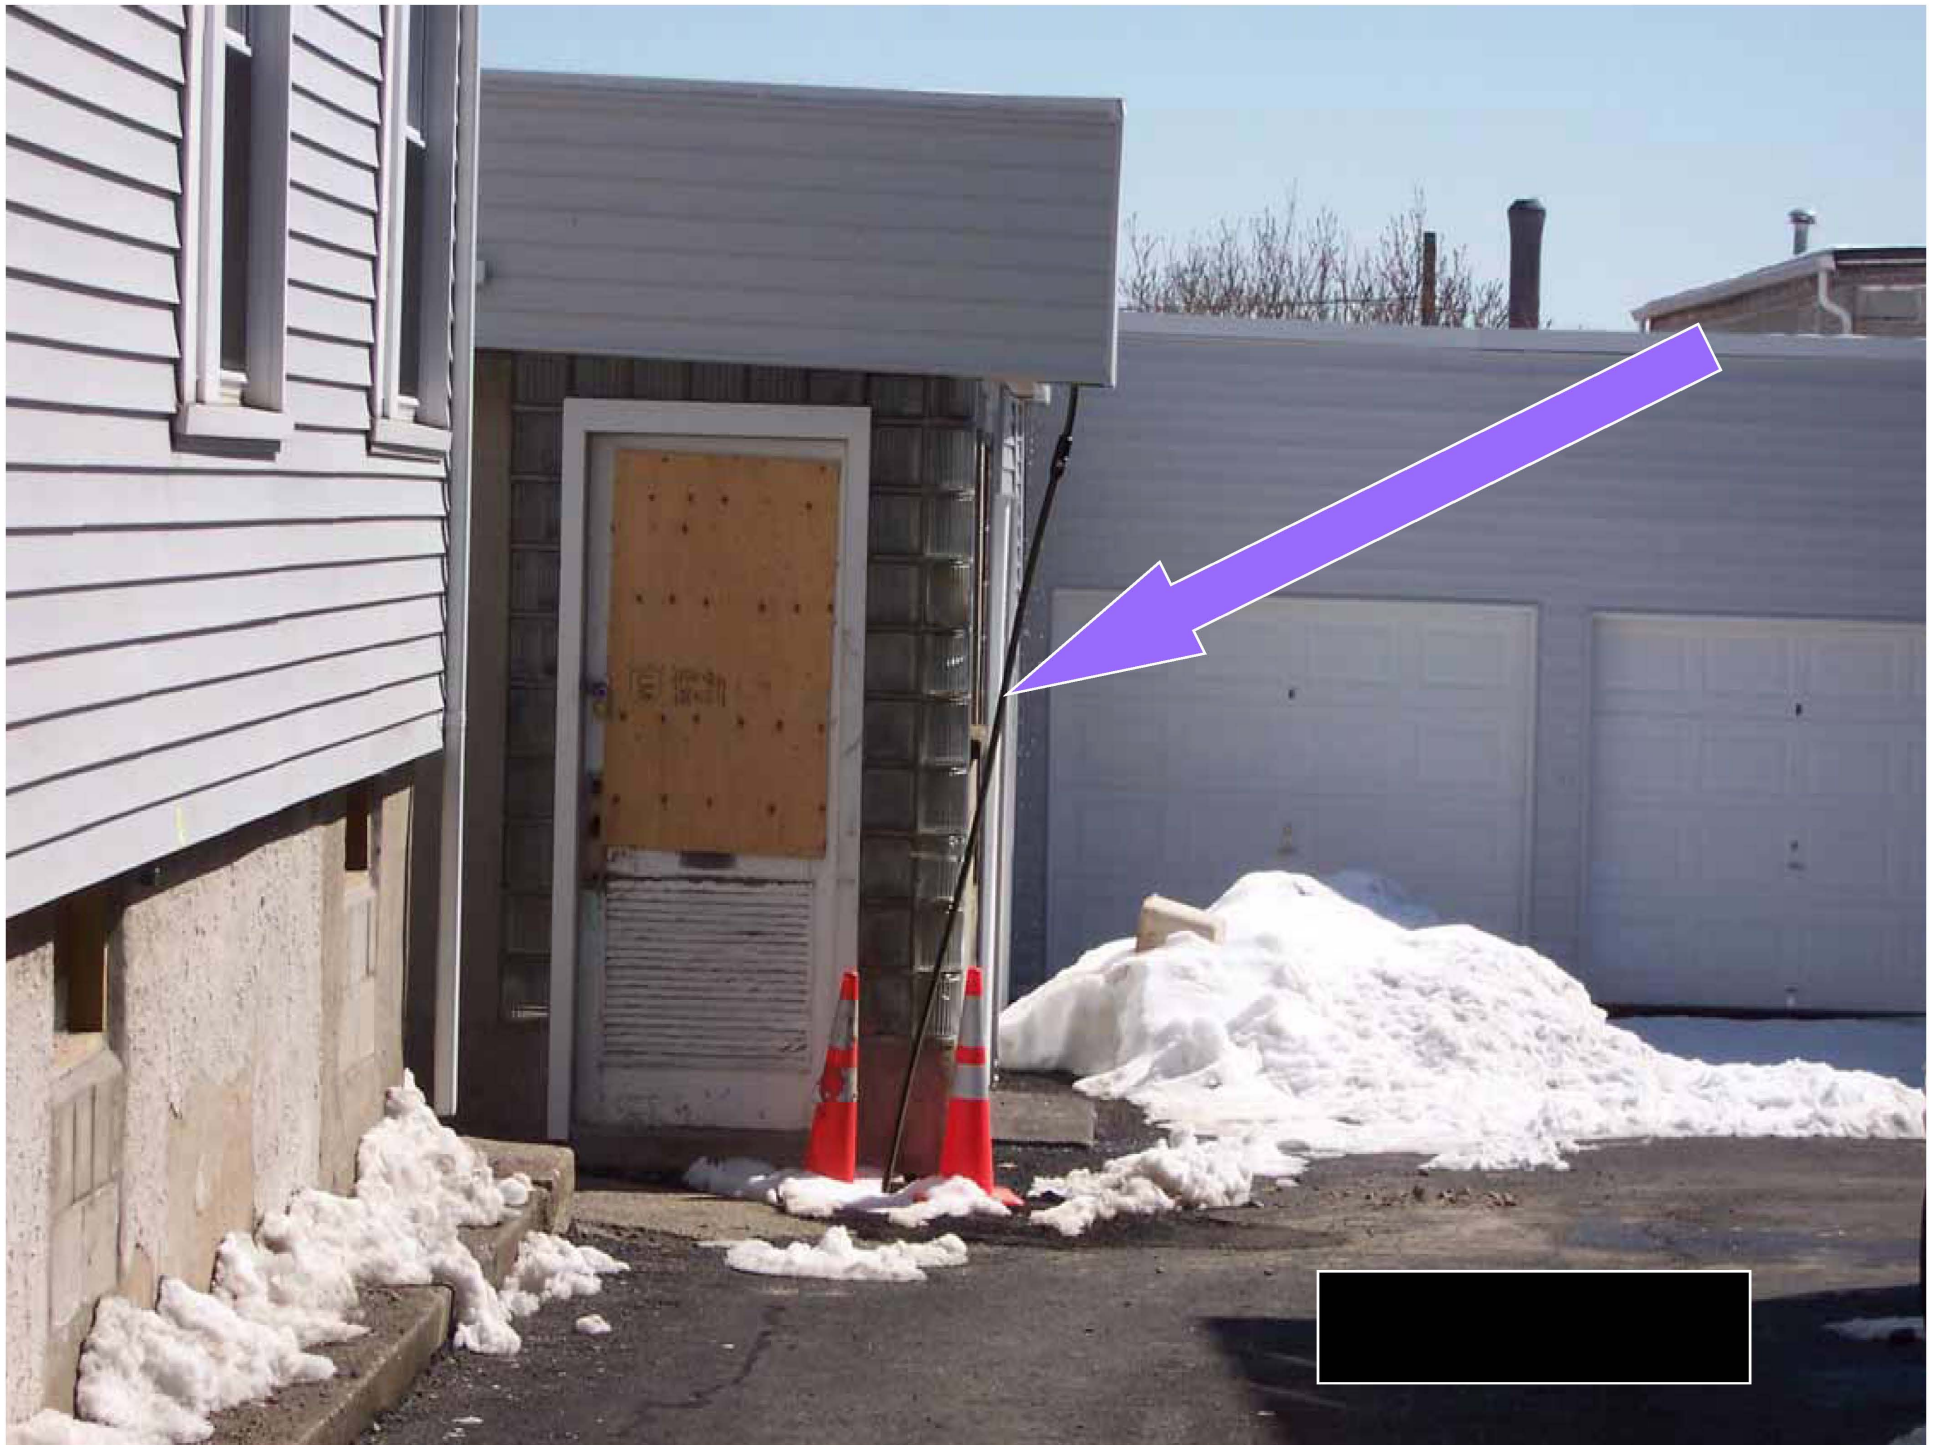
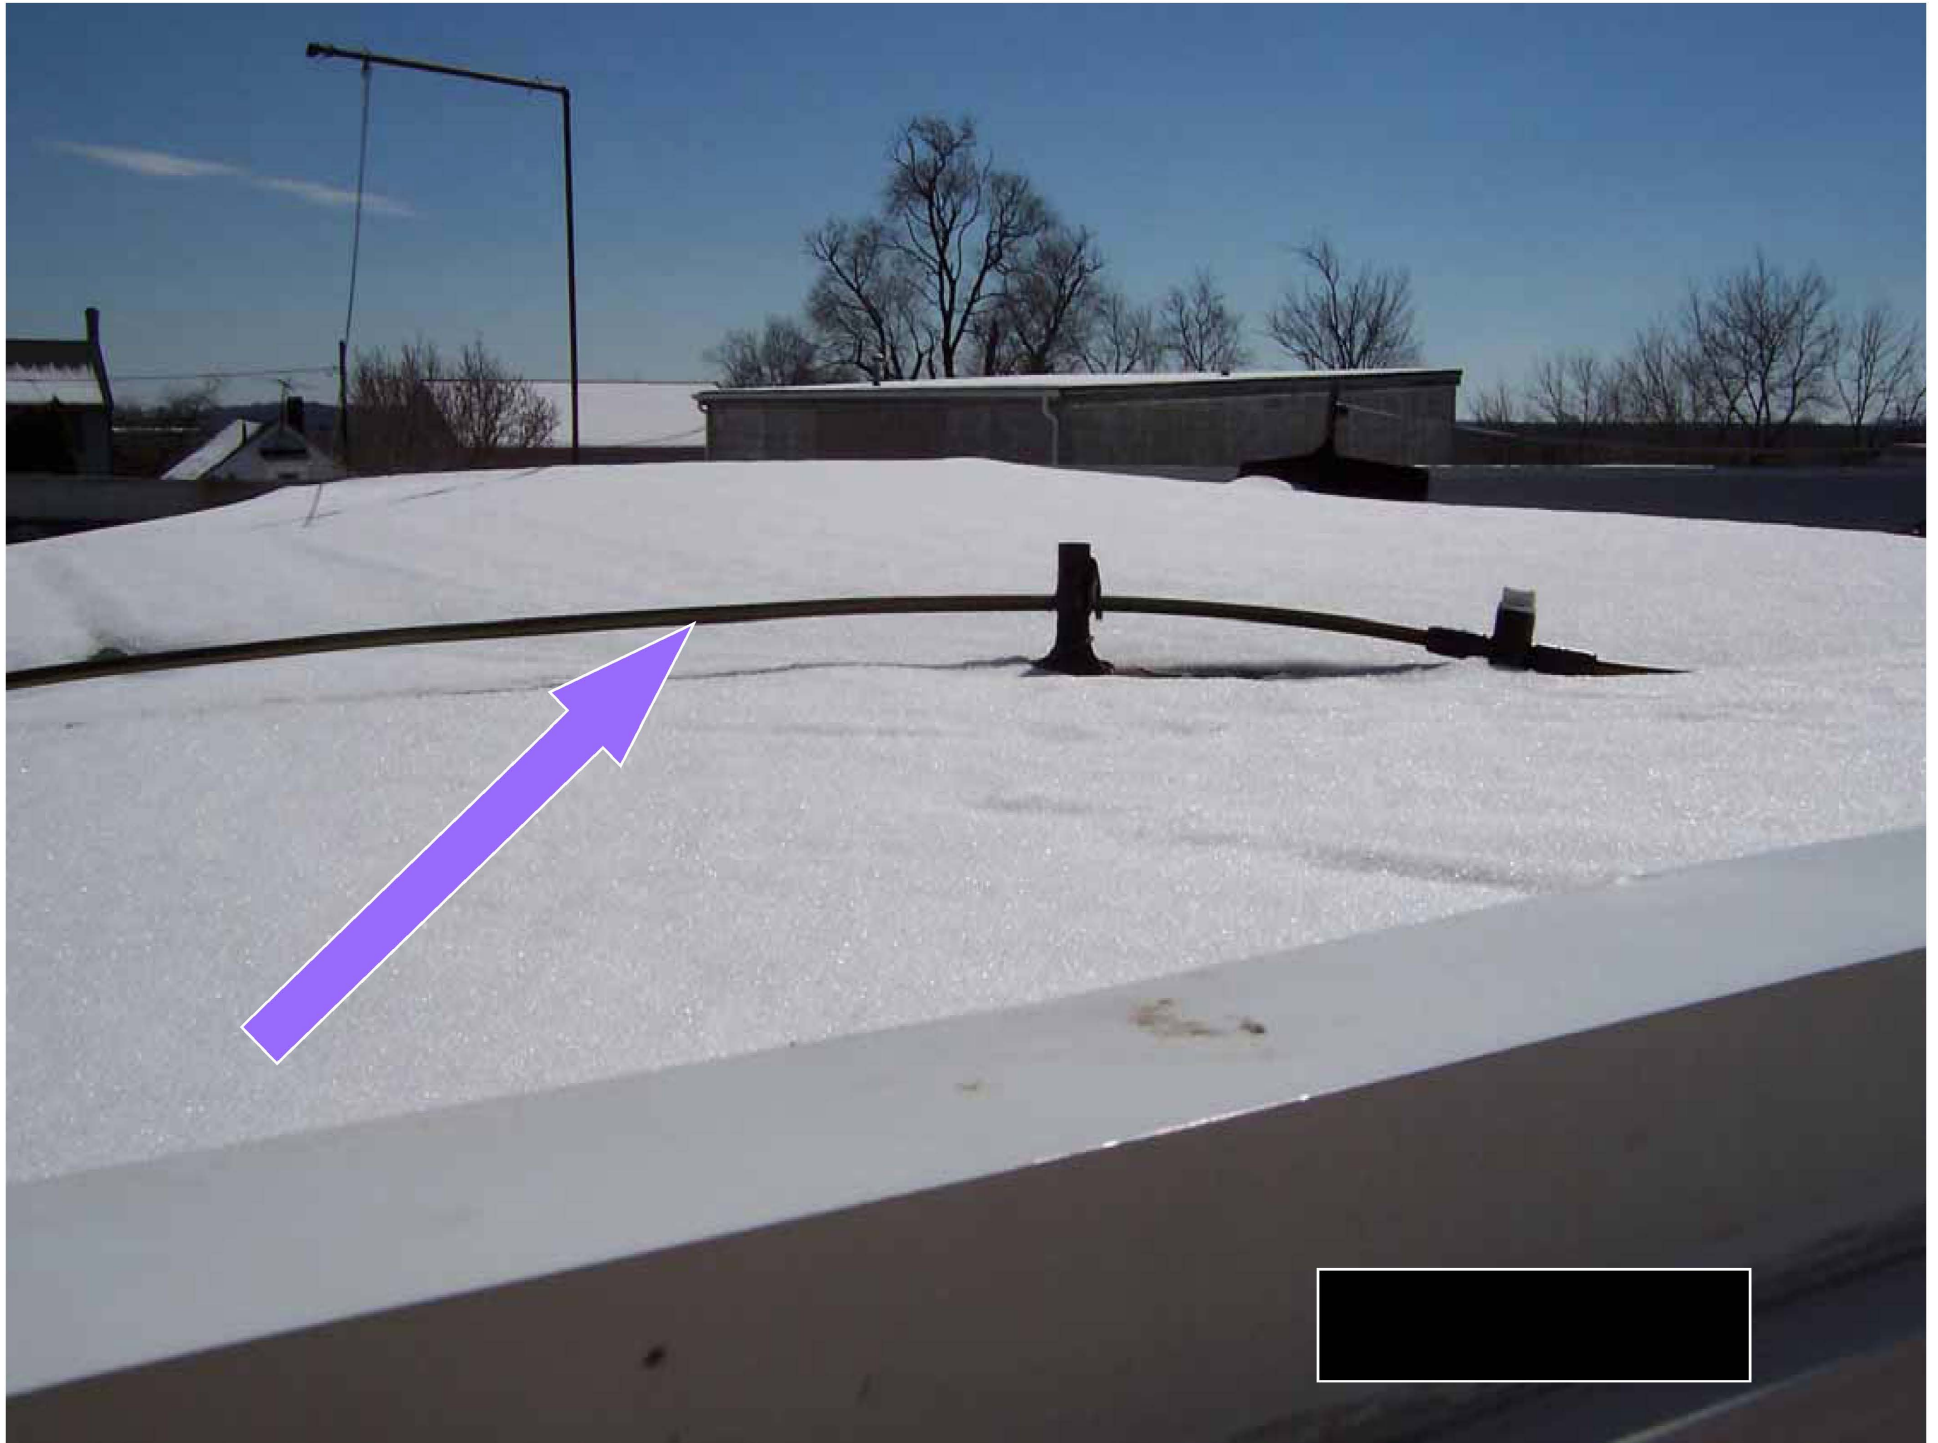
► The Operator installed a temporary gas service above ground over a garage.

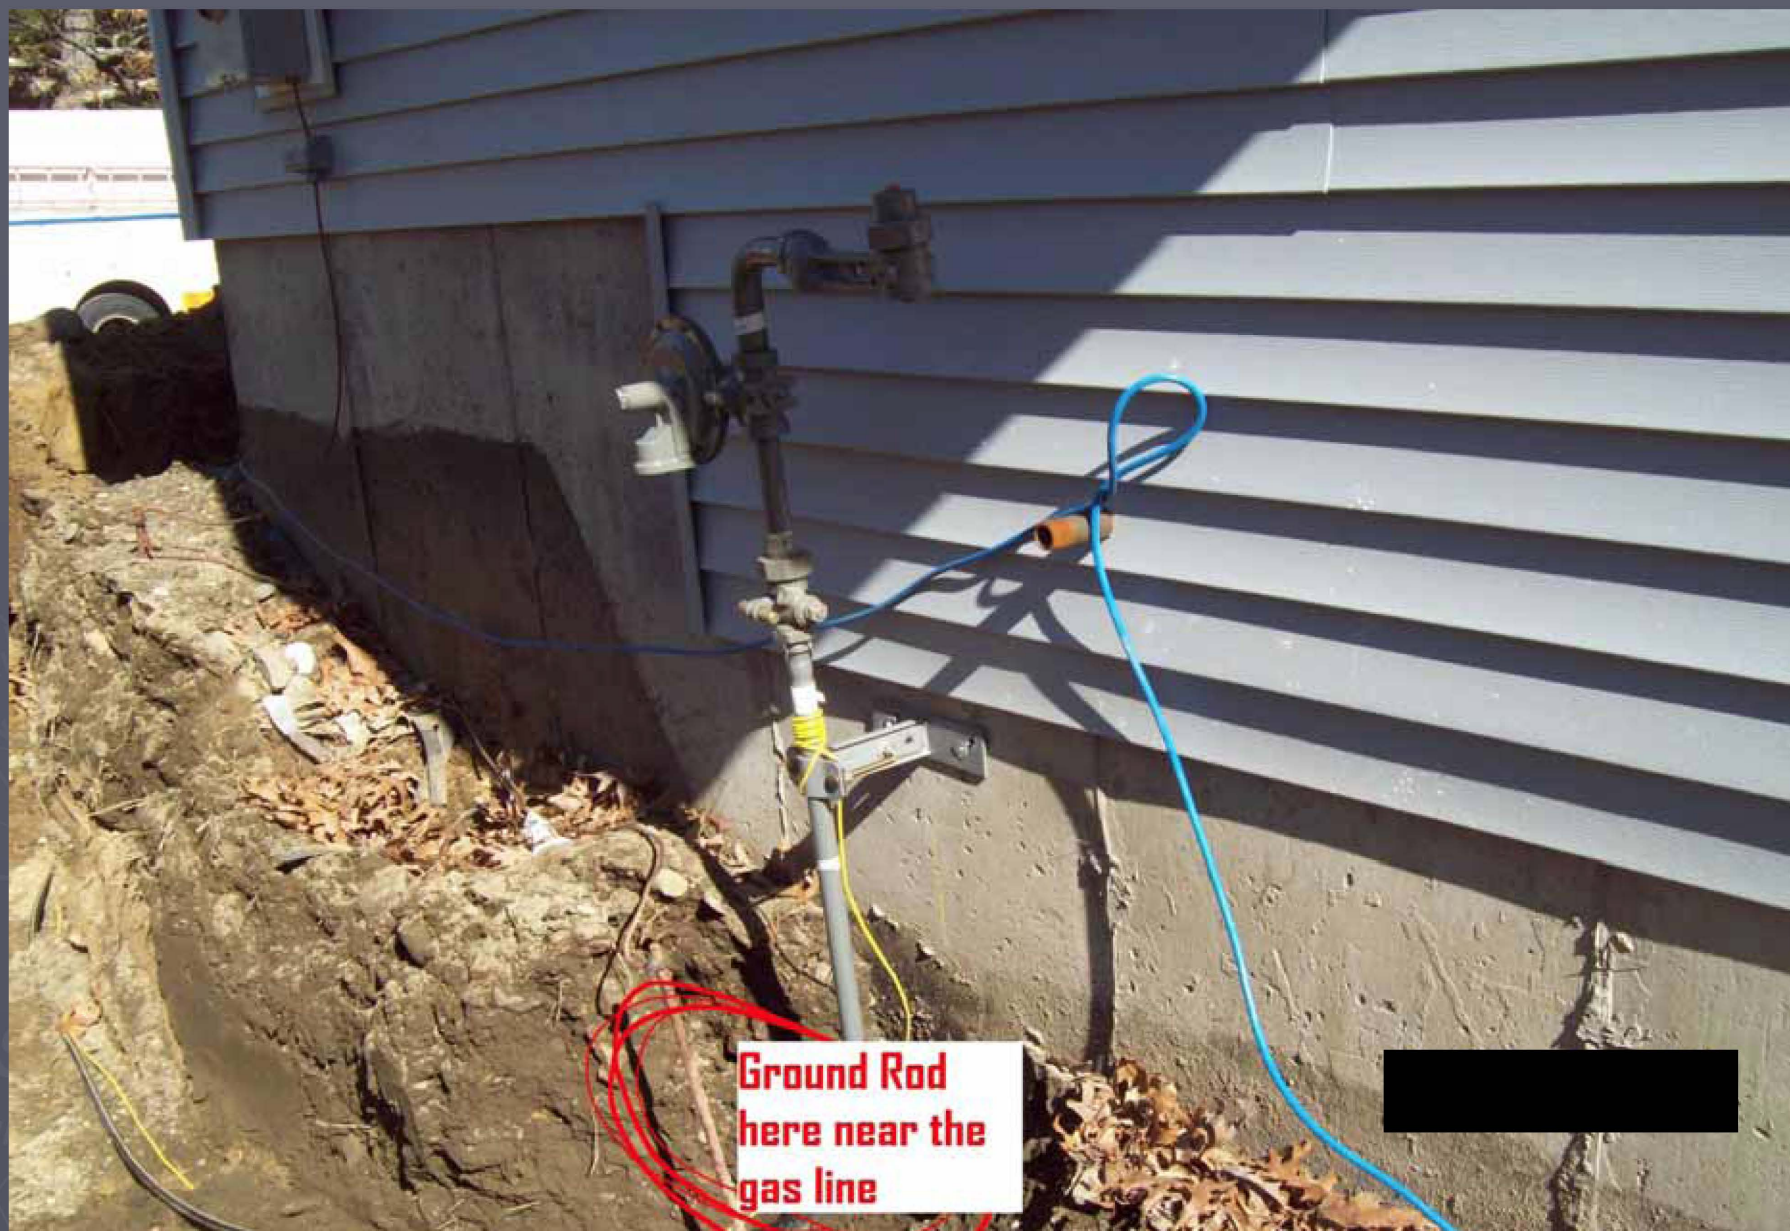
Grounding rod right next to the service

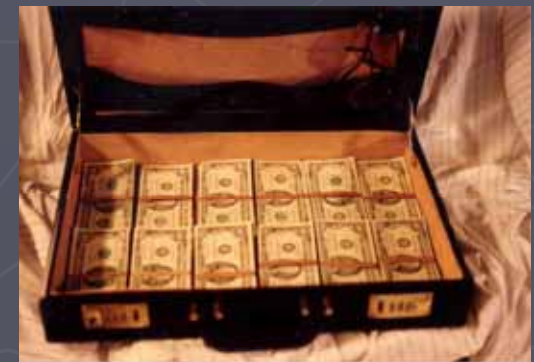
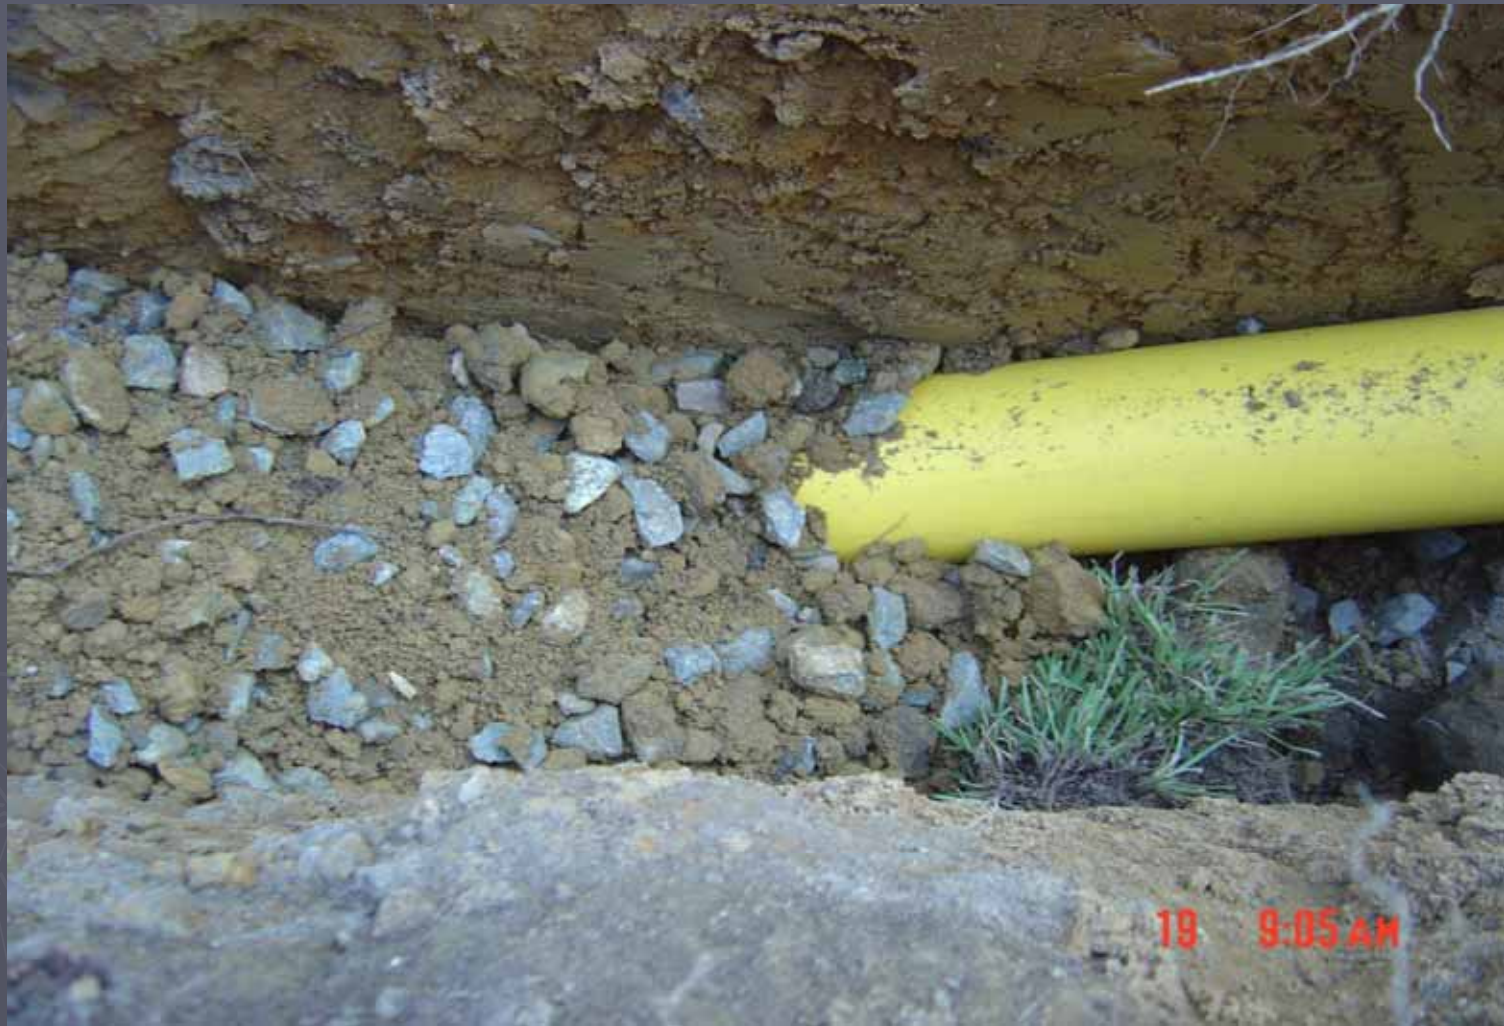
- The Operator's contractor installed a 4" plastic main with improper backfill material. About 2500' (about a ½ mile) of the newly installed 4" gas main was replaced and select backfill was brought in.
