Distribution New Construction
St. Louis, Missouri April 20, 2010
Inspection findings related to Plastic Materials

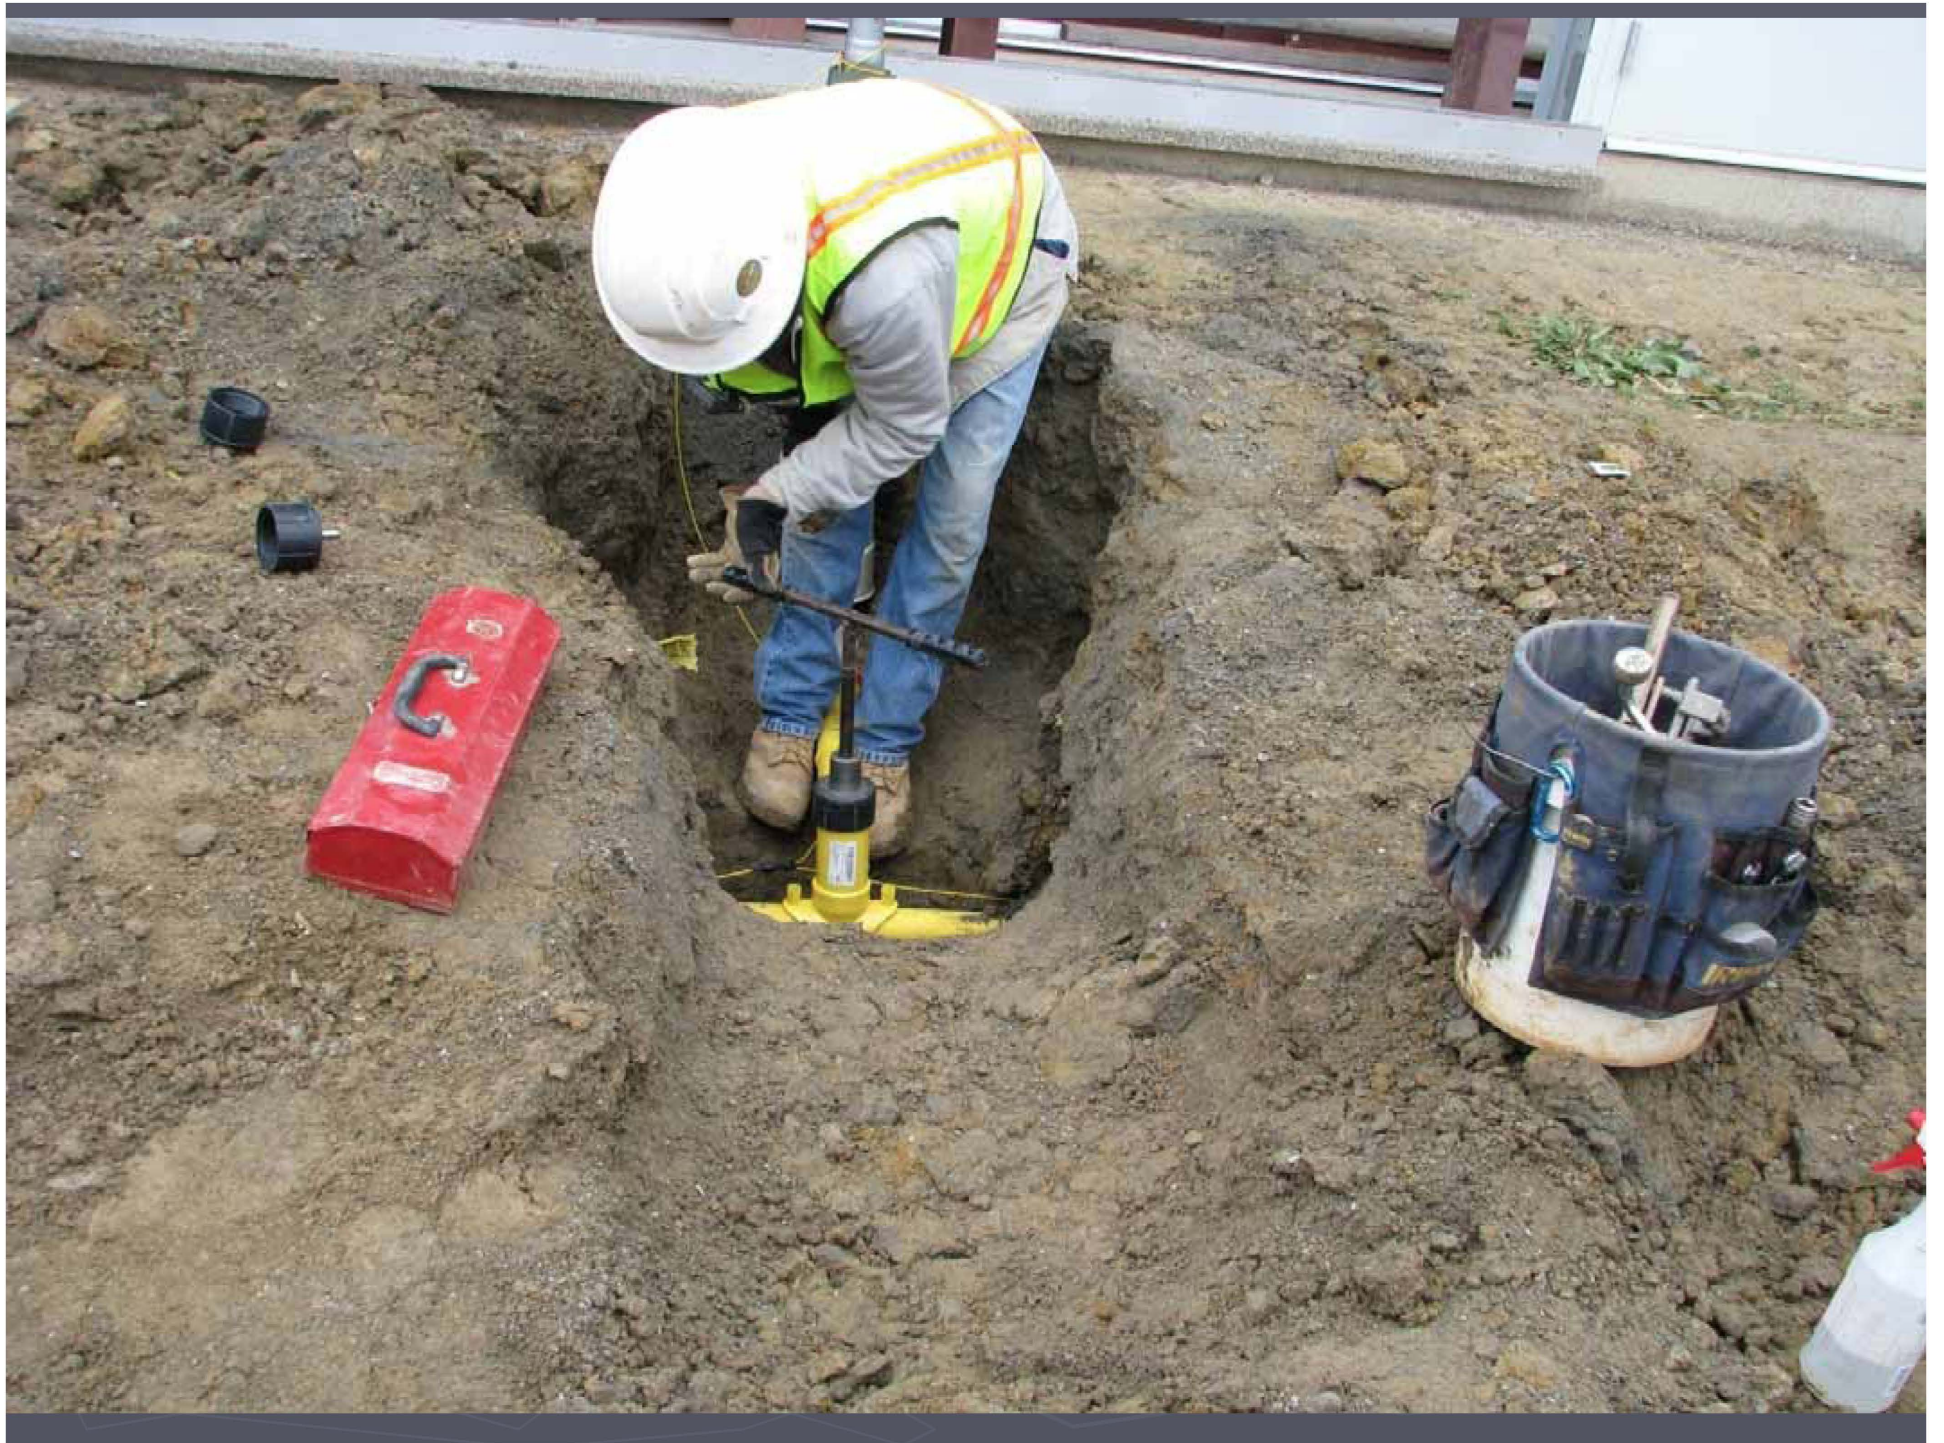
- The background is a dark blue-grey color. In the lower-left corner, there is a faint, light-grey graphic. It includes a compass rose with the letters 'N', 'S', 'E', and 'W' visible. Overlaid on the compass is a gear-like shape with a small 'M' inside it. There are also some other faint geometric lines and shapes.
- ▶ The Operator was performing a tapping process without properly grounding the cutting tool. A failure of the operator to follow procedures.

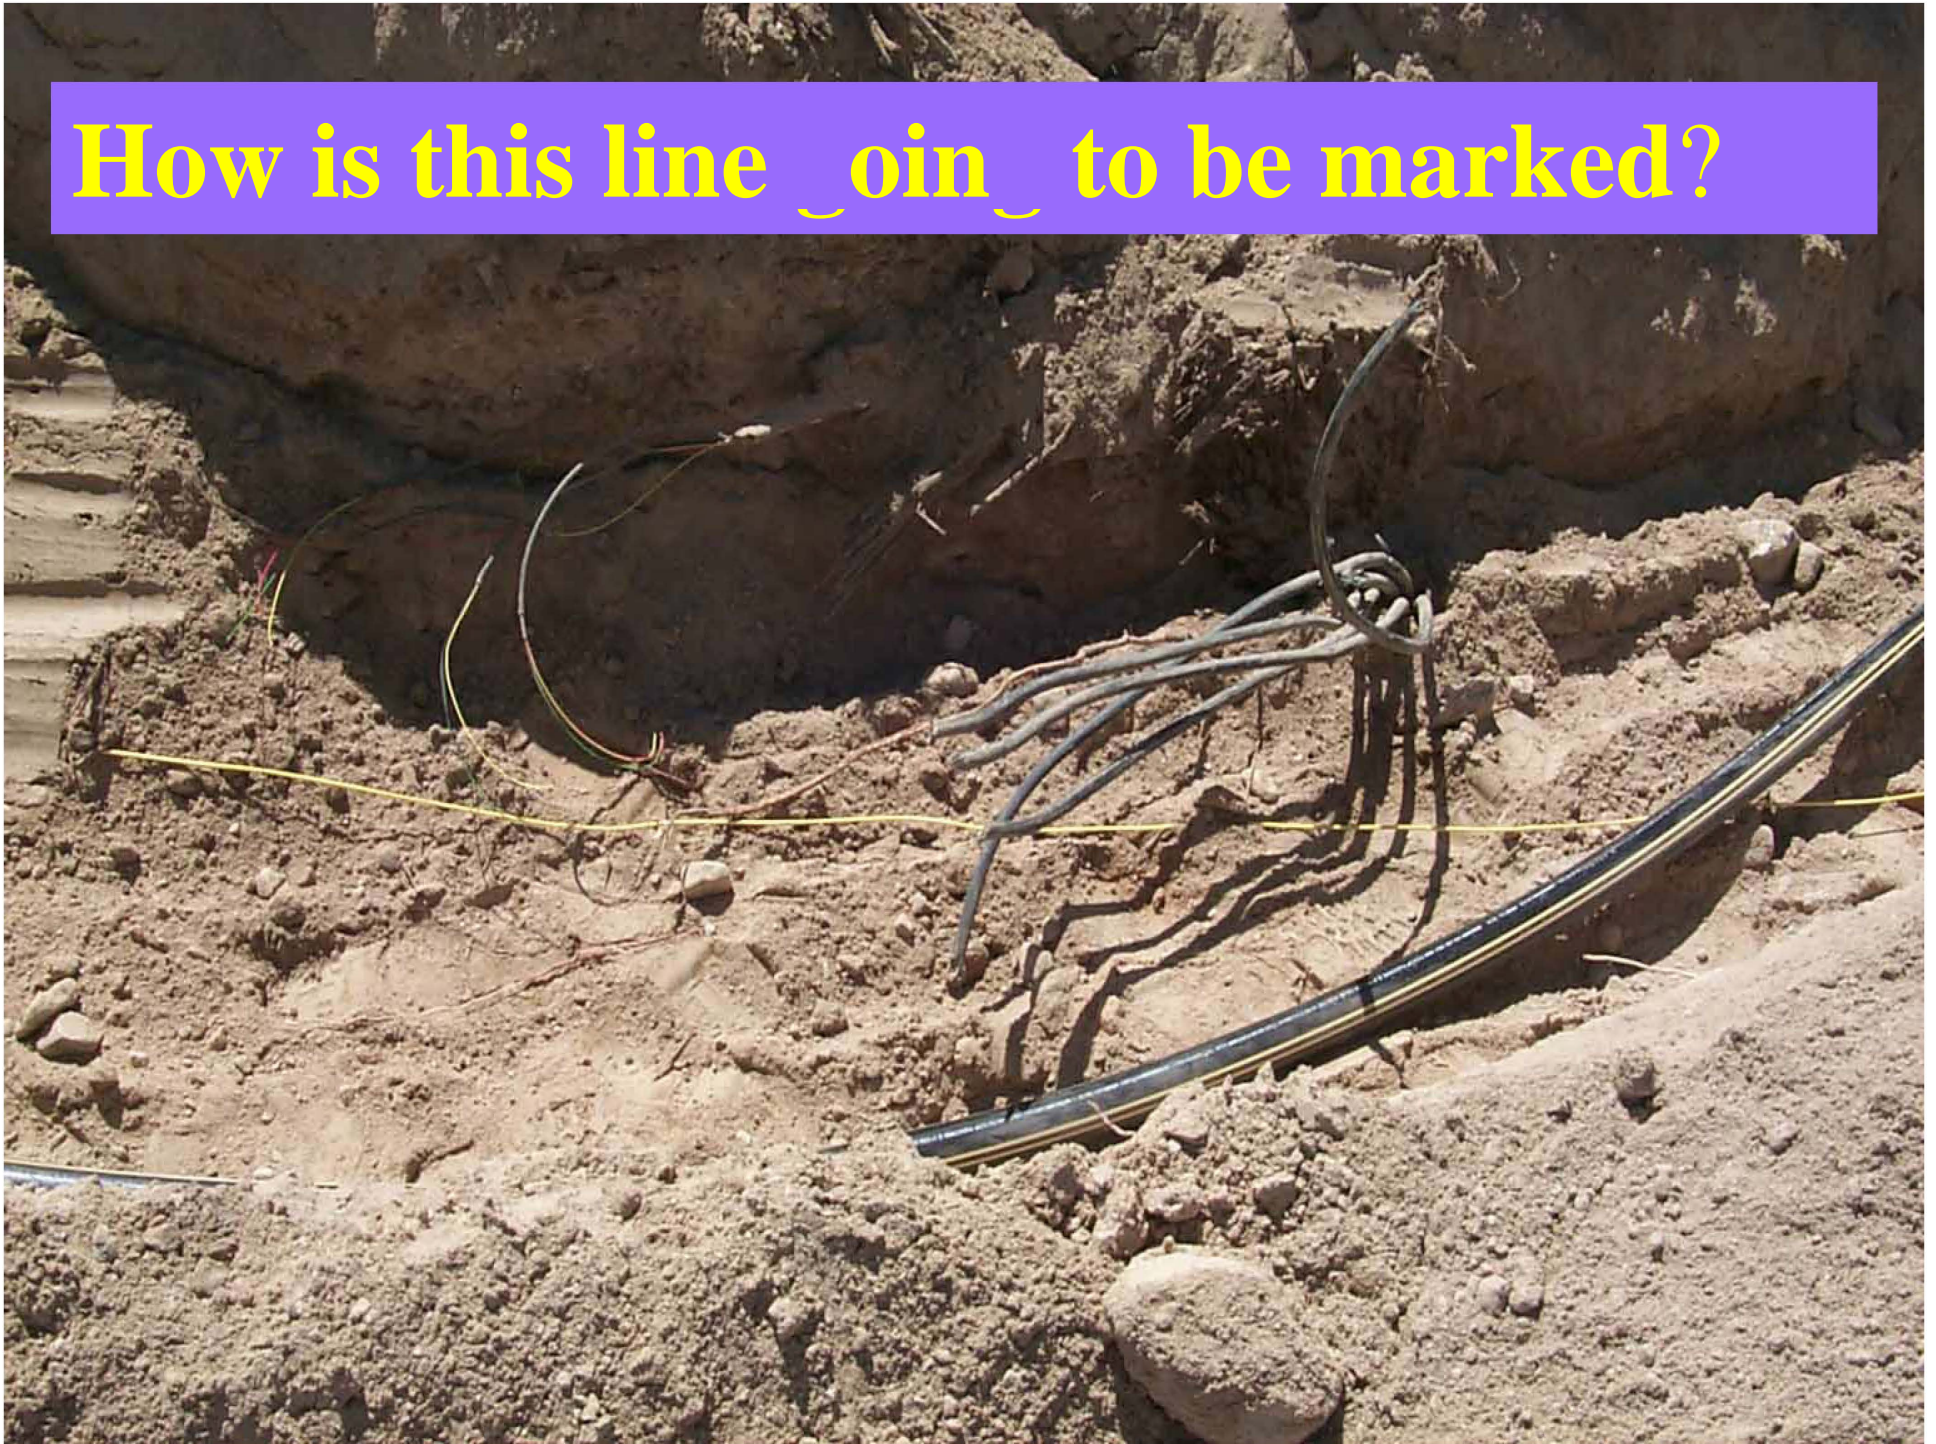
§192.327(b) - Failure to install a main with at least 24 inches of cover.

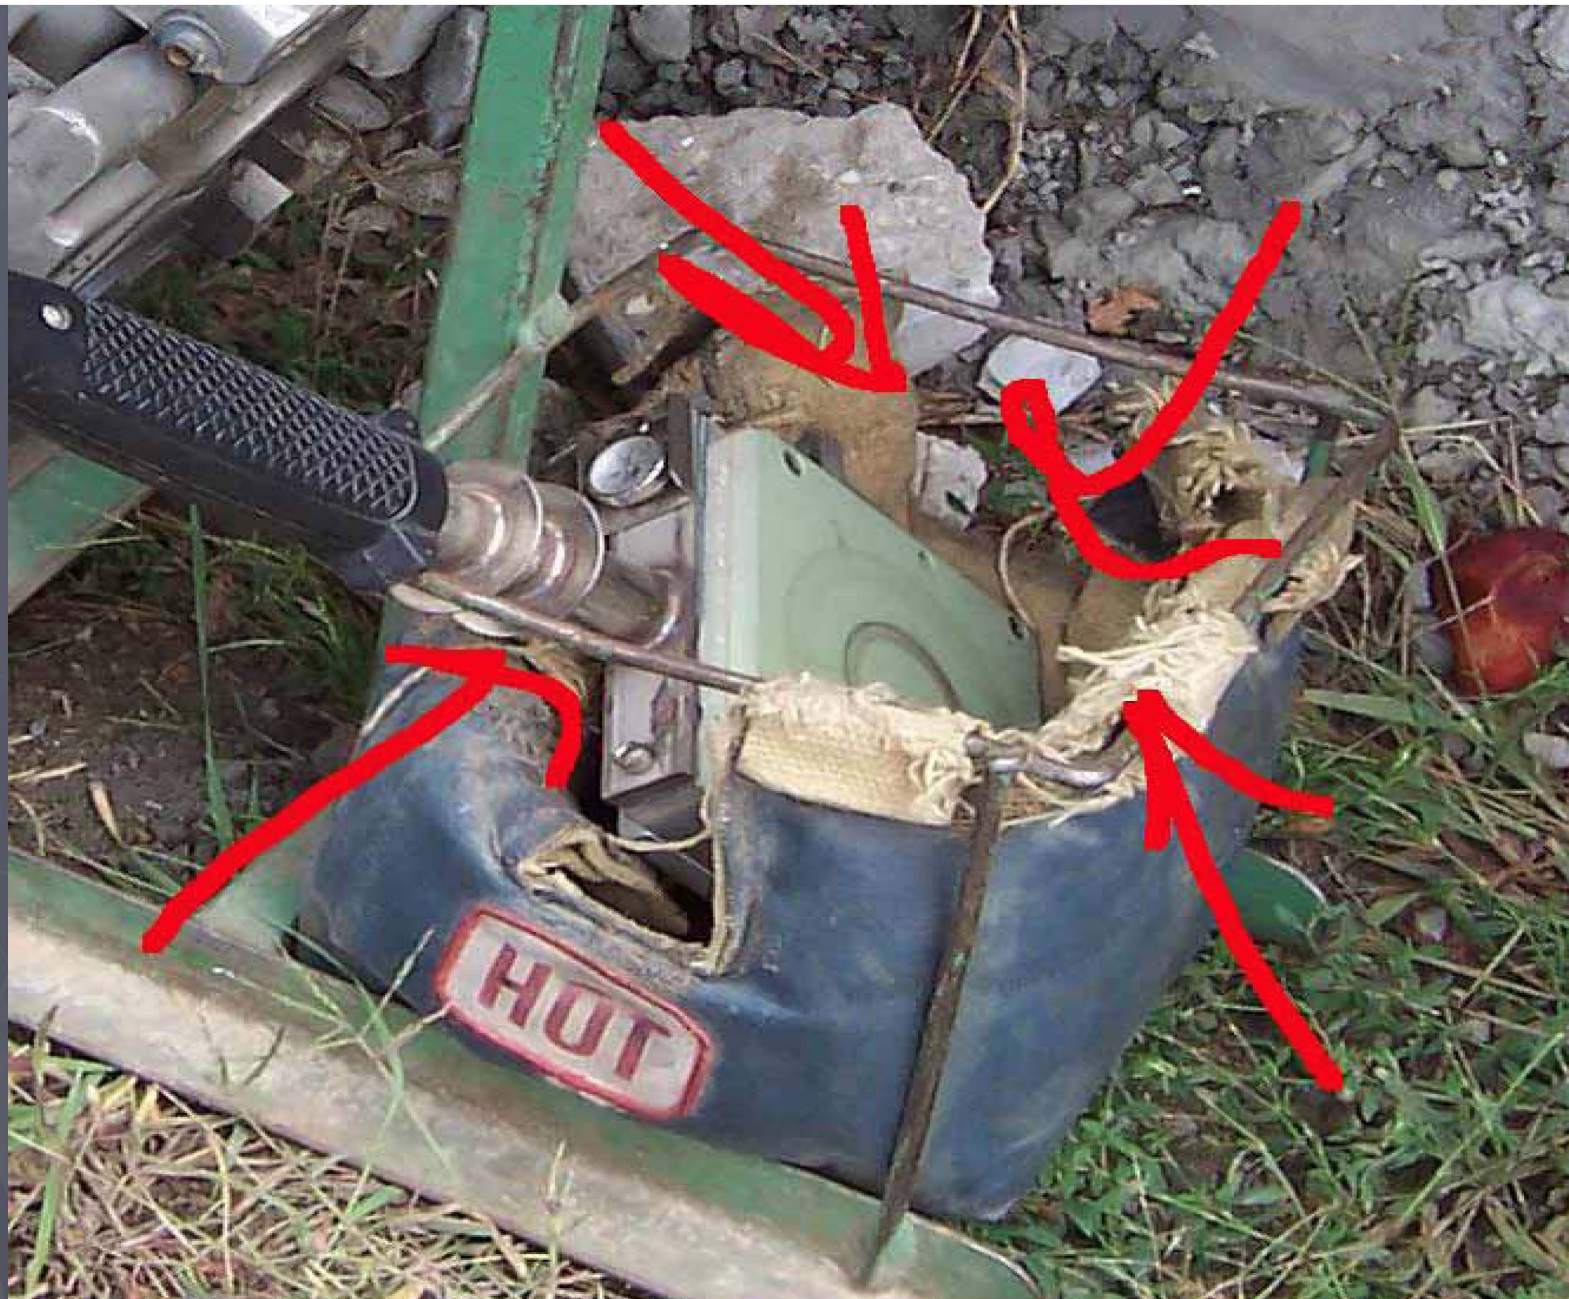
Ripped heater bag and dirty heat plate.

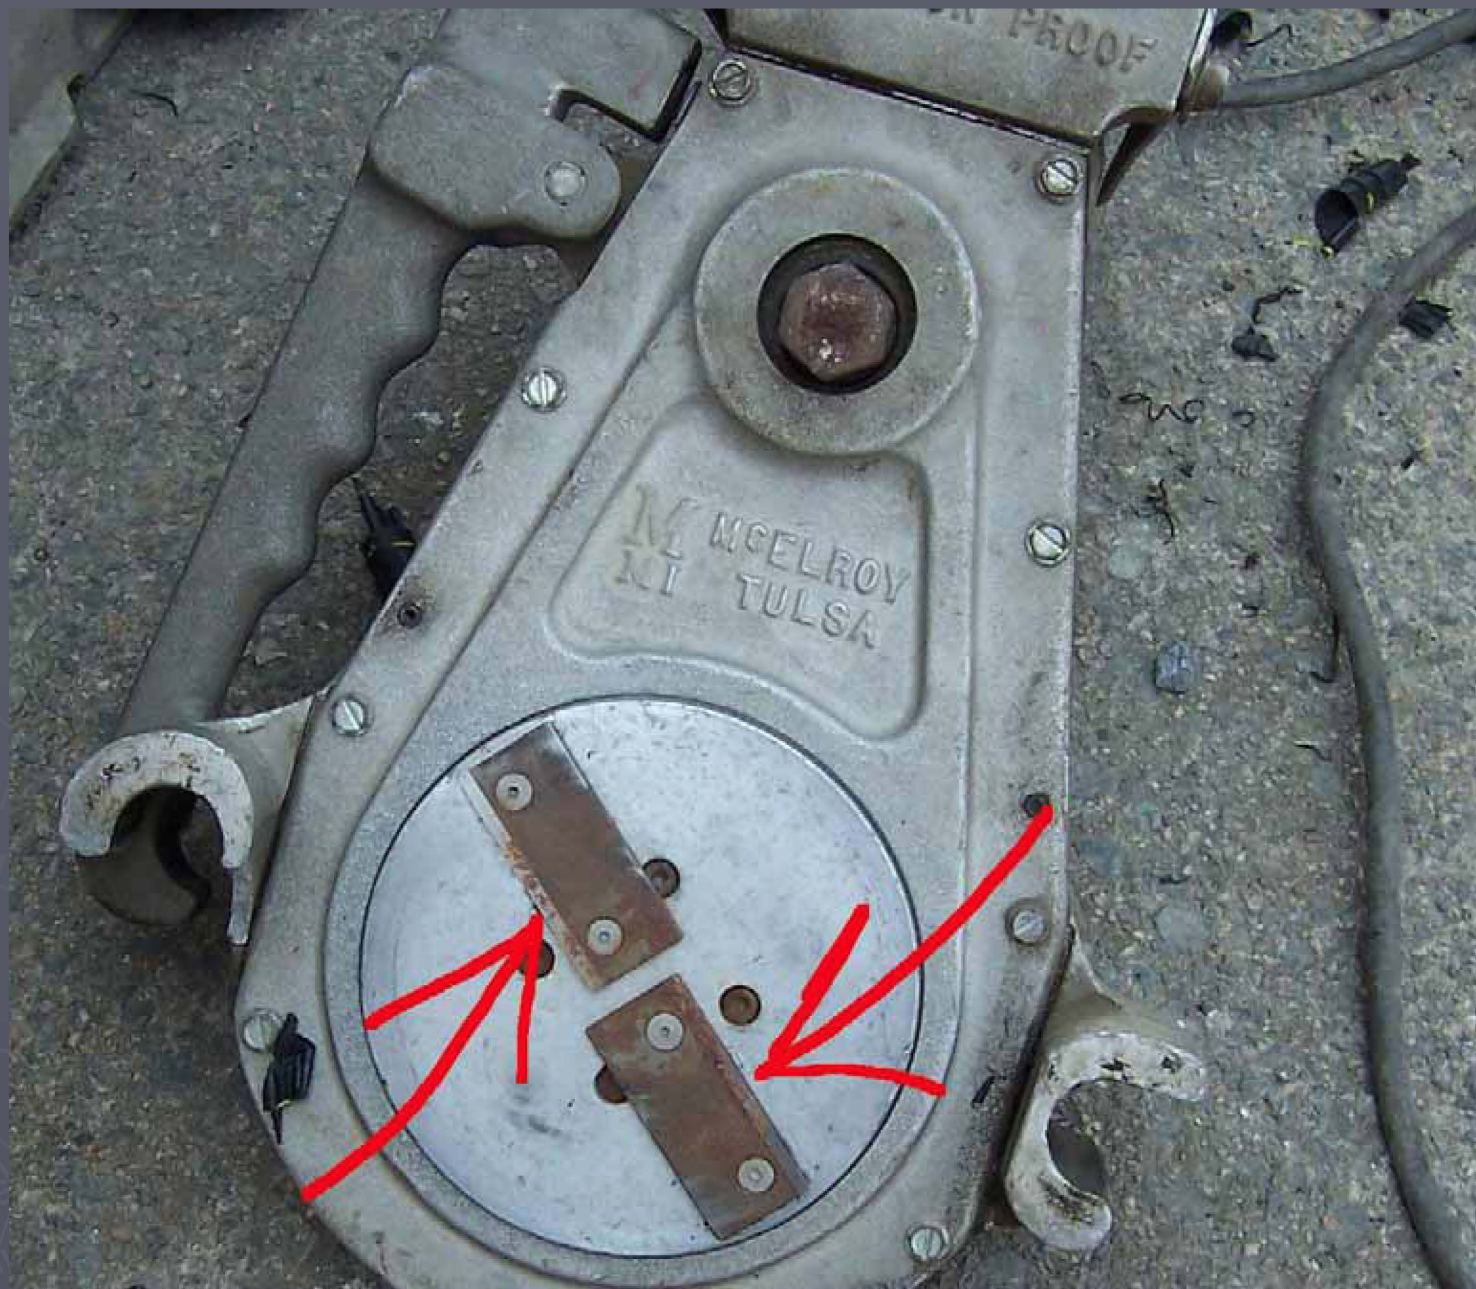
Rusty facing blades, your prone to failure.
