Construction & Pipeline Coatings

Corrosion Found Less than One Year of Service

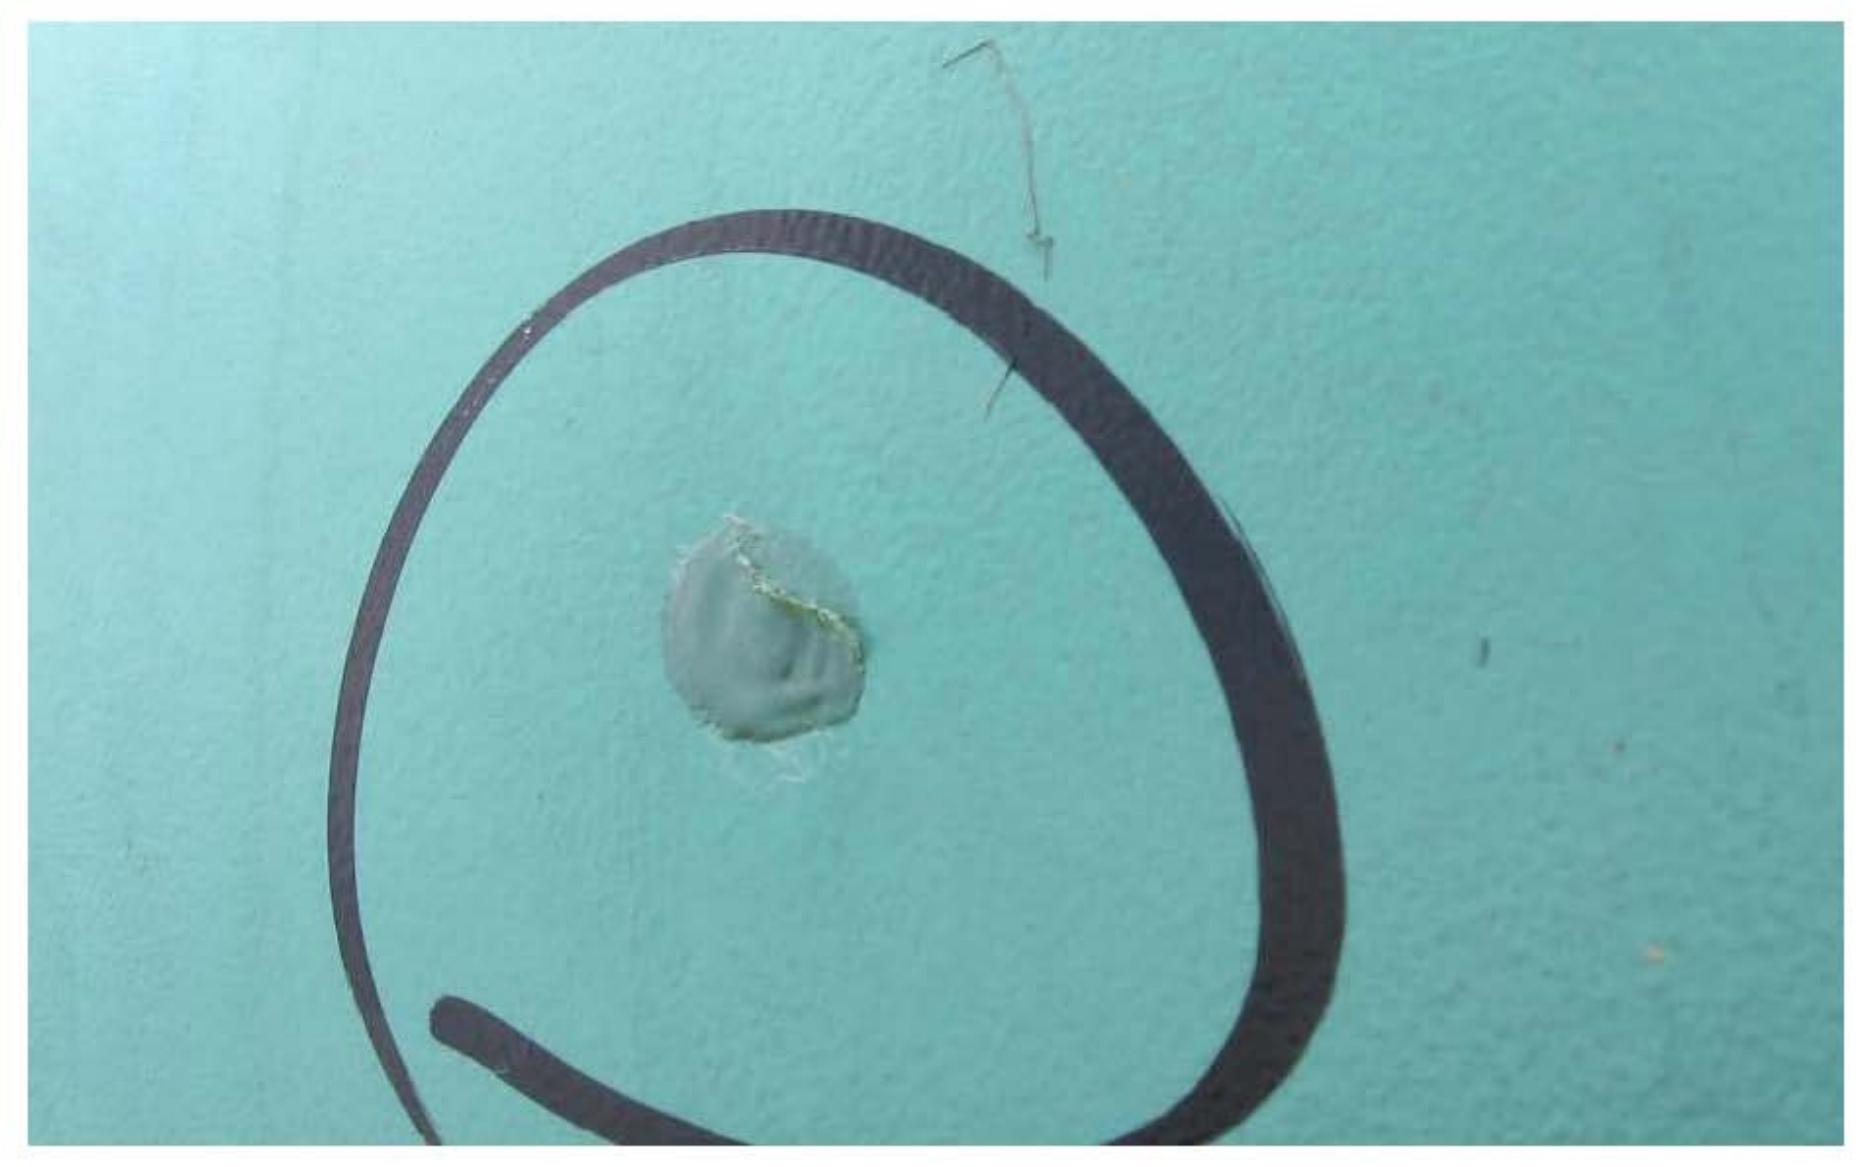
Poor Patch Stick Application Lack of Adhesion

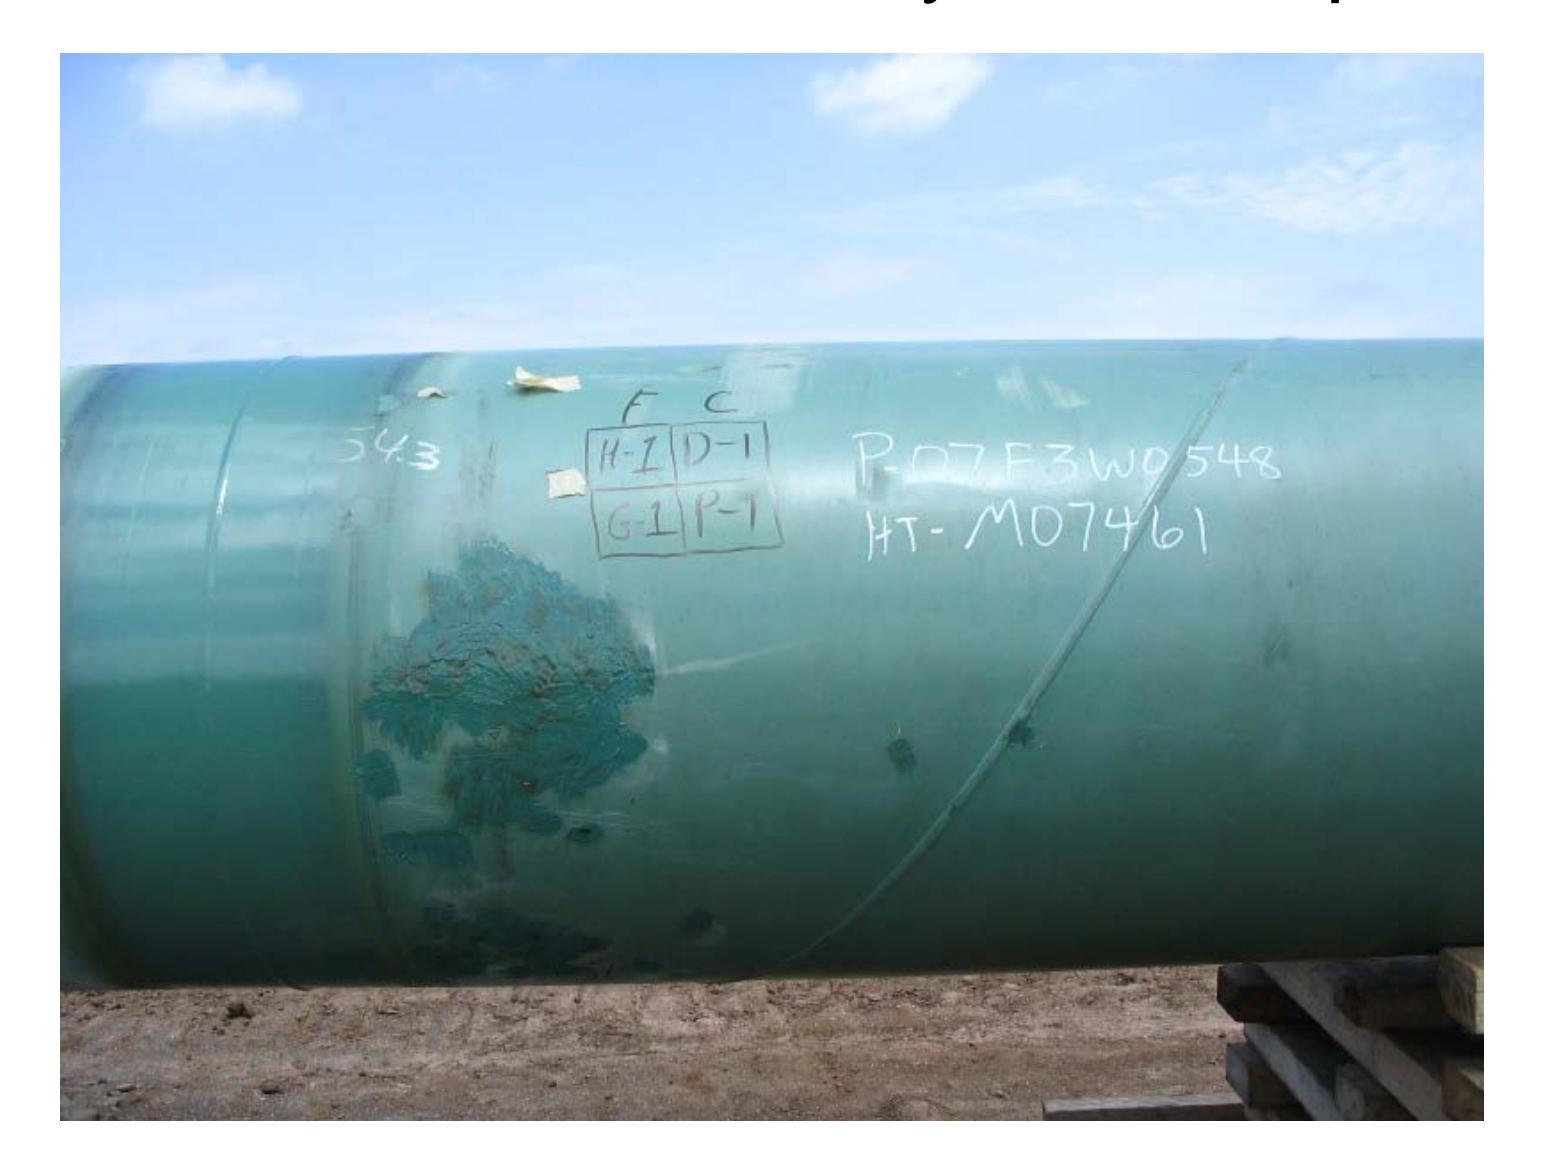
Excessively Large Patch Stick Application Use for Pinholes Only on 42" Pipe

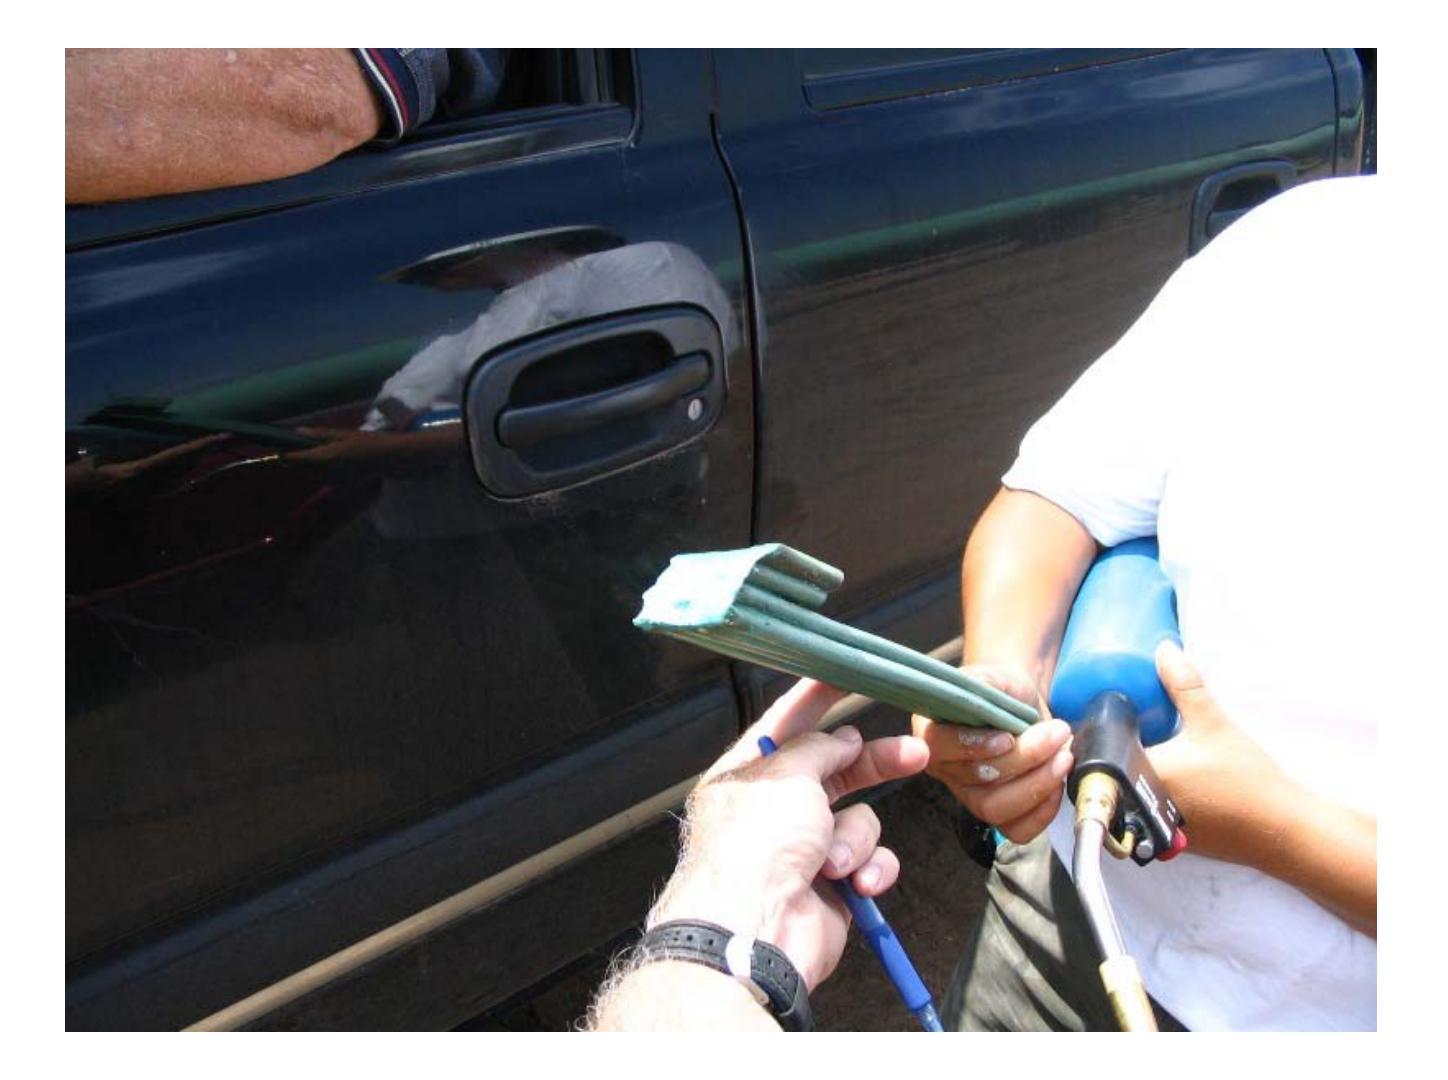
Inappropriate Bundling of Patch Sticks Use One Only-Small Areas

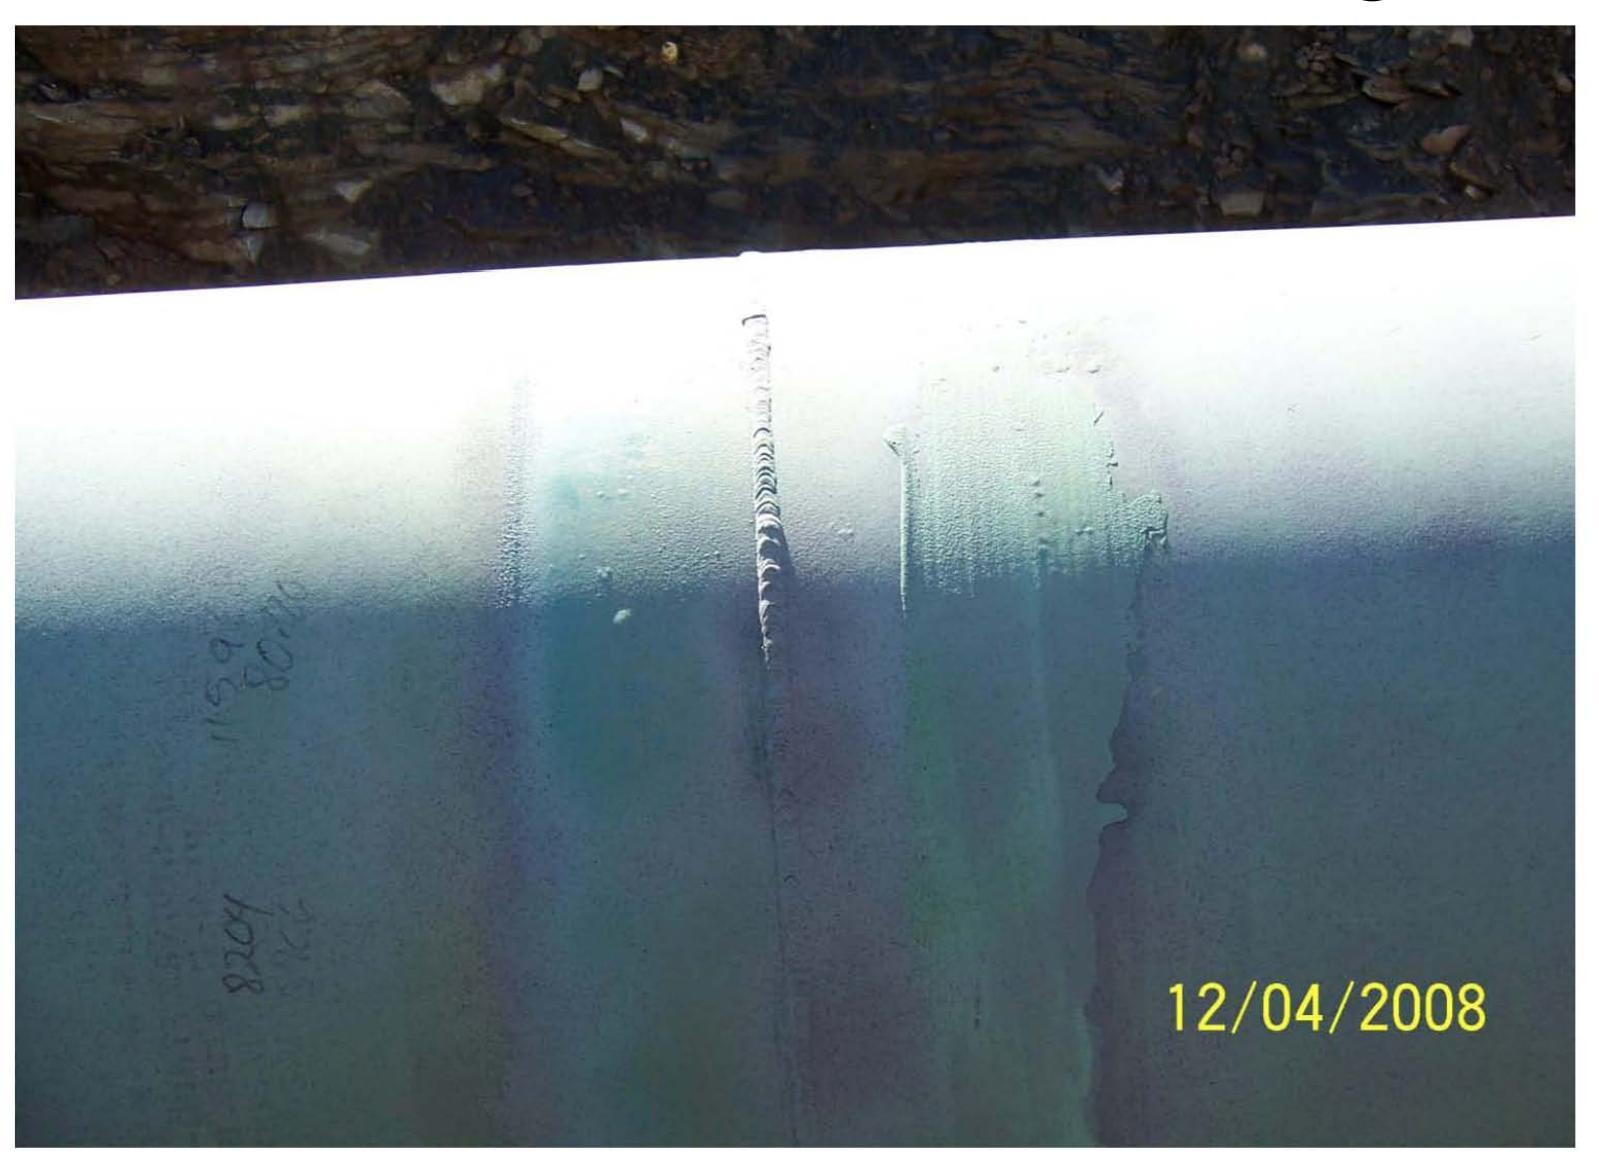
Thin Field Joint Coating

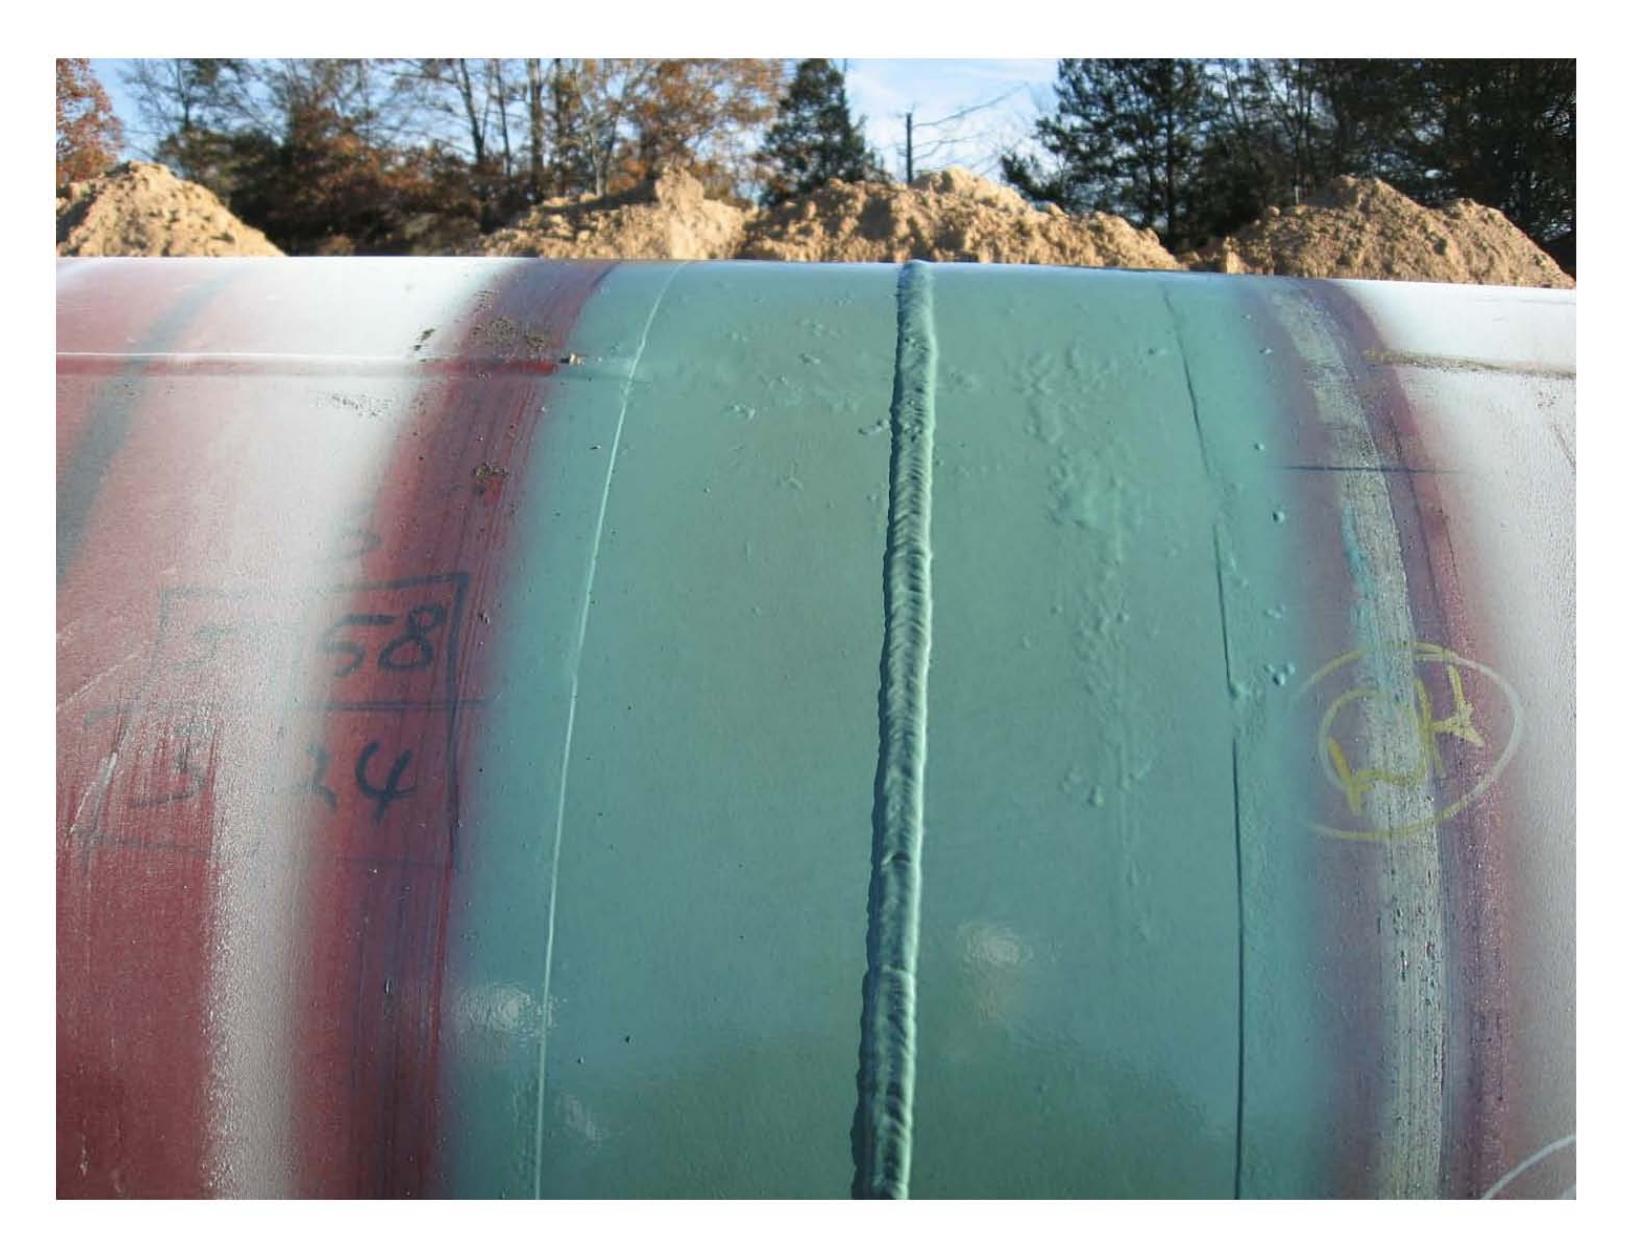
Joint Coating Applied over Dirt/Debris

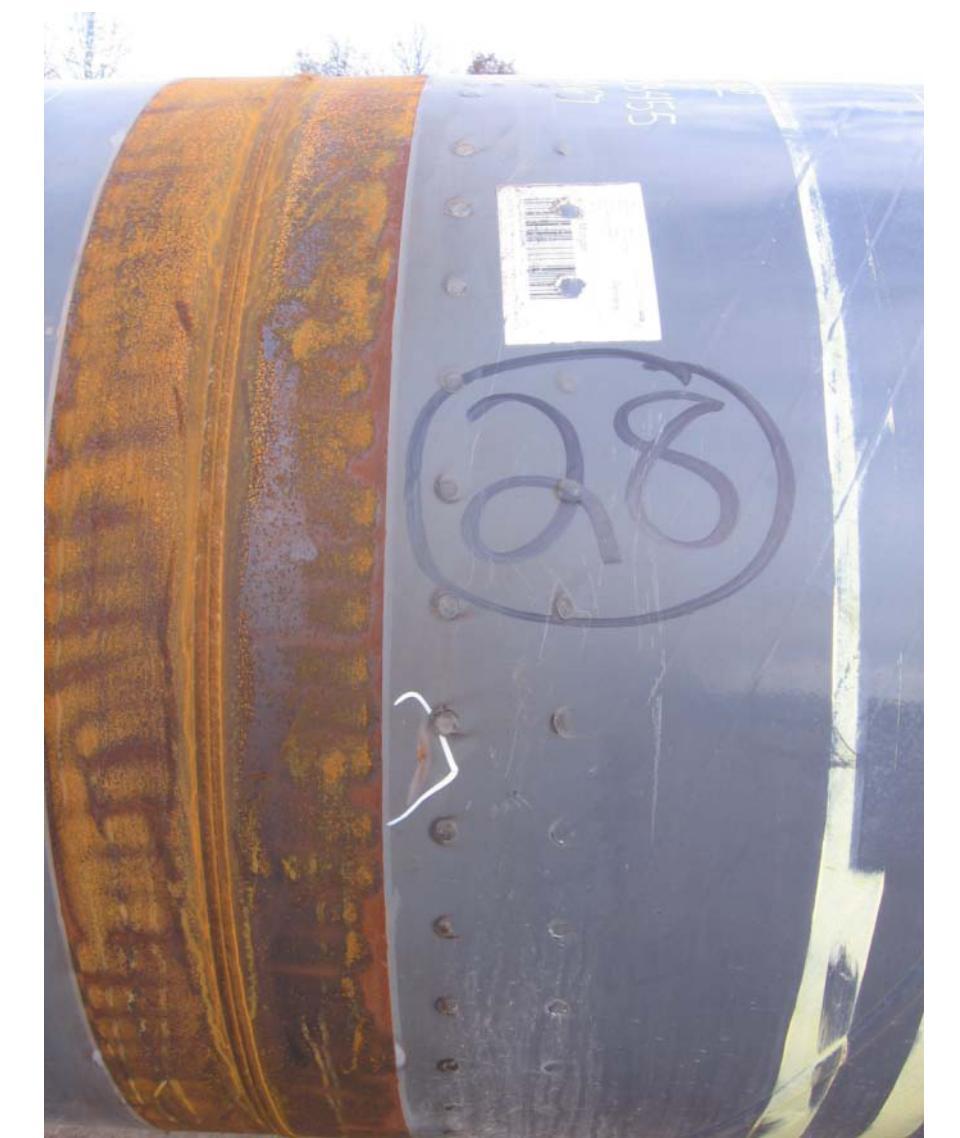
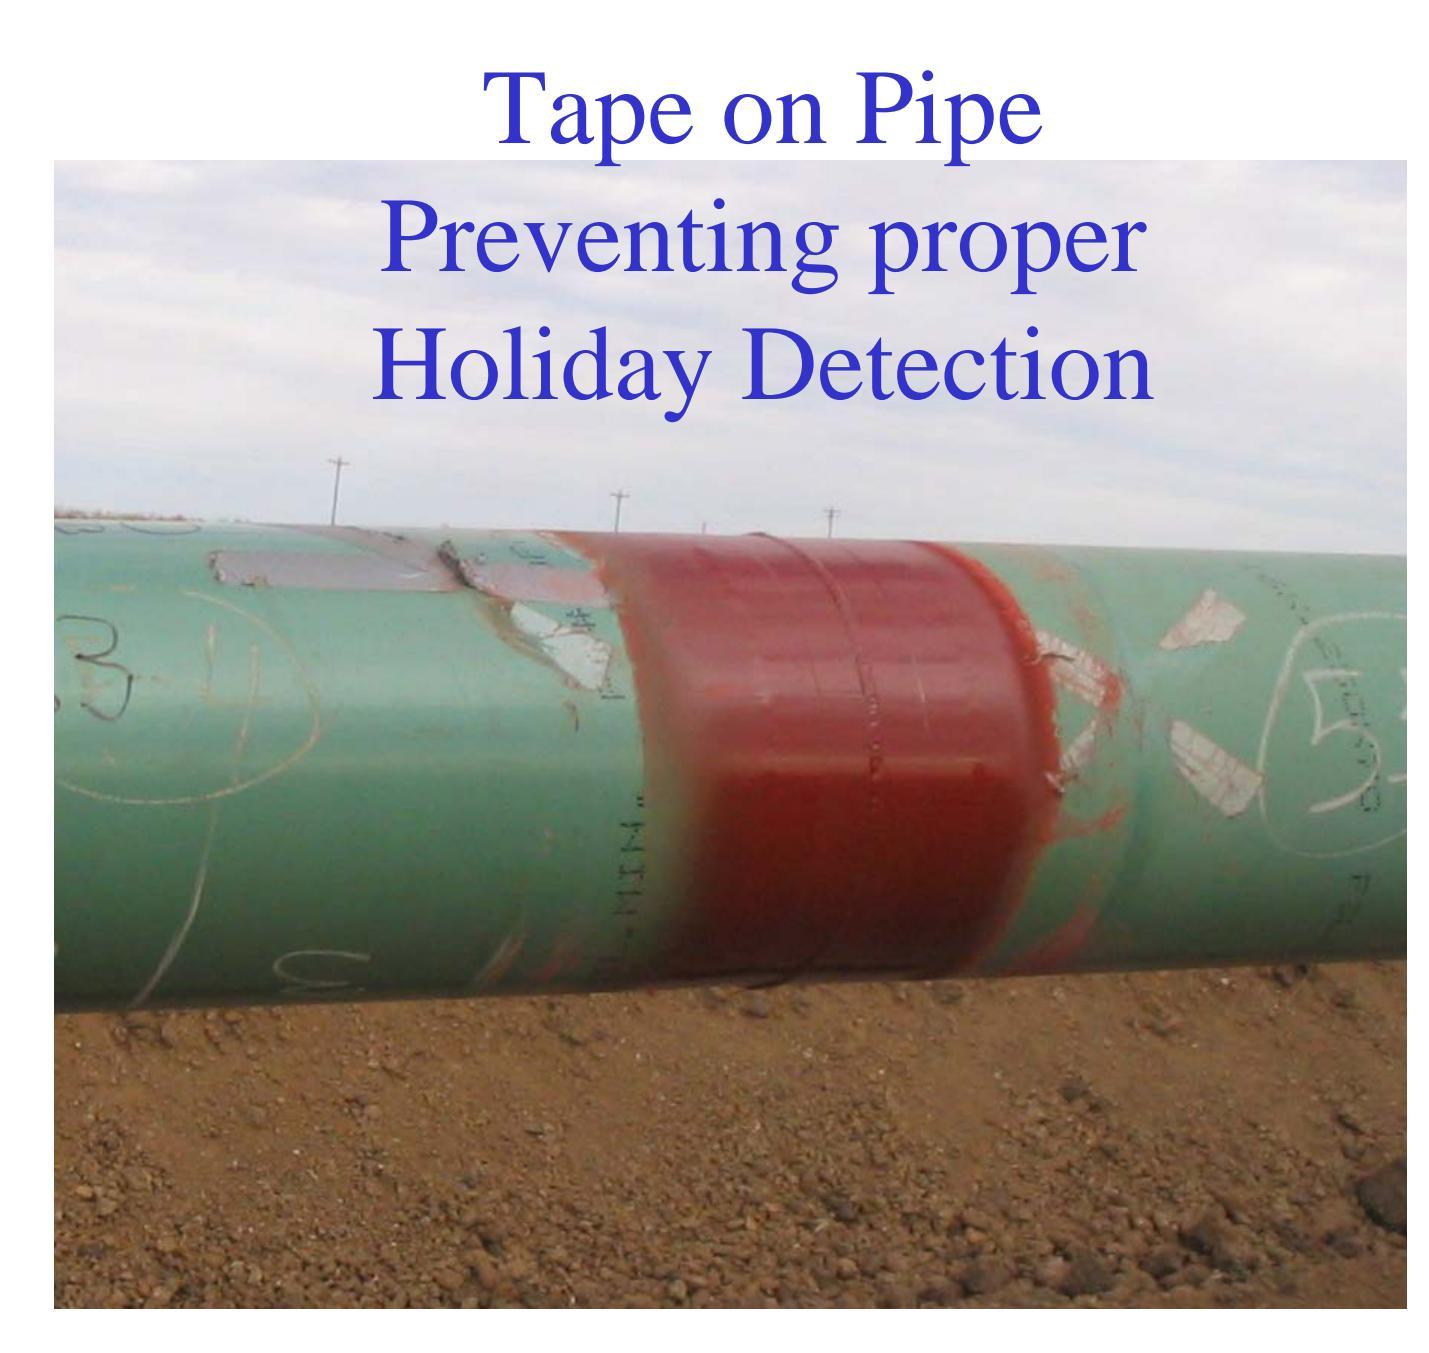
Coating Damage Cause by Welding Band (Jeeper did not indicate holiday)

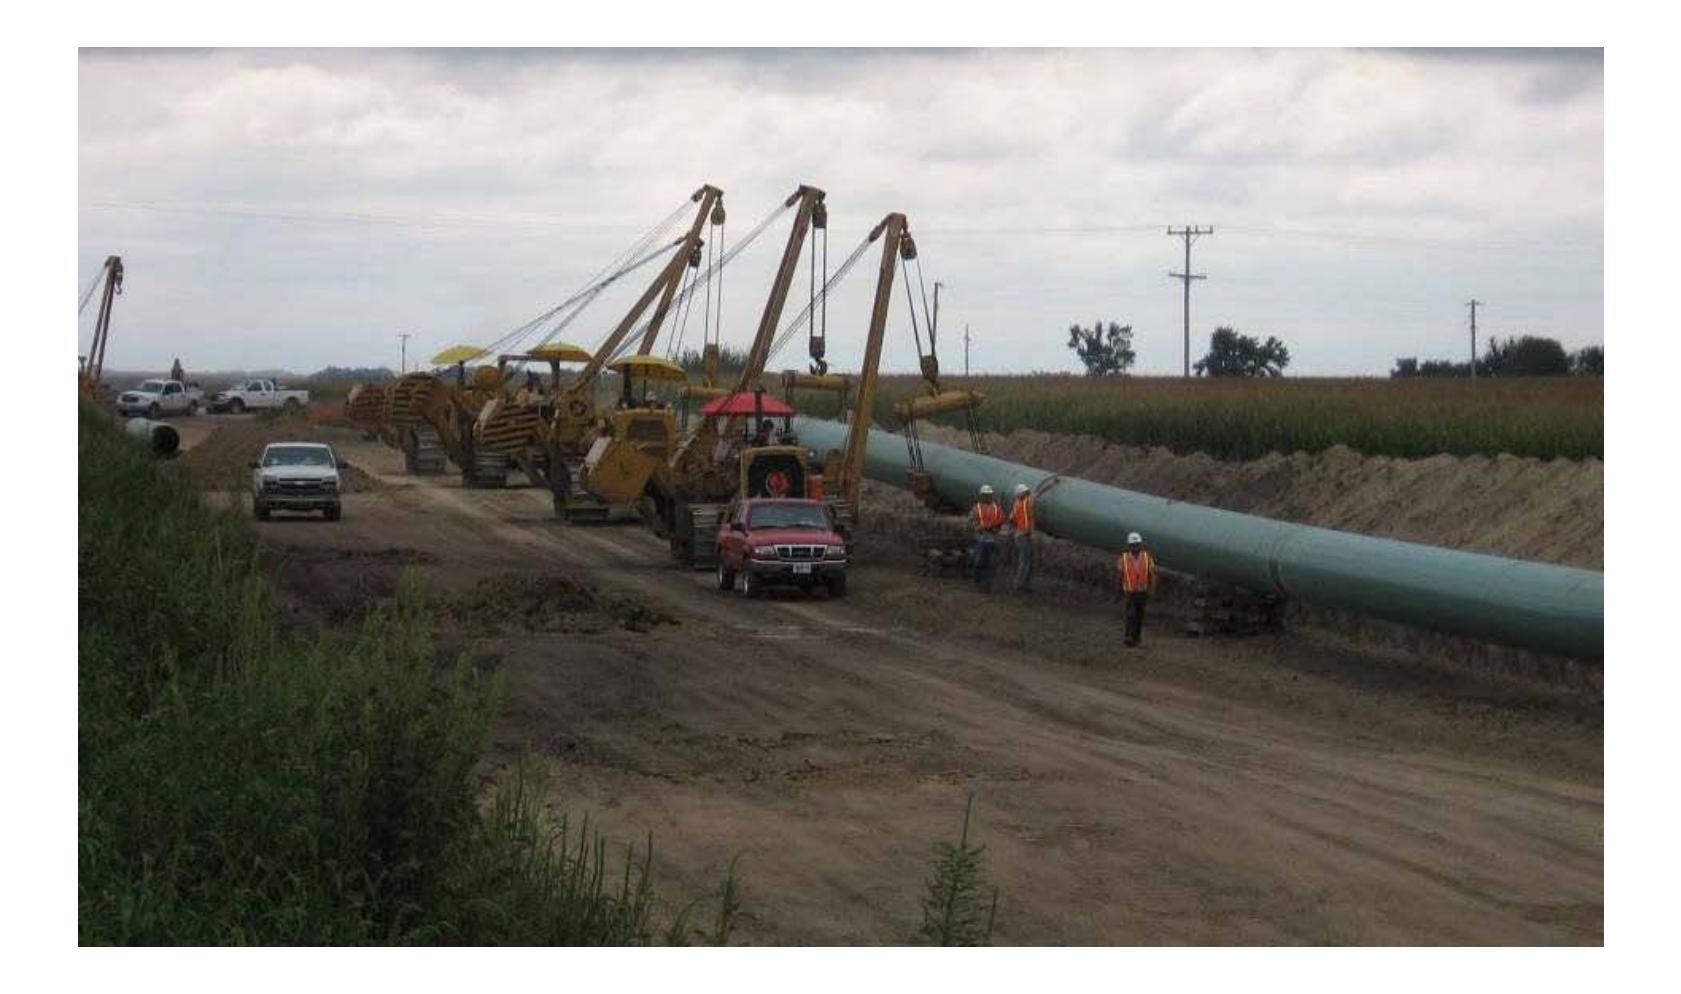
Lowering Sidebooms Spaced Per API 1104, Appendix A, ECA Stress Analysis

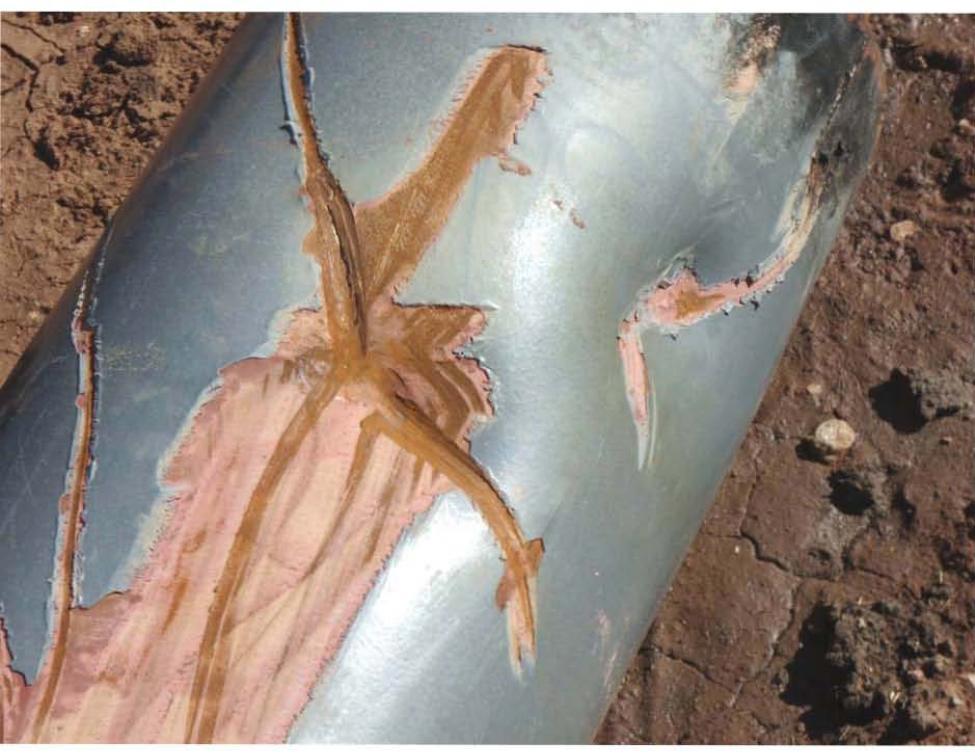
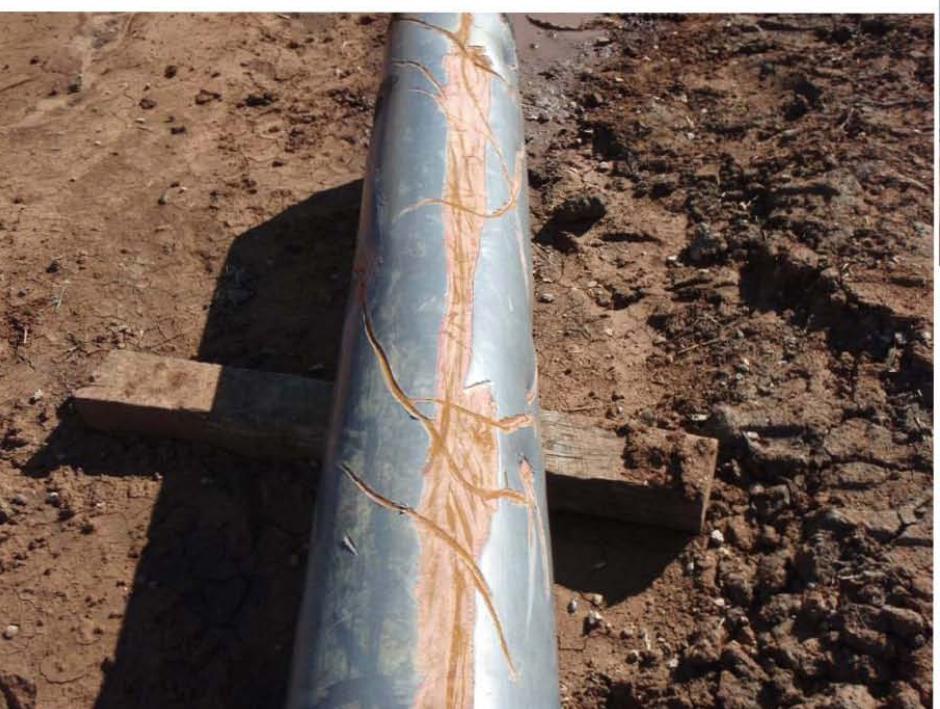
Bored Crossing – Failed Hydro Test

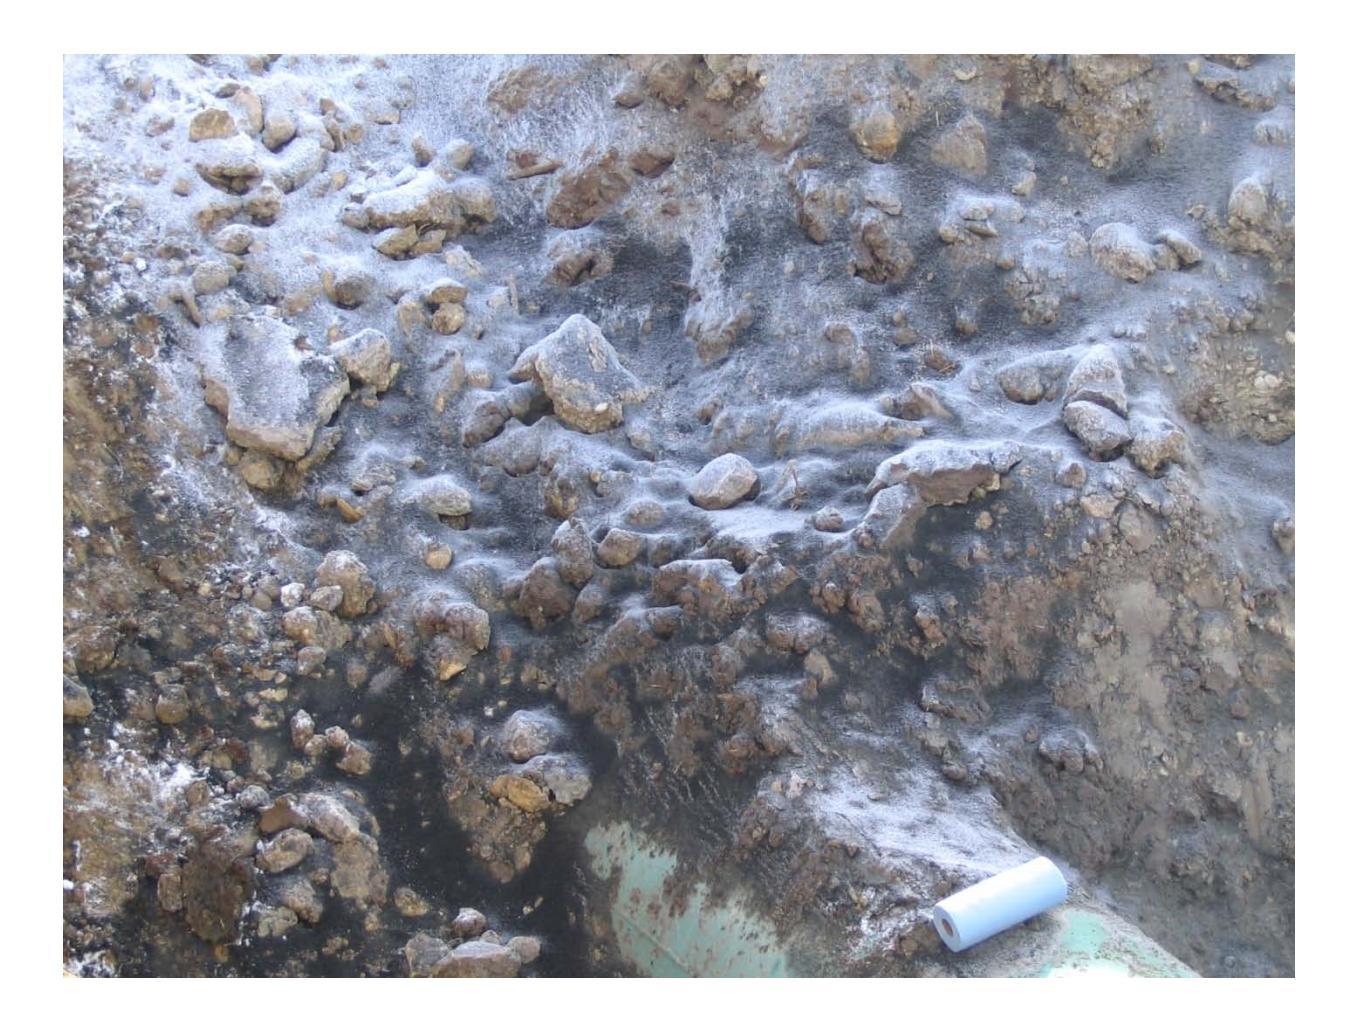
Rocks against pipe (No screening for over 1 mile)

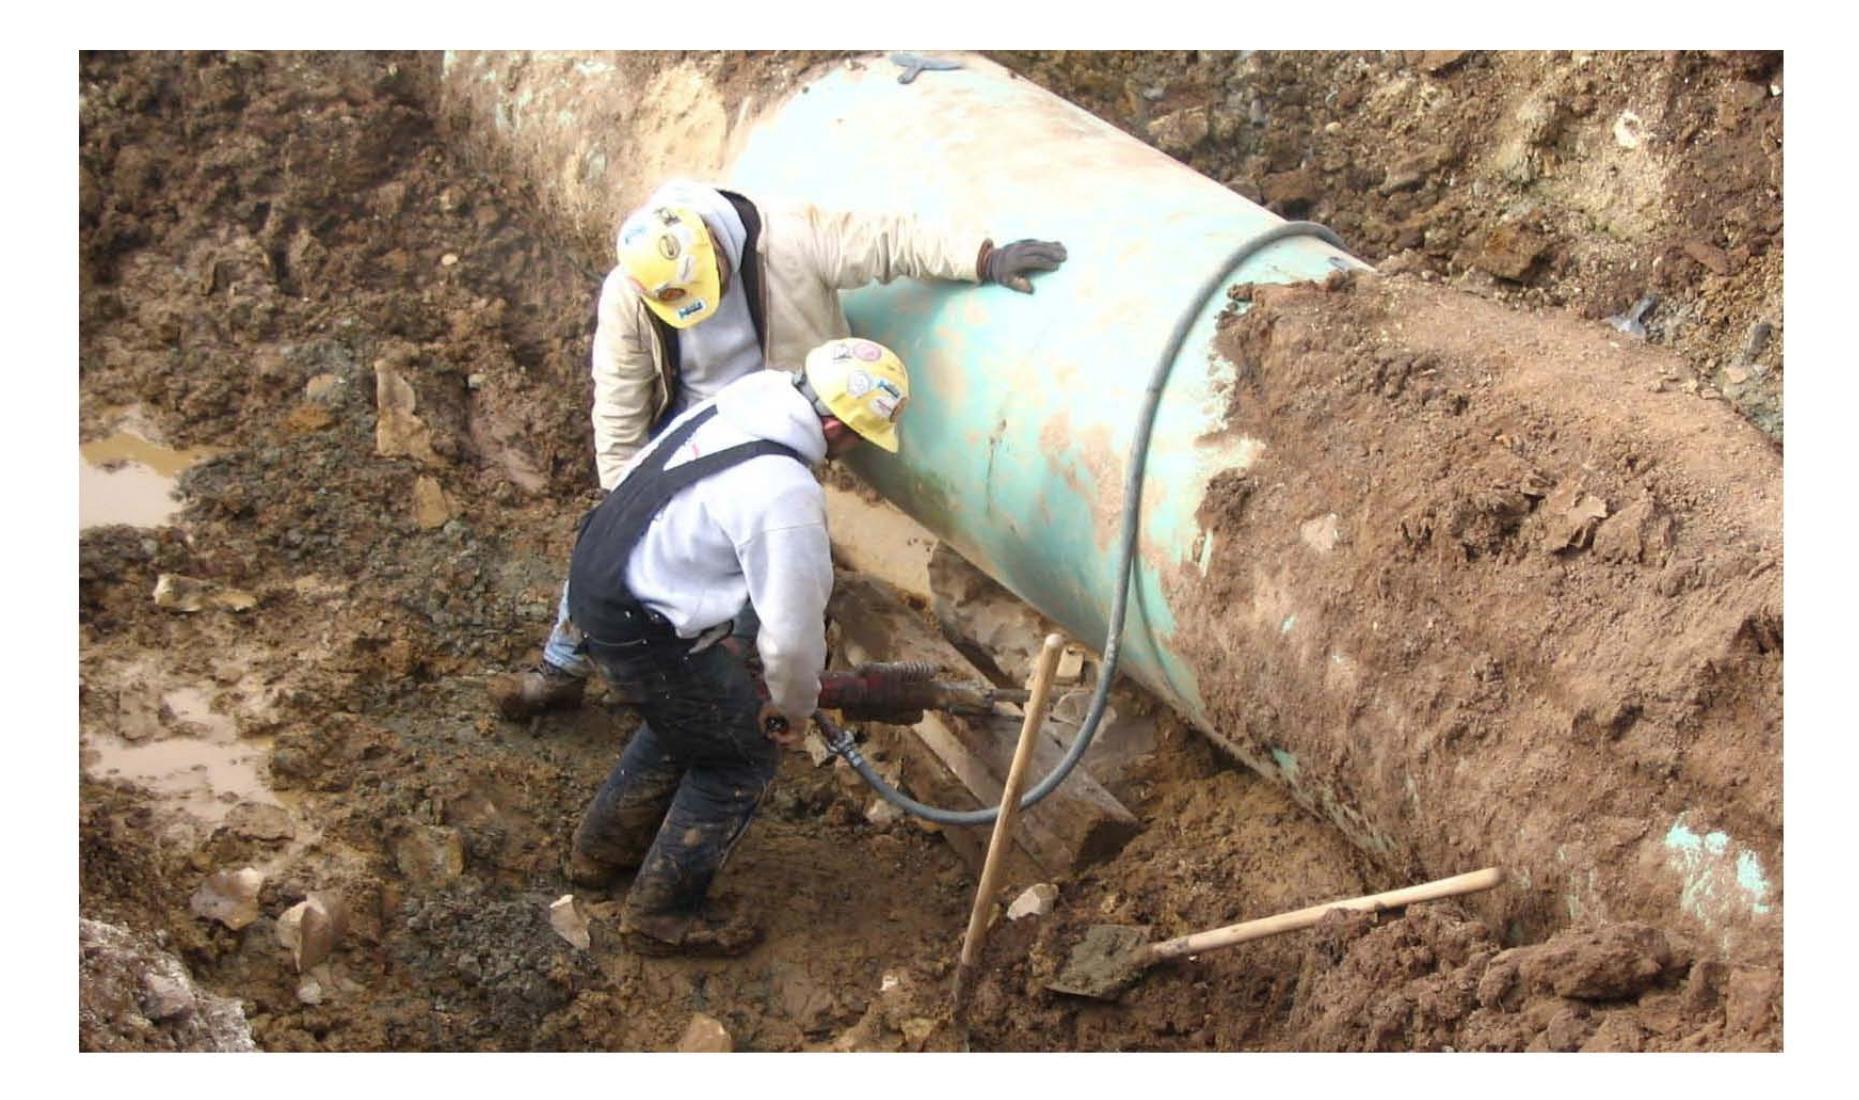
Pipe laid directly on solid rock

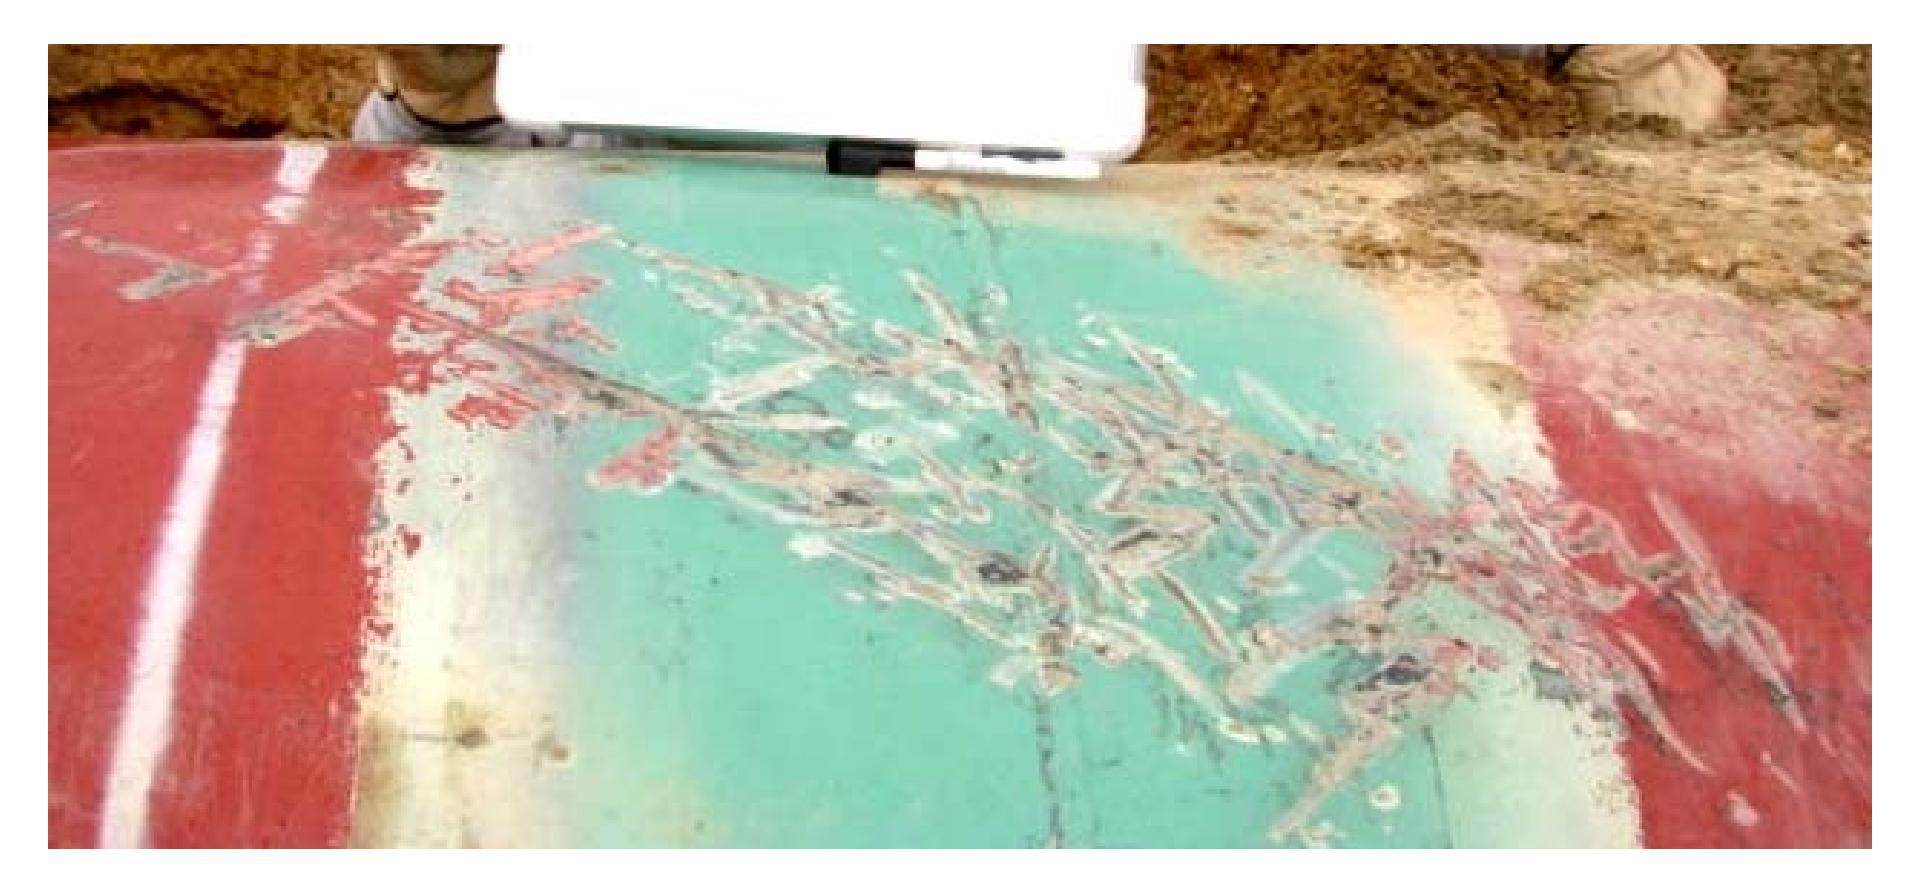
Construction Damage Section of Pipe was Replaced (found by DCVG Survey-Line was in Service)

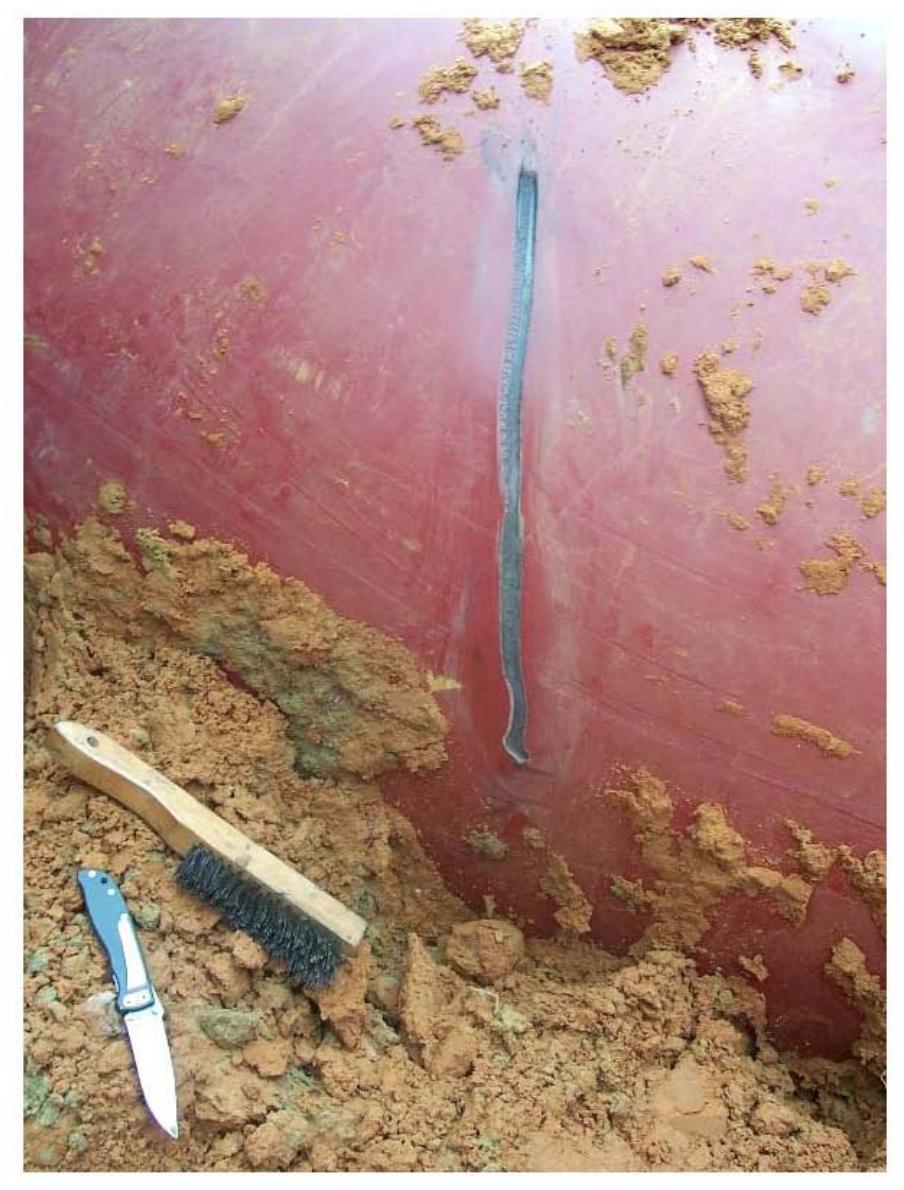
Gouge in Pipe

(found by DCVG Survey-Line was in Service)
