**KANSAS CORPORATION COMMISSION**  
*Remediation Site Status Report*

**Abandoned Oil and Gas Well / Remediation Site Fund  
Remediation Sites  
Status Report**

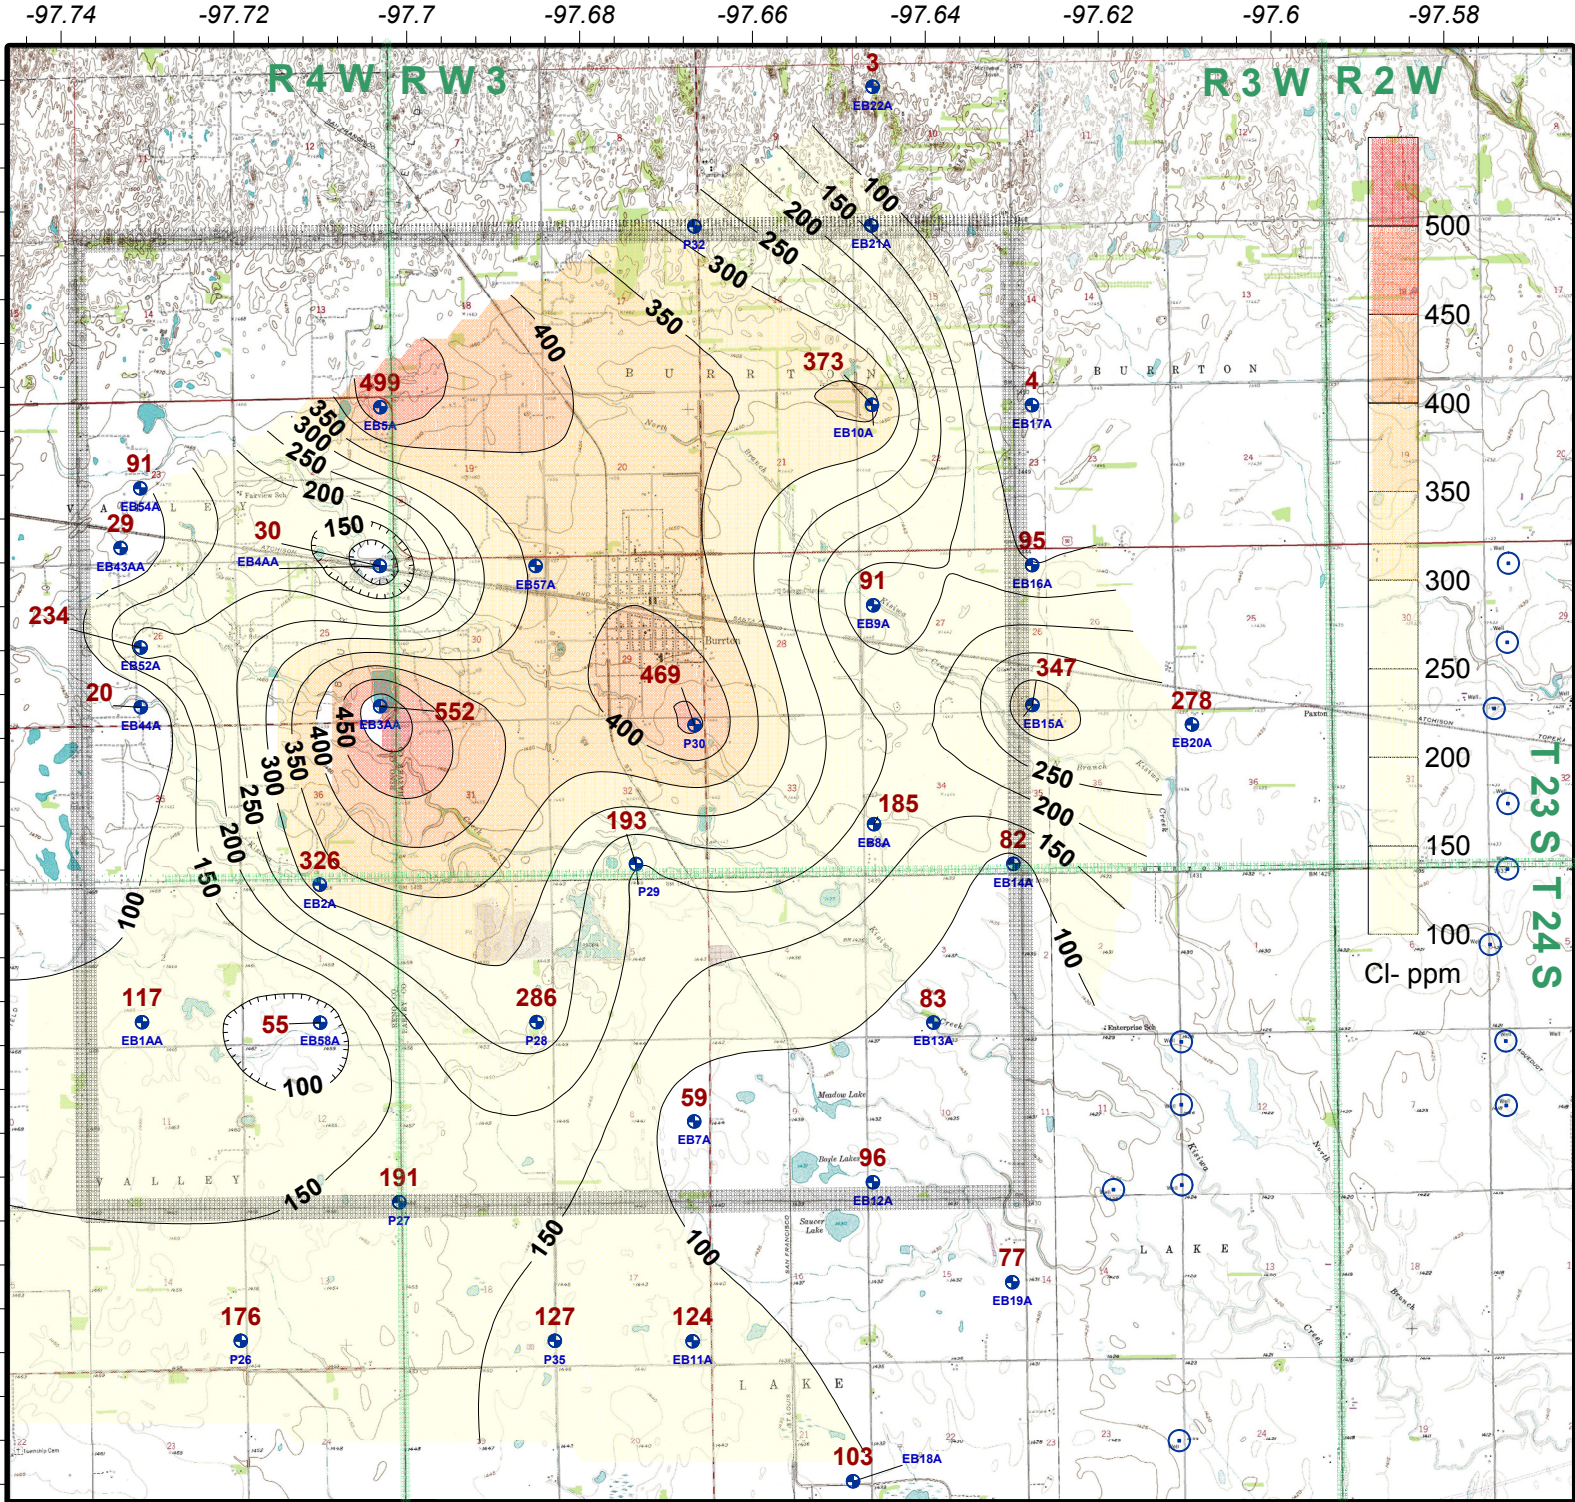
**Burrton (IGUCA) Oil Field Brine Contamination Site**  
**2013-14 Equus Beds A Zone Chloride Concentration Map**  
 Harvey and Reno Counties, Kansas - KCC Control #970003-00  
 KCC District #2 - Sampled by GMD#2 - Map Drawn by D. Bollenback on 9/18/2013

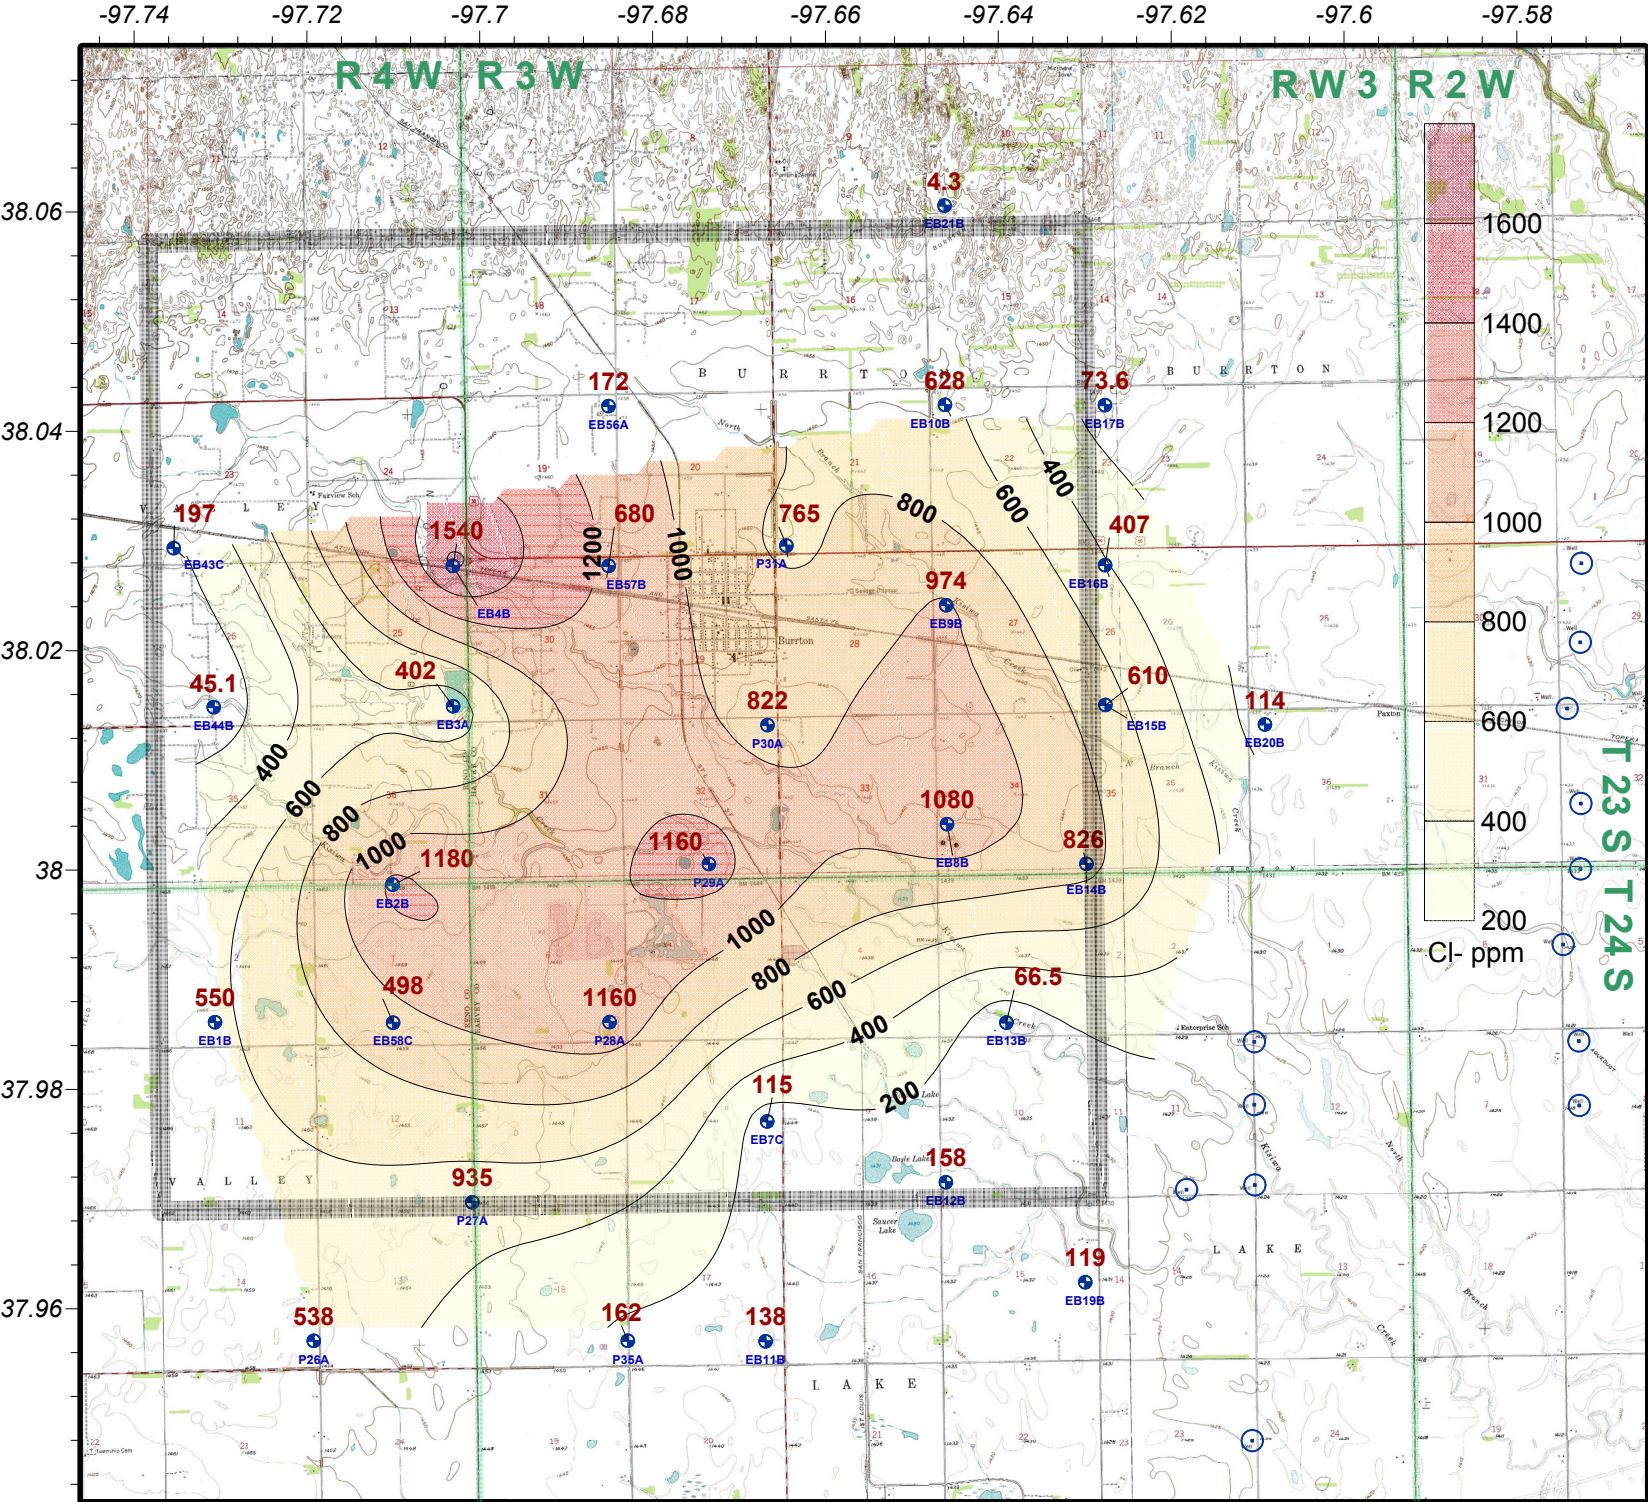
**Burrtion (IGUCA) Oil field Brine Contamination Site**  
**2013-14 Equus Beds B Zone Chloride Concentration Map**  
 Harvey and Reno Counties, Kansas - KCC Control #970003-00  
 KCC District #2 - Sampled by GMD#2 - Map Drawn by D. Bollenback on 9/18/2013

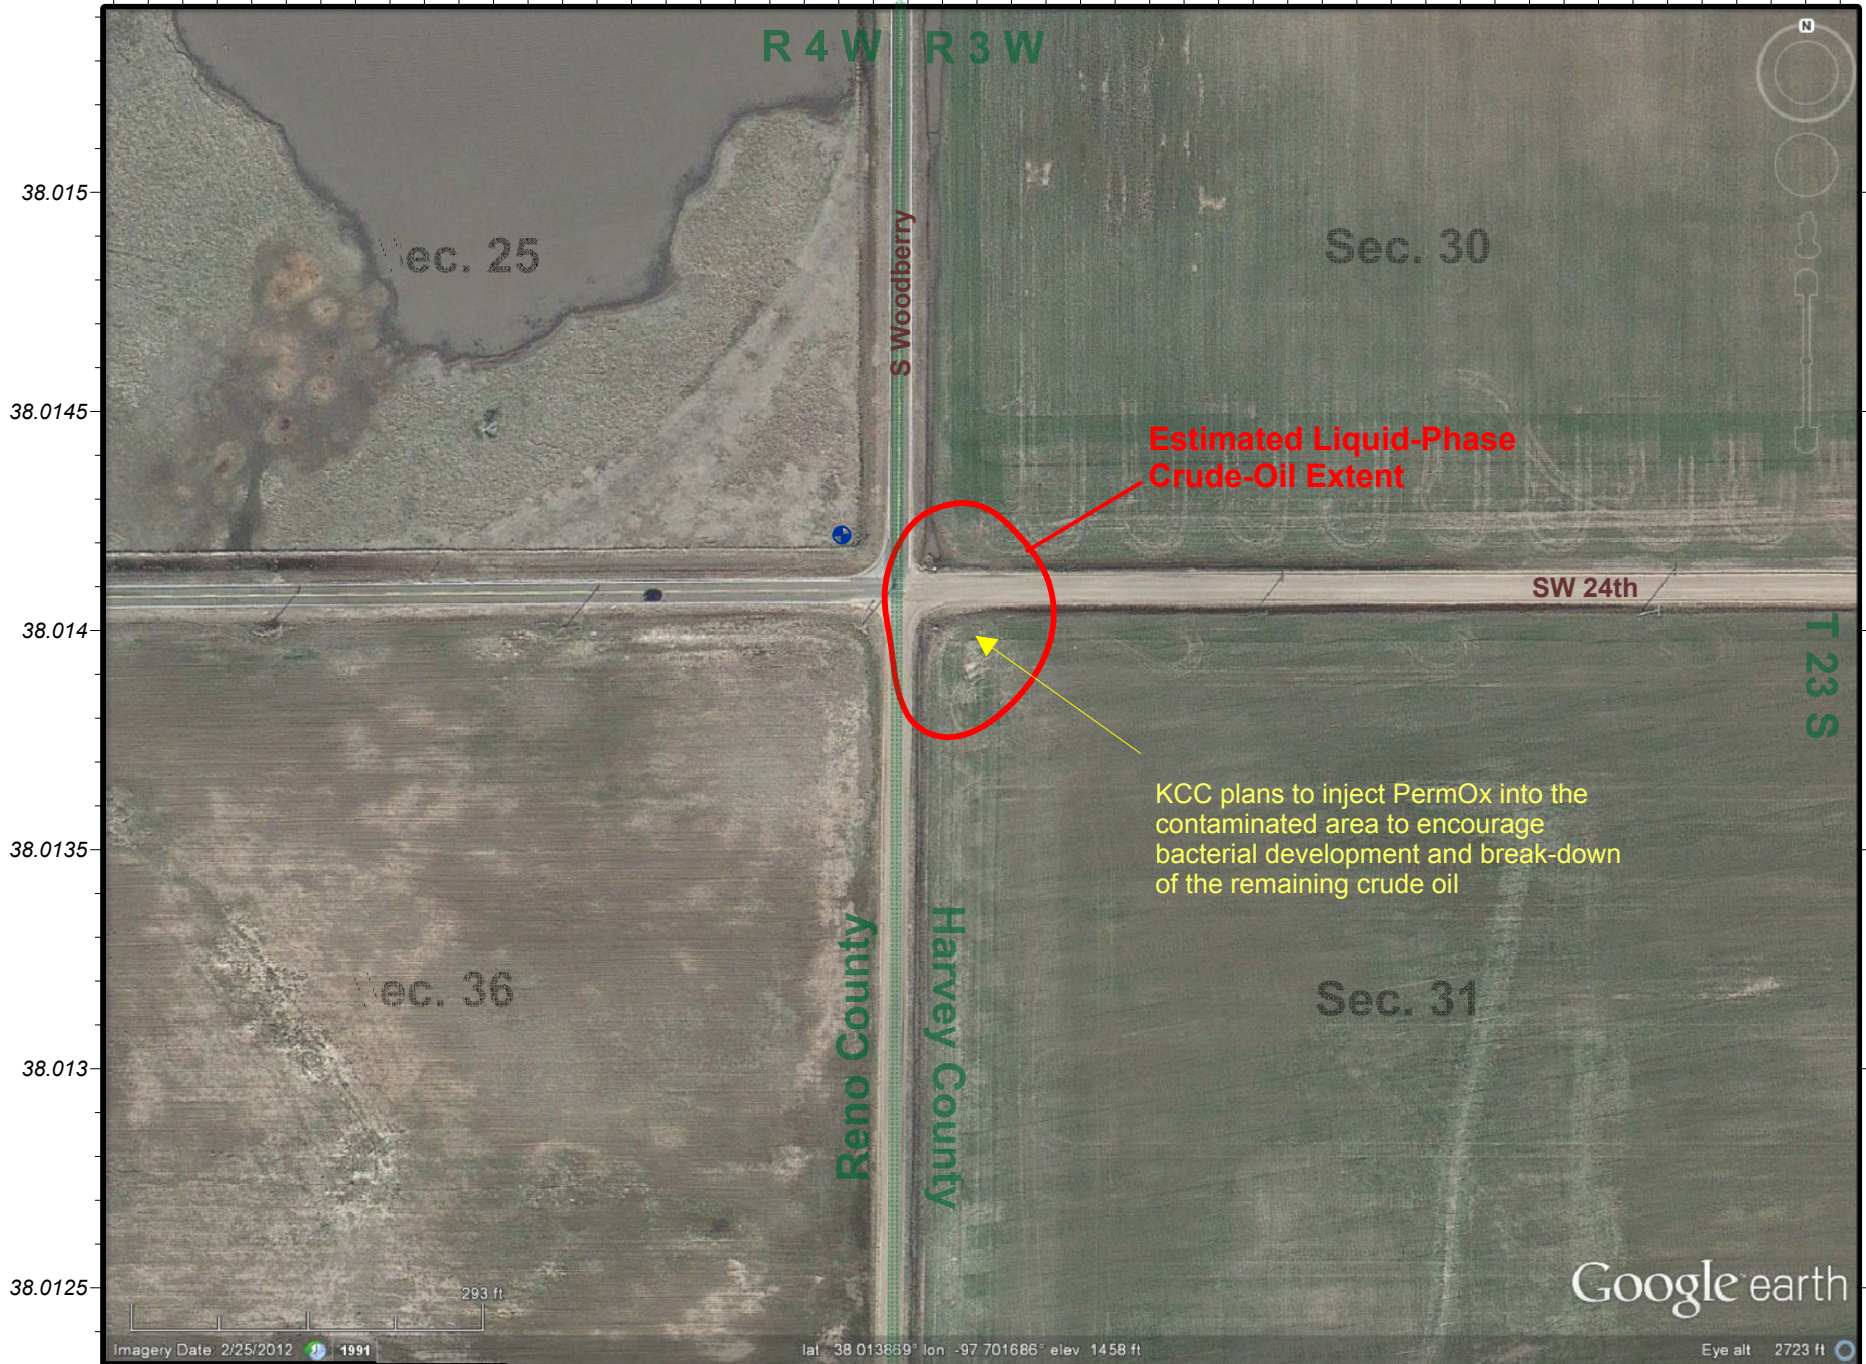
Burrton EB-3C - Crude Oil Spill - Control # 970042-00  
 Section 25, Township 23 South & Range 4 West, Harvey and Reno Counties, Kansas  
 Annual Site Update Map  
 District #2 - Drawn on:9/29/2013 by D. Bollenback

**Recommendations for Future Work:** After the injection of Perm-Ox KCC will also install multiple 1 inch monitoring wells to observe the effects and rate of attenuation. After sufficient improvement is found KCC will close the site.

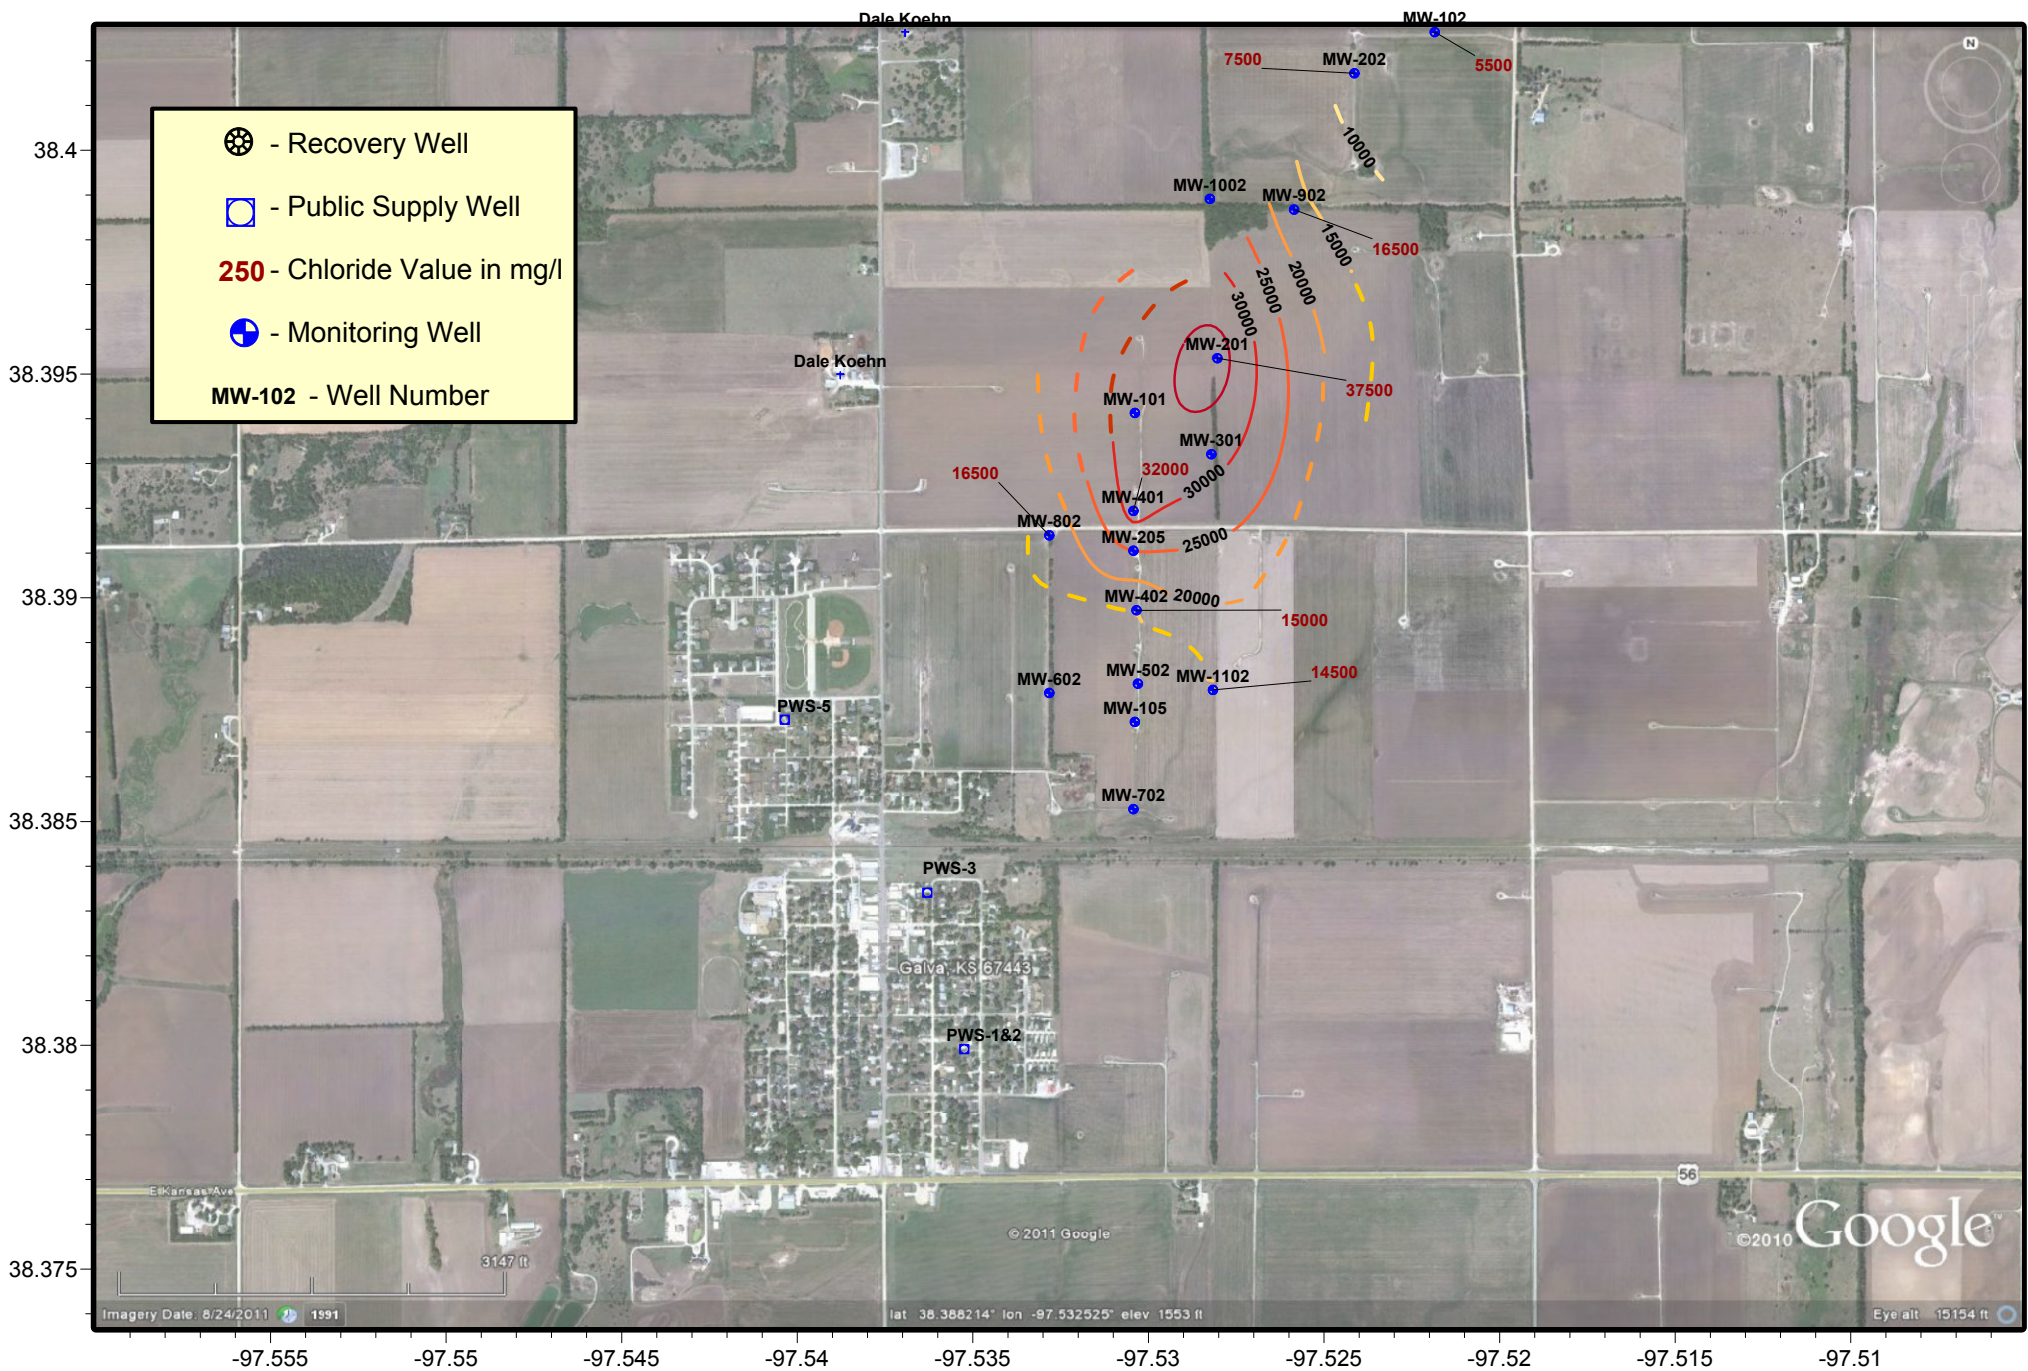
**Galva City Contamination Site**  
 Sec. 15, 16, 21, &22 - T19S - R2W, McPherson County  
**2013-14 Chloride Concentration Map**

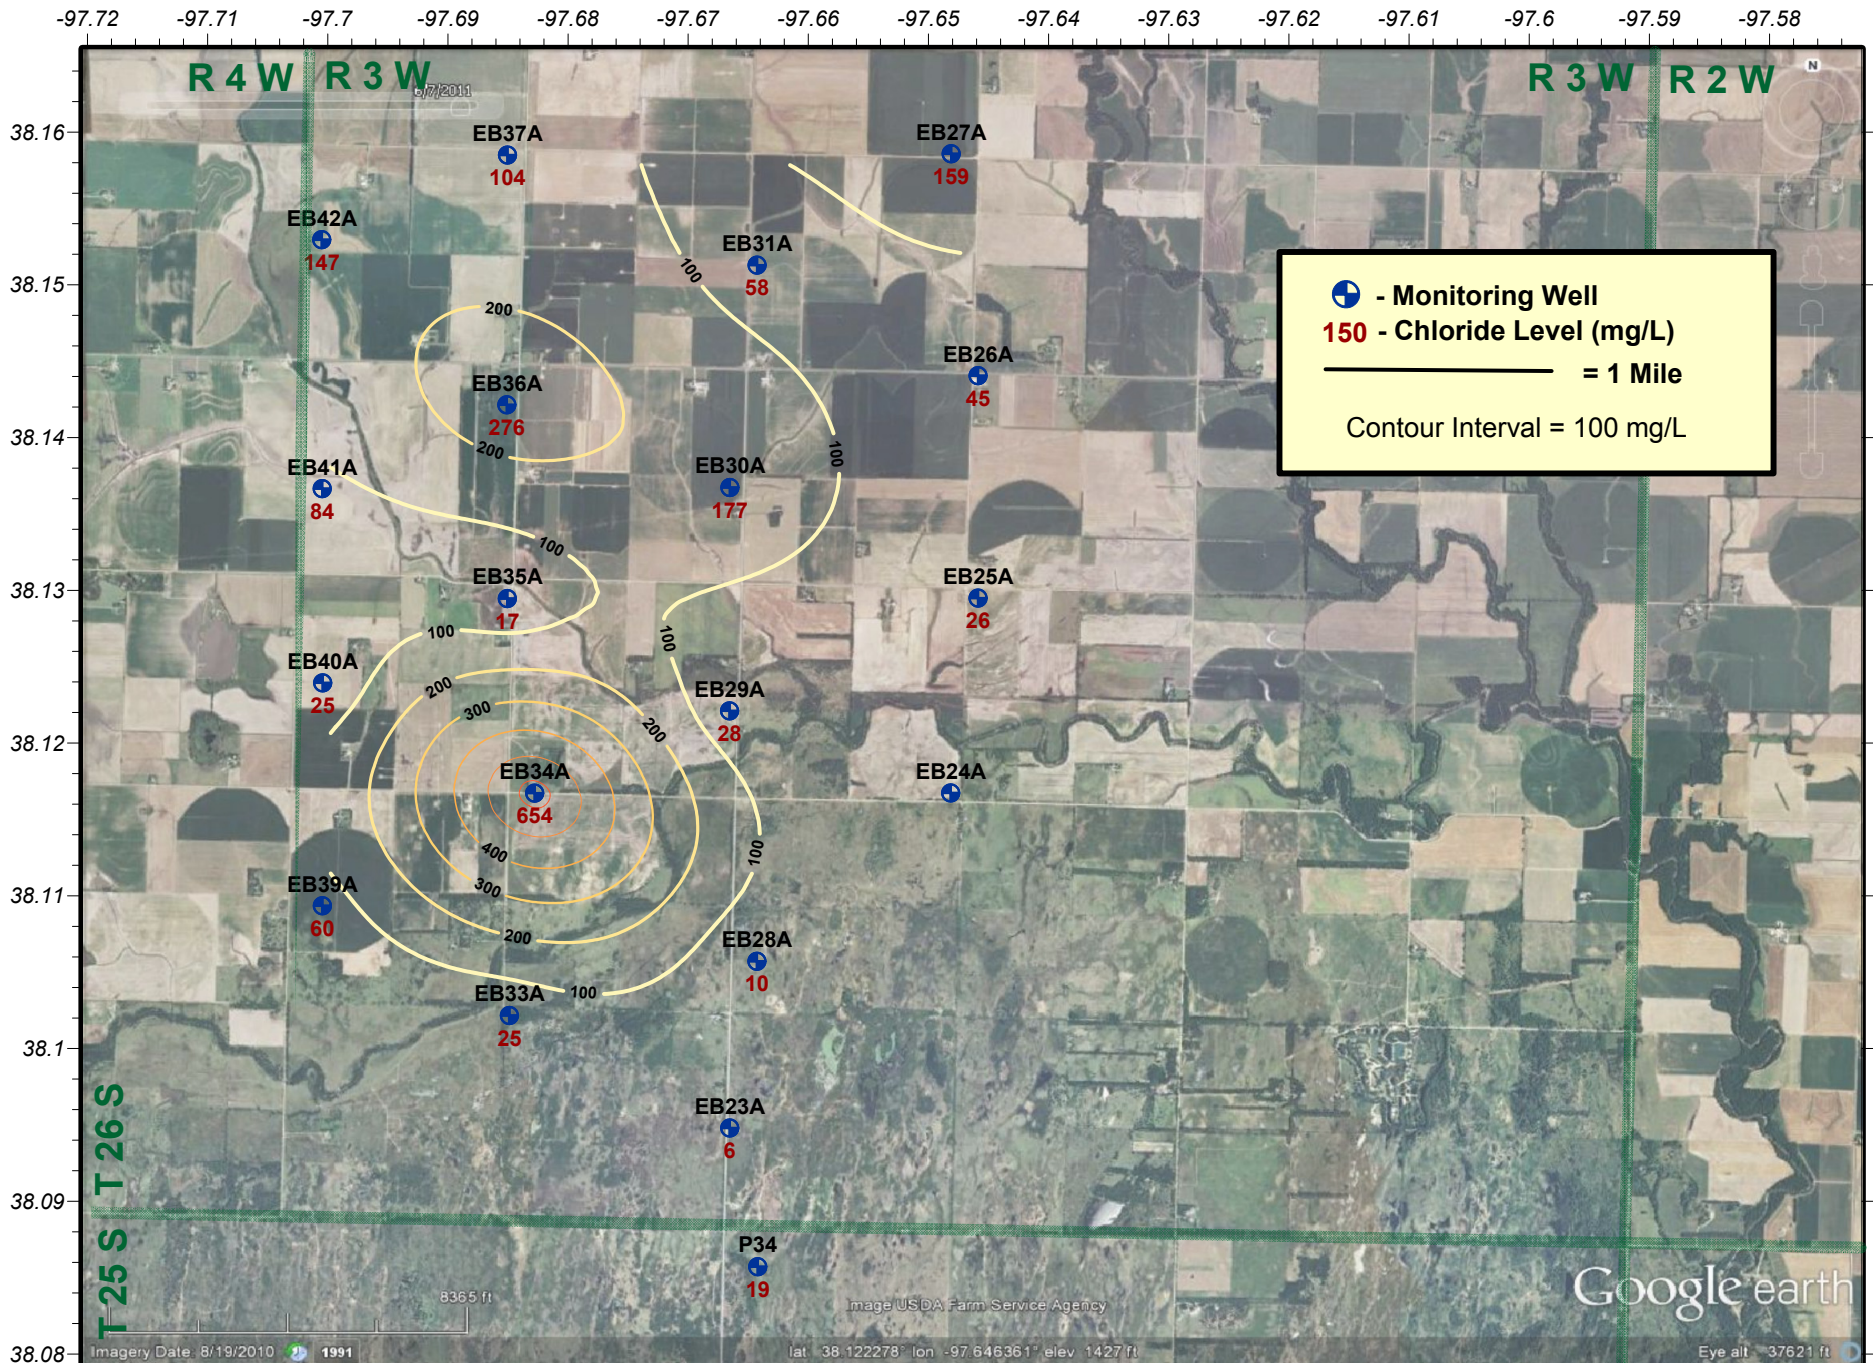
**Hollow-Nikkel Brine Contamination Site - KCC Control #970009-00**  
 Multiple Sections of Townships 25 and 26 South & Ranges 3 and 4 West, Harvey County, Kansas  
 2013 Chloride levels in the Equus Beds A Zone  
 KCC District #2 Office - Wells Sampled Summer 2013 by GMD #2 - Map Drawn by D.Bollenback on 9/17/2013

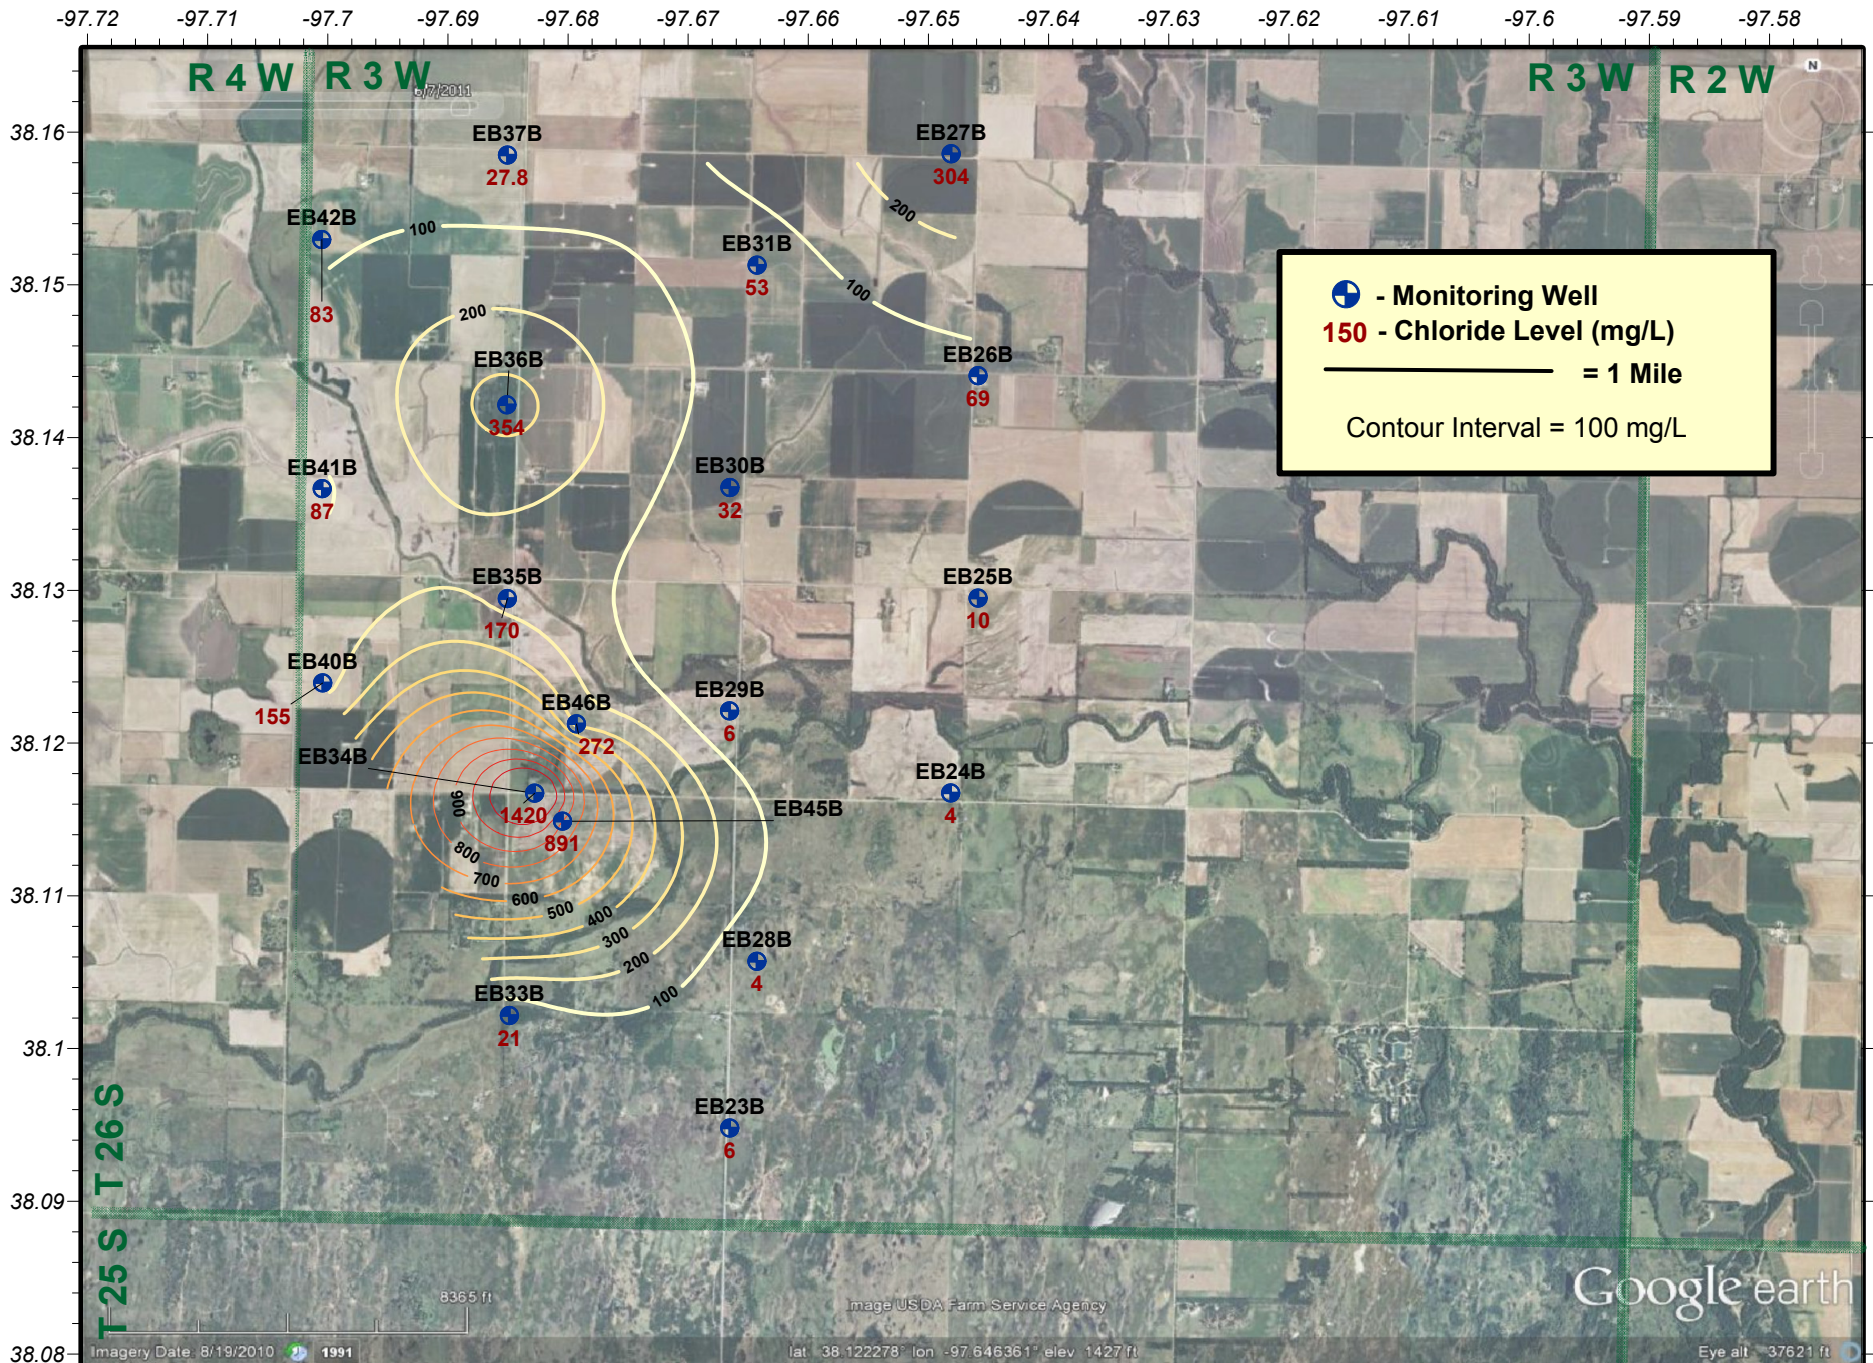
**Hollow-Nikkel Brine Contamination Site - KCC Control #970009-00**  
 Multiple Sections of Townships 25 and 26 South & Ranges 3 and 4 West, Harvey County, Kansas  
 2013 Chloride levels in the Equus Beds B Zone  
 KCC District #2 Office - Wells Sampled Summer of 2013 by GMD #2 - Map Drawn by D.Bollenback on 9/17/2013

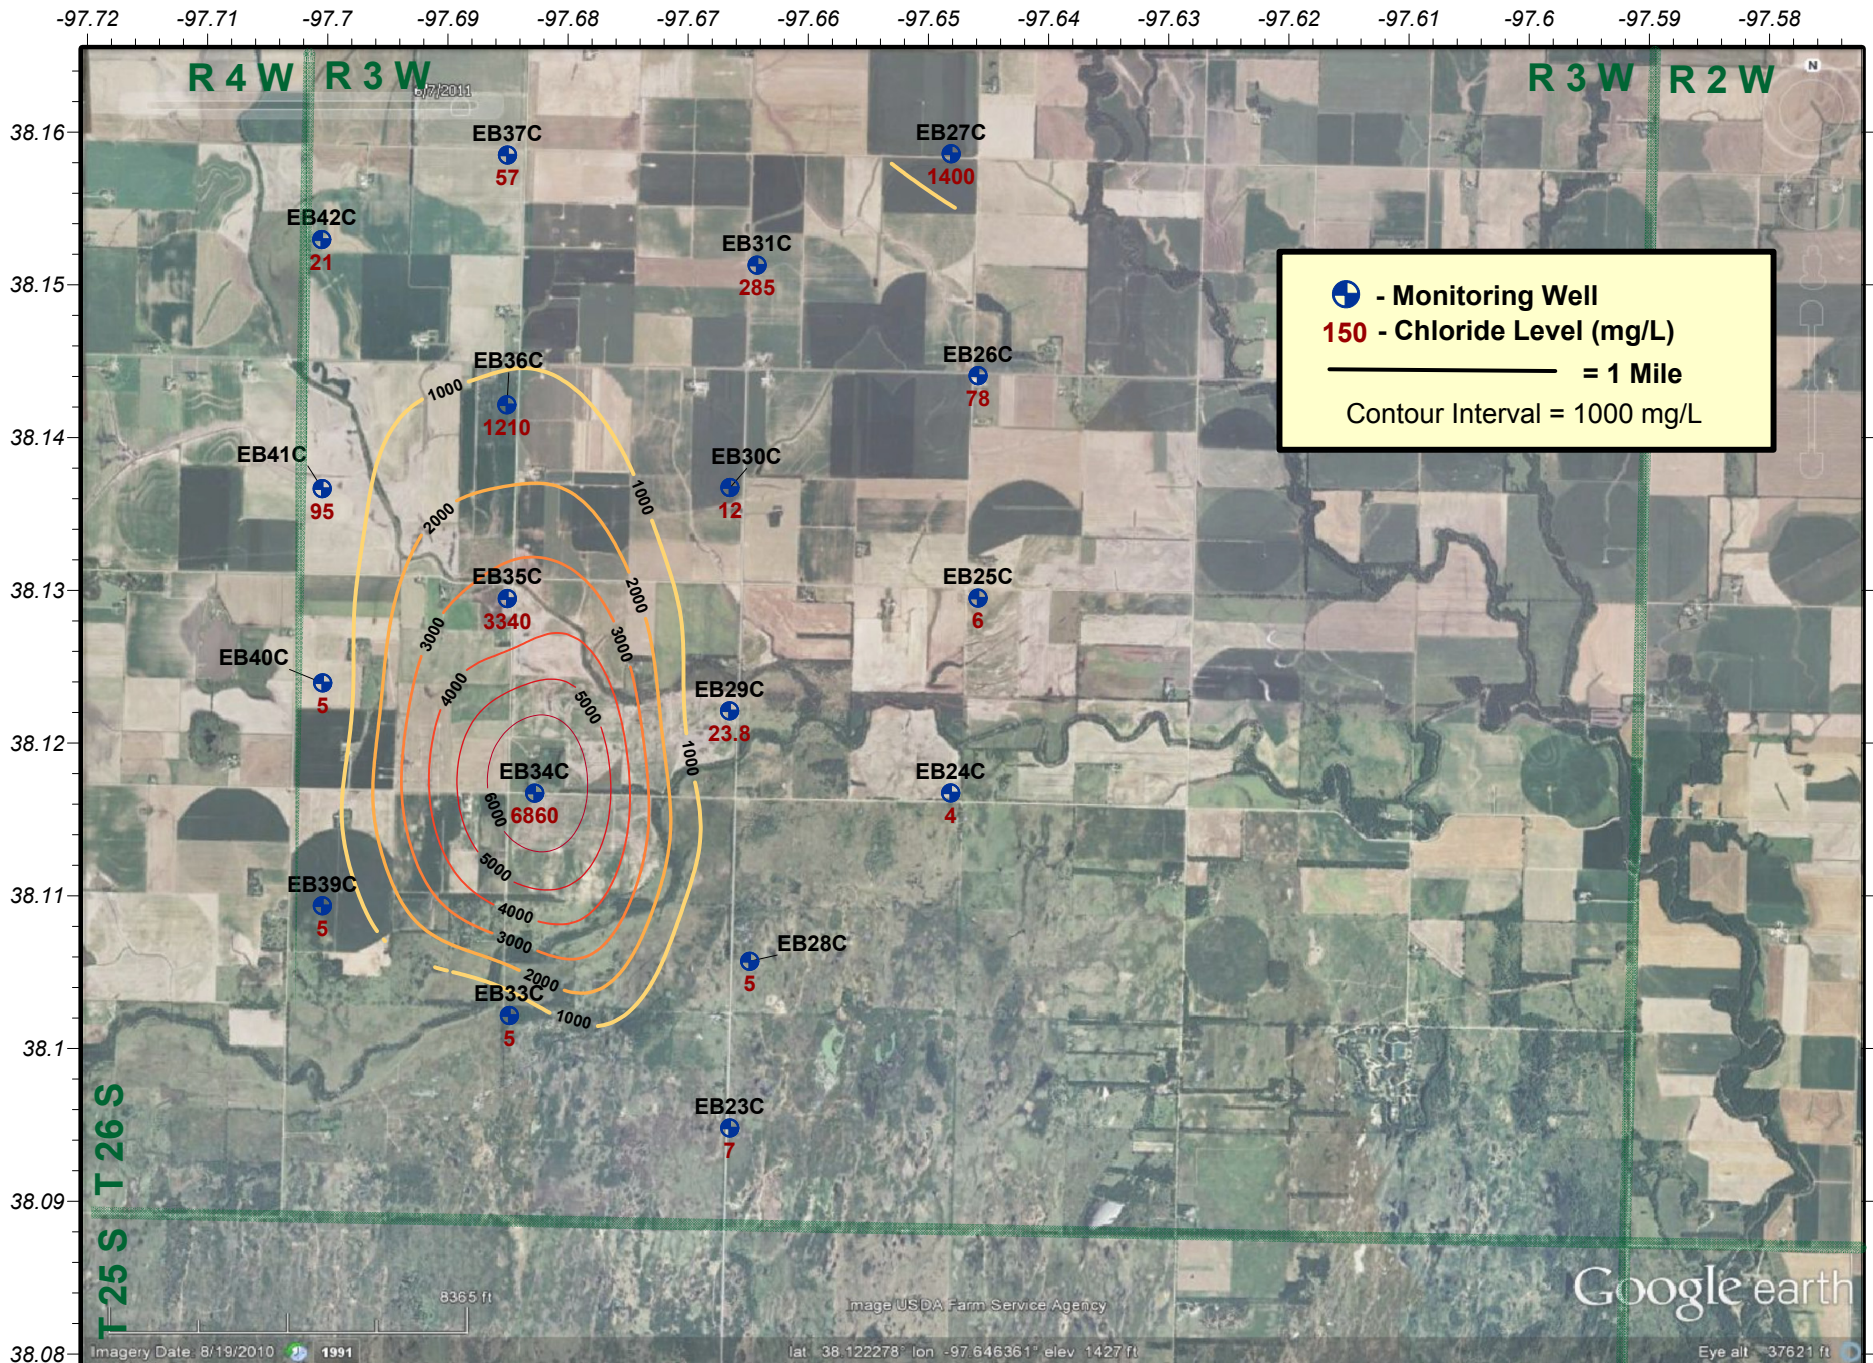
Hollow-Nikkel Brine Contamination Site - KCC Control #970009-00  
 Multiple Sections of Townships 25 and 26 South & Ranges 3 and 4 West, Harvey County, Kansas  
 2013 Chloride levels in the Equus Beds C Zone  
 KCC District #2 Office - Wells Sampled Summer of 2013 by GMD #2 - Map Drawn by D.Bollenback on 9/17/2013

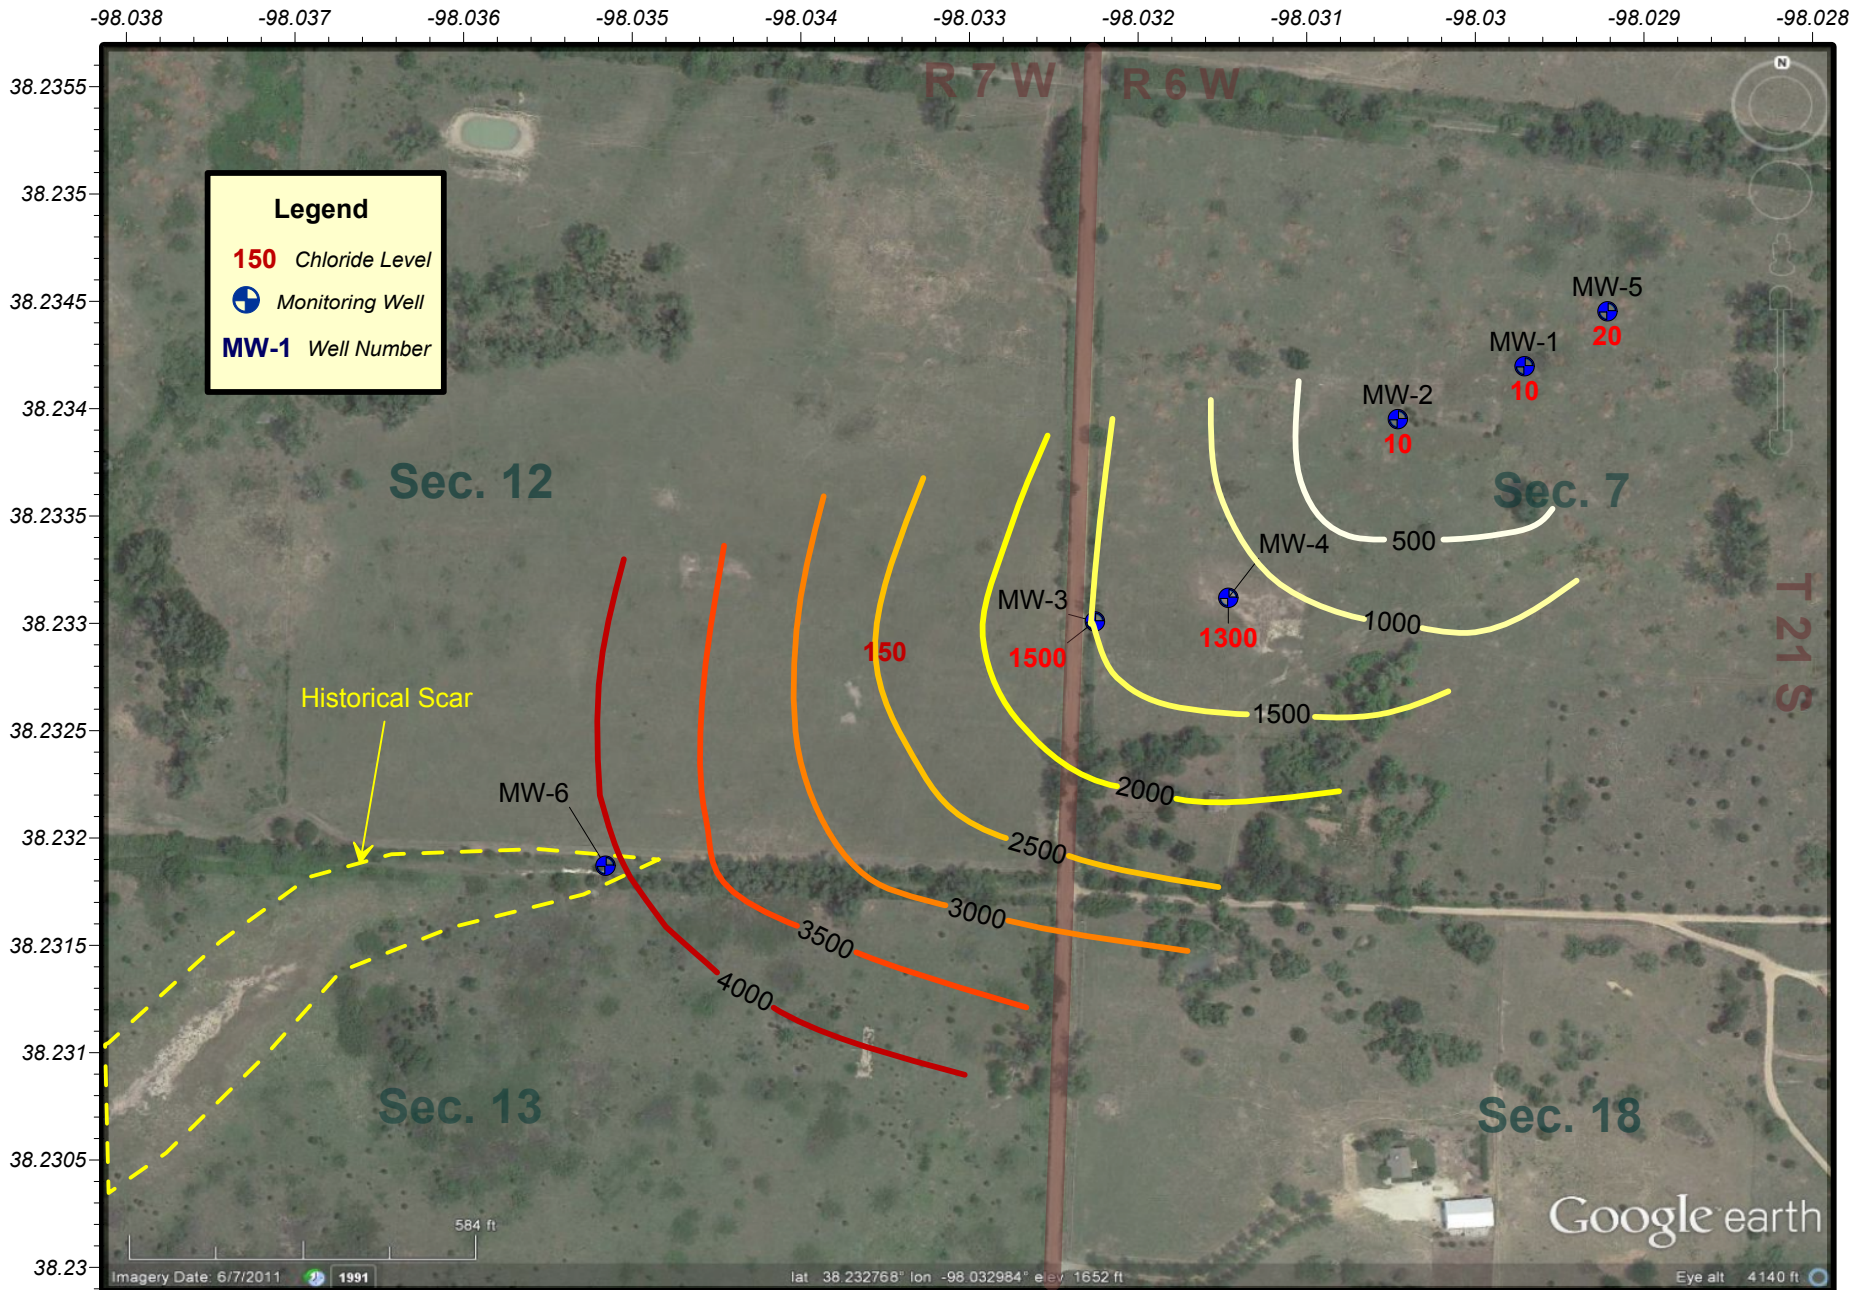
**Johnson/Ramsey Monitoring Site - KCC Control # 970055-00**  
**Section 7 of T 21 S & R 6 W, and Section 12 of T 21 S & R 7 W, Rice County, Kansas**  
**2013 Groundwater Chloride Levels**  
**District #2 - Sampled 9/5/2013 - Map Drawn 9/18/13 by B. Milner**
