**KANSAS CORPORATION COMMISSION**  
*Remediation Site Status Report*

**Abandoned Oil and Gas Well / Remediation Site Fund  
Remediation Sites  
Status Report**

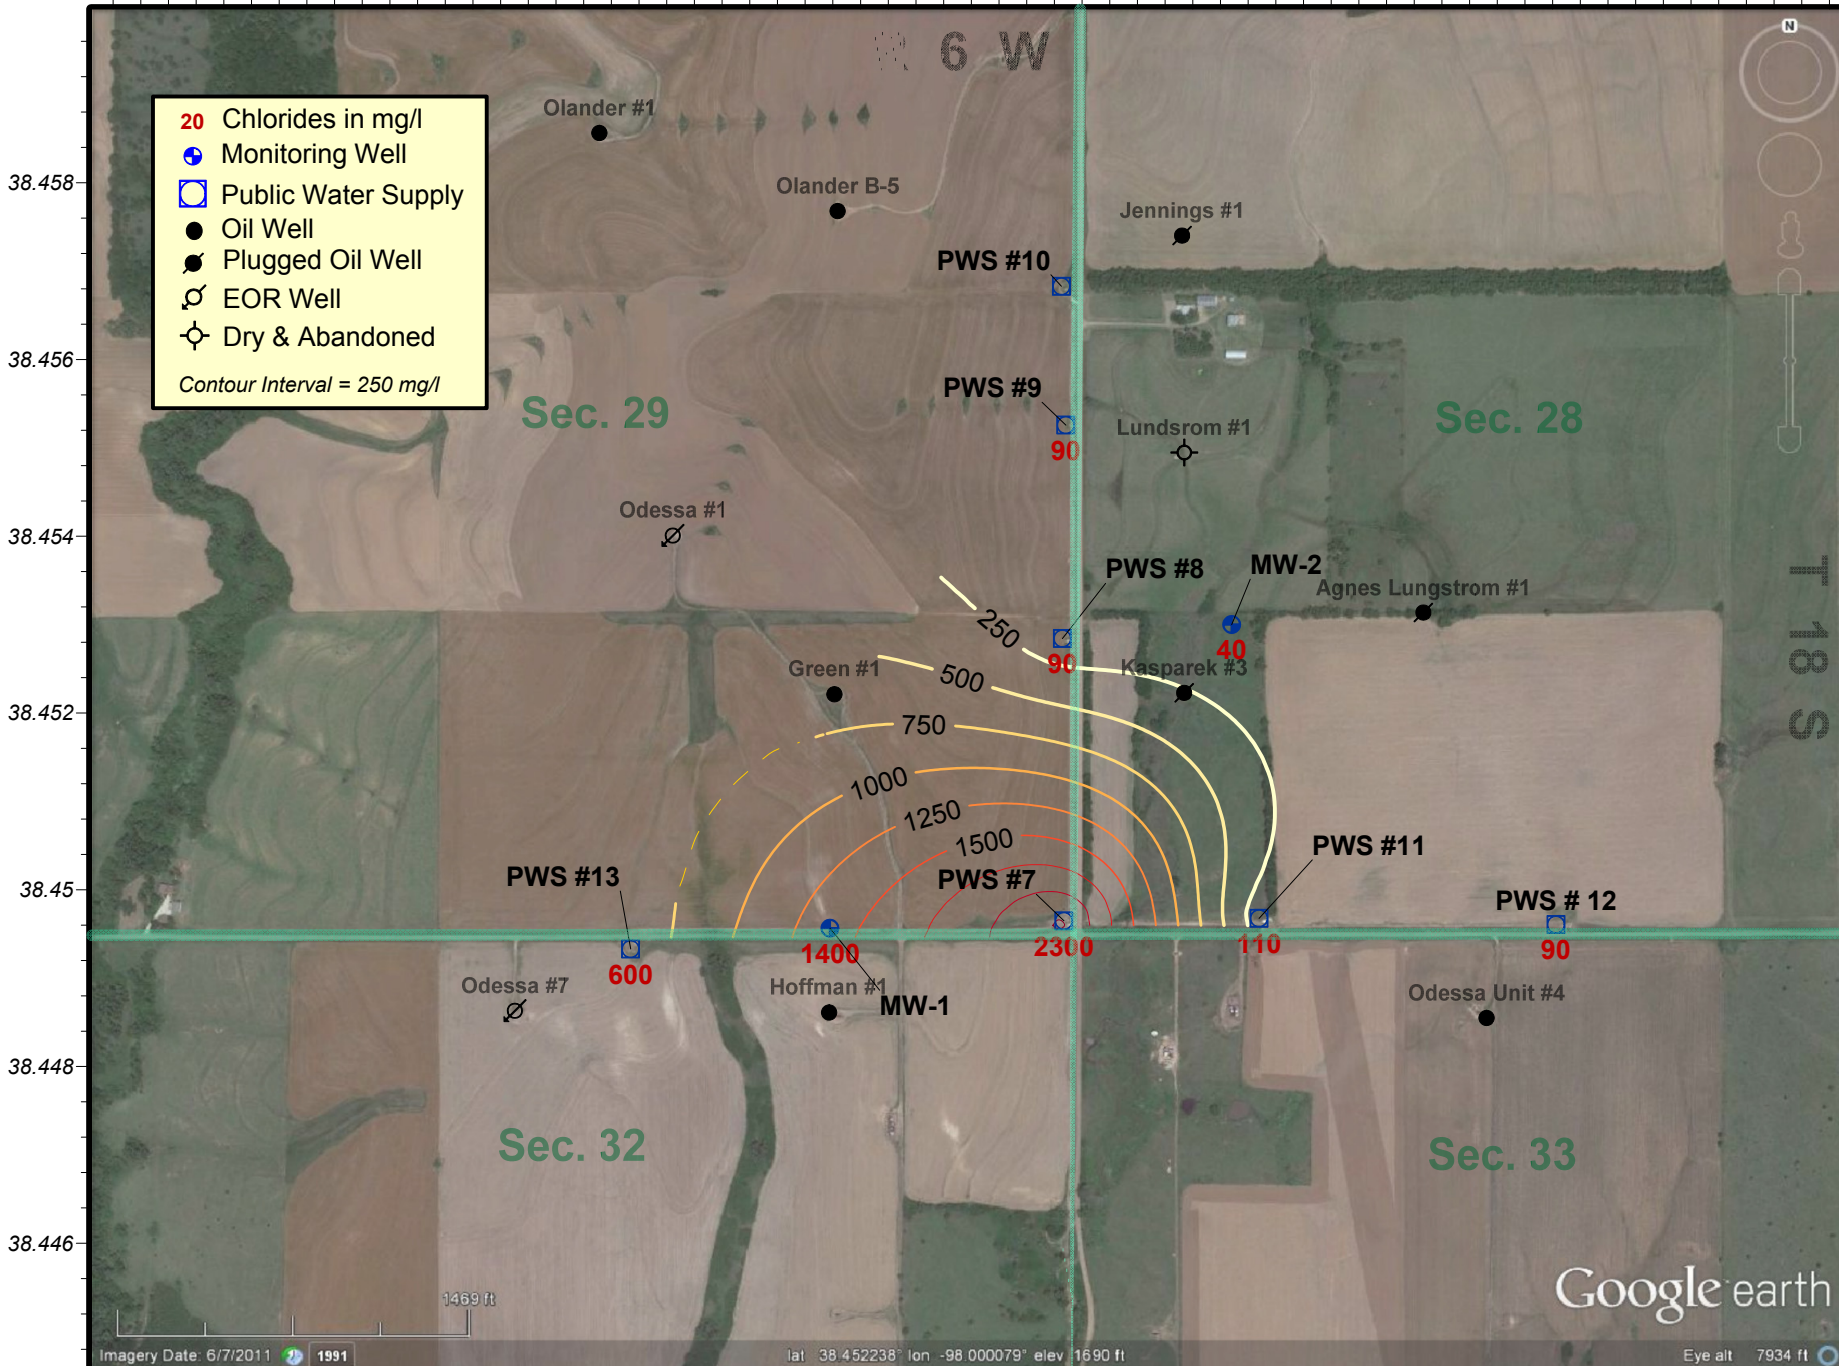
**Little River Groundwater Monitoring Site**  
 Section 29 of Township 18 South & Range 6 West, Rice County, Kansas  
 2013 Groundwater Chloride Levels  
 District #2 - Sampled on 9/25/2013 - Map Drawn on 9/30/2013 by D. Bollenback

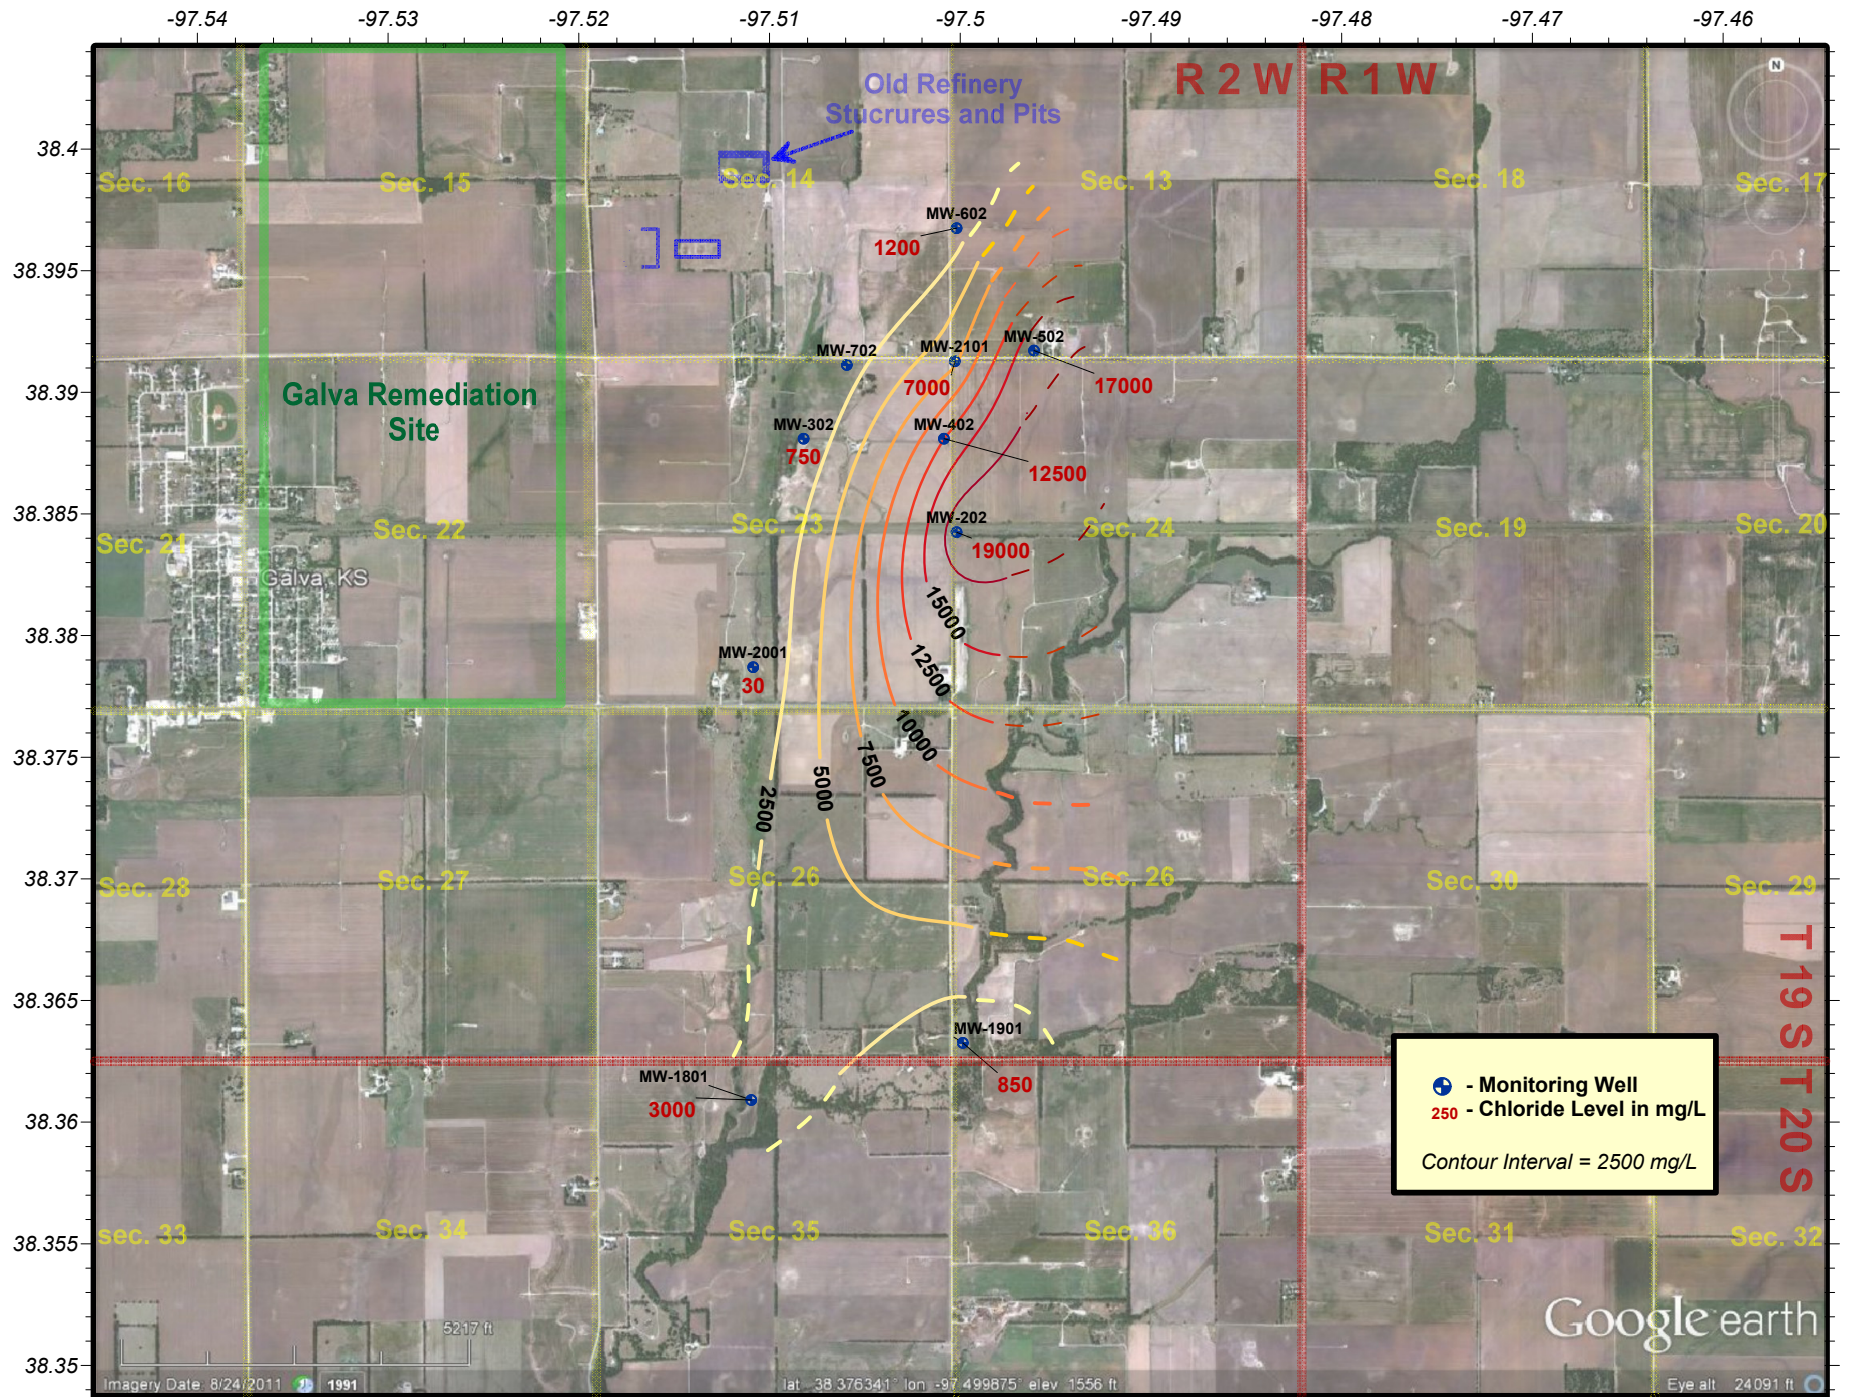
**Northern Running Turkey Creek Contamination and Monitoring Site - KCC Control #20030059-001**  
 Multiple sections in Township 19 & 20 South and Range 2 West, McPherson County, Kansas  
 2013 Groundwater Chloride Levels  
 District #2 - Sampled 9/24/2013 - Map Drawn on 10/1/2013 by D.Bollenback

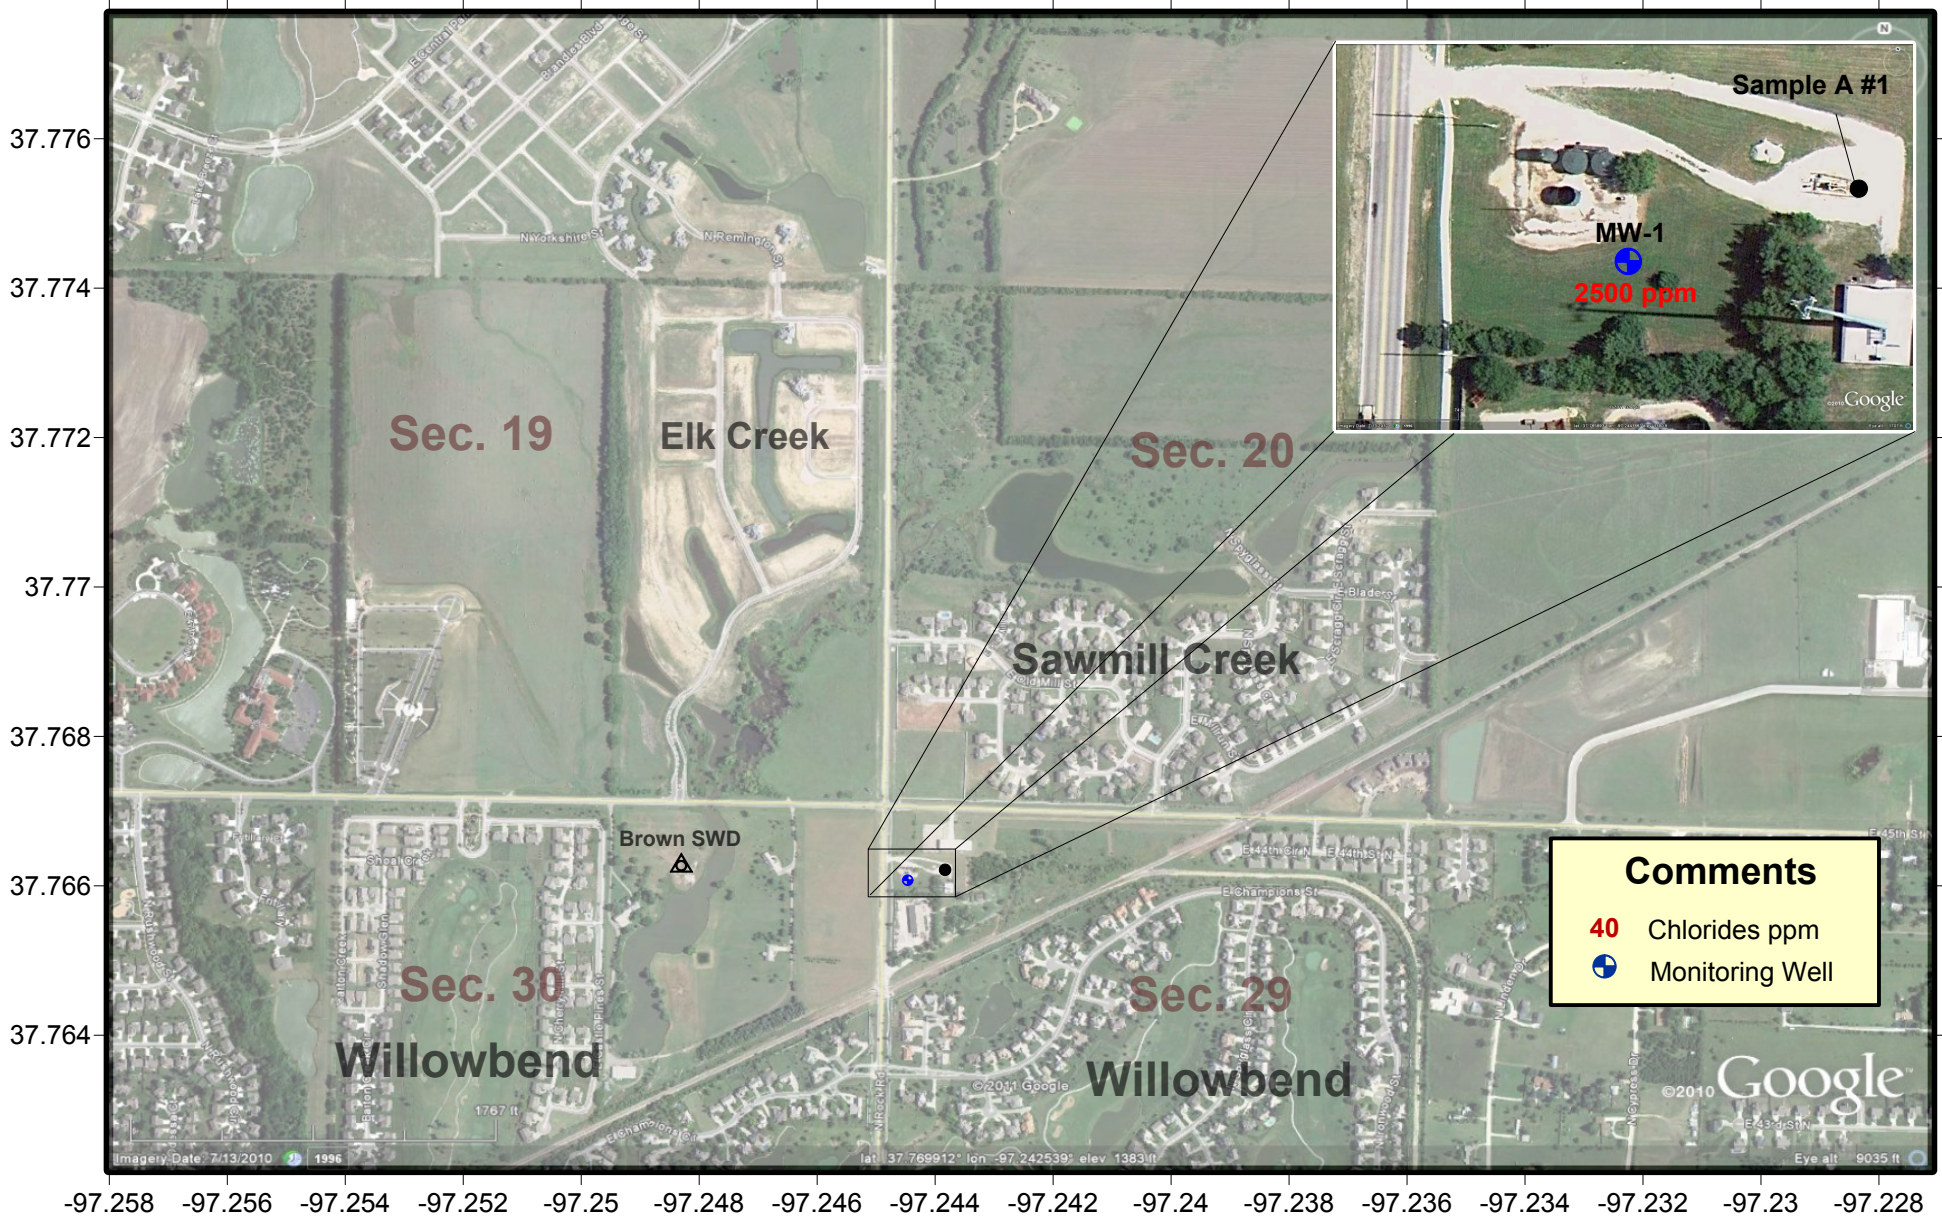
## Sample 'A' Contamination Site

NW - Sec. 29 - T 26 S - R 2 E, Sedgwick County, Kansas

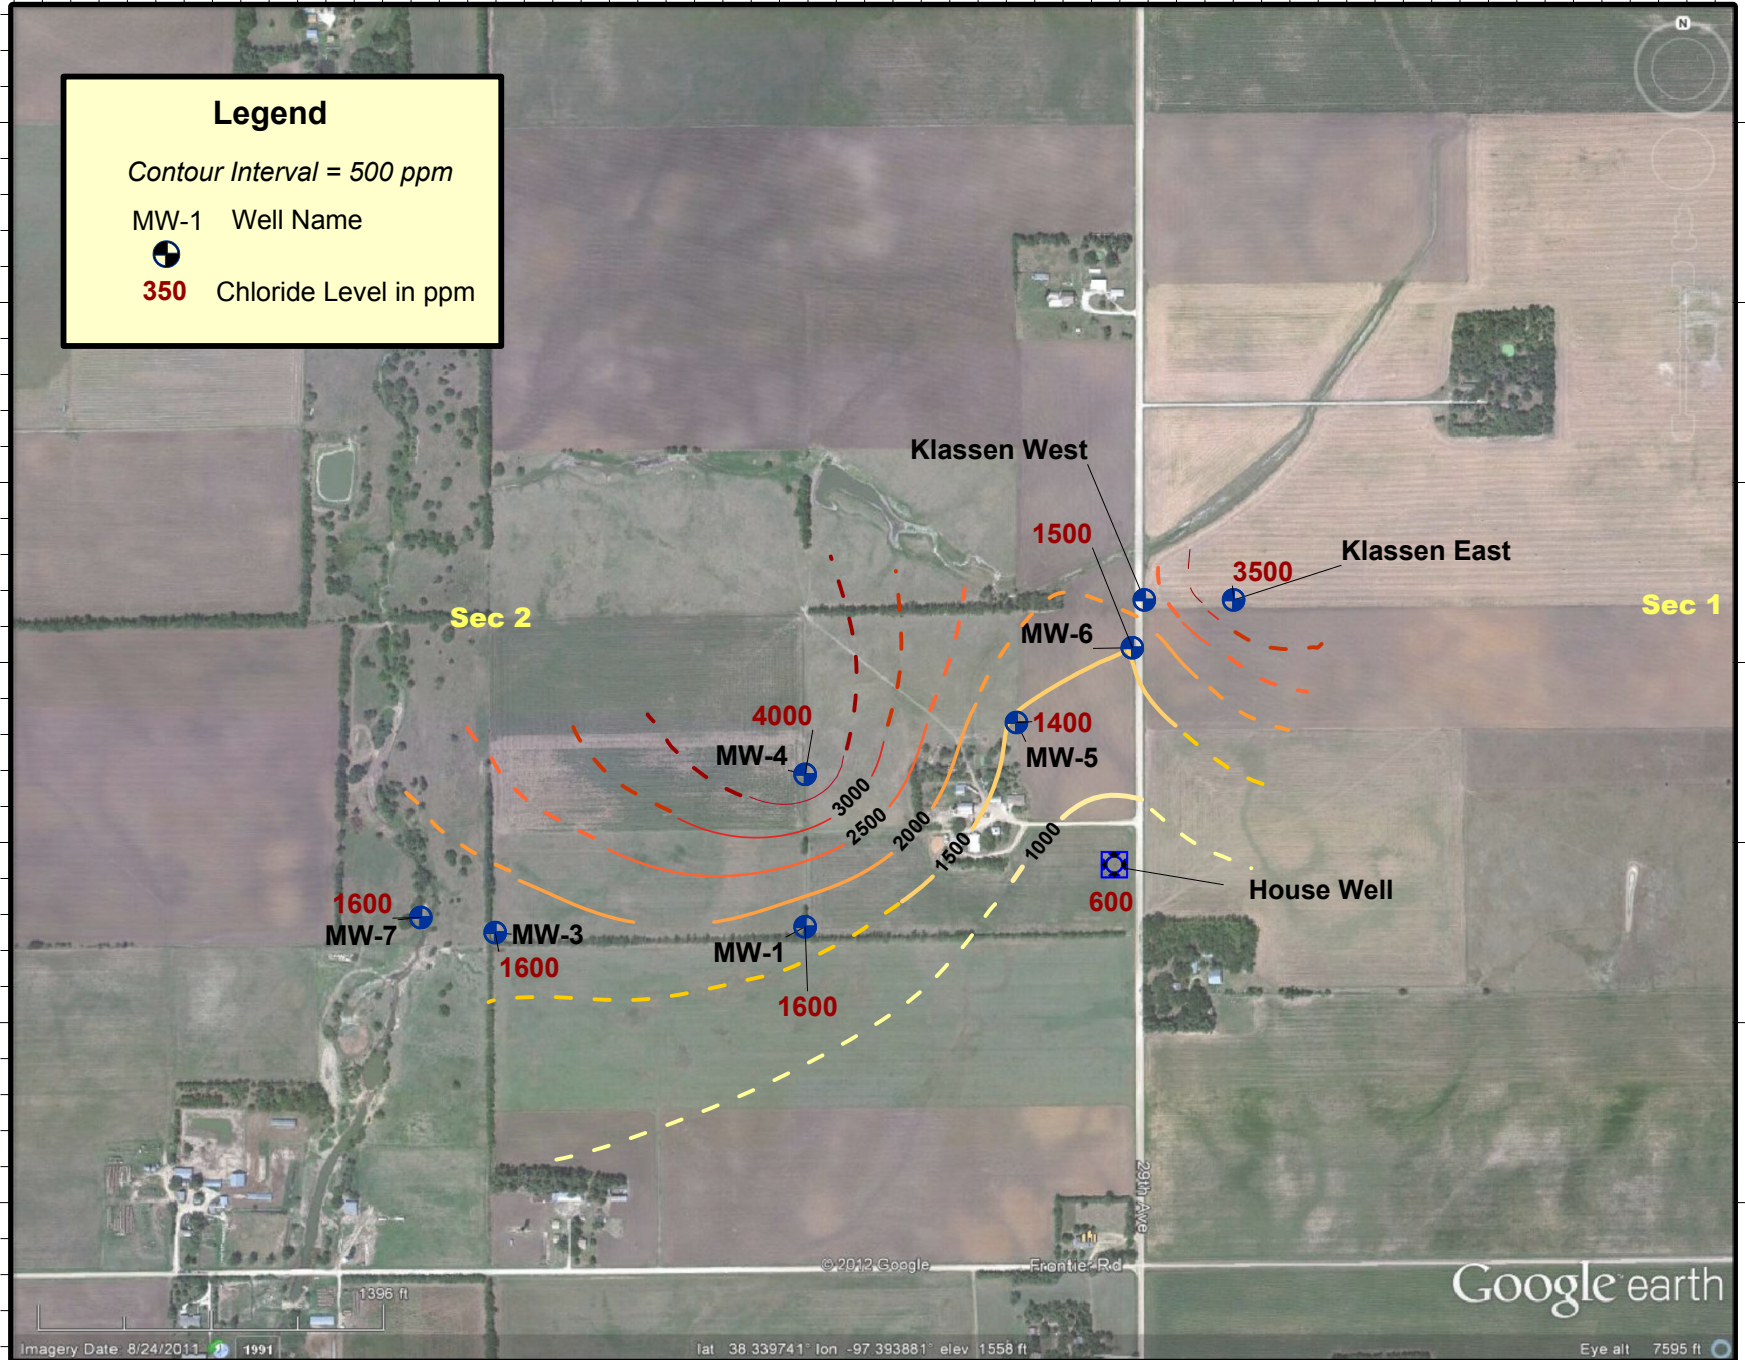
**Selzer-Bitikofer Contamination Site**  
 KCC Control #9700093-00 - District #2 - Map Drawn on 9/30/2013 by D. Bollenback  
**2013 Chlorides Map**  
 Sections 1 & 2, T20S and R1W, McMpherson County, Kansas

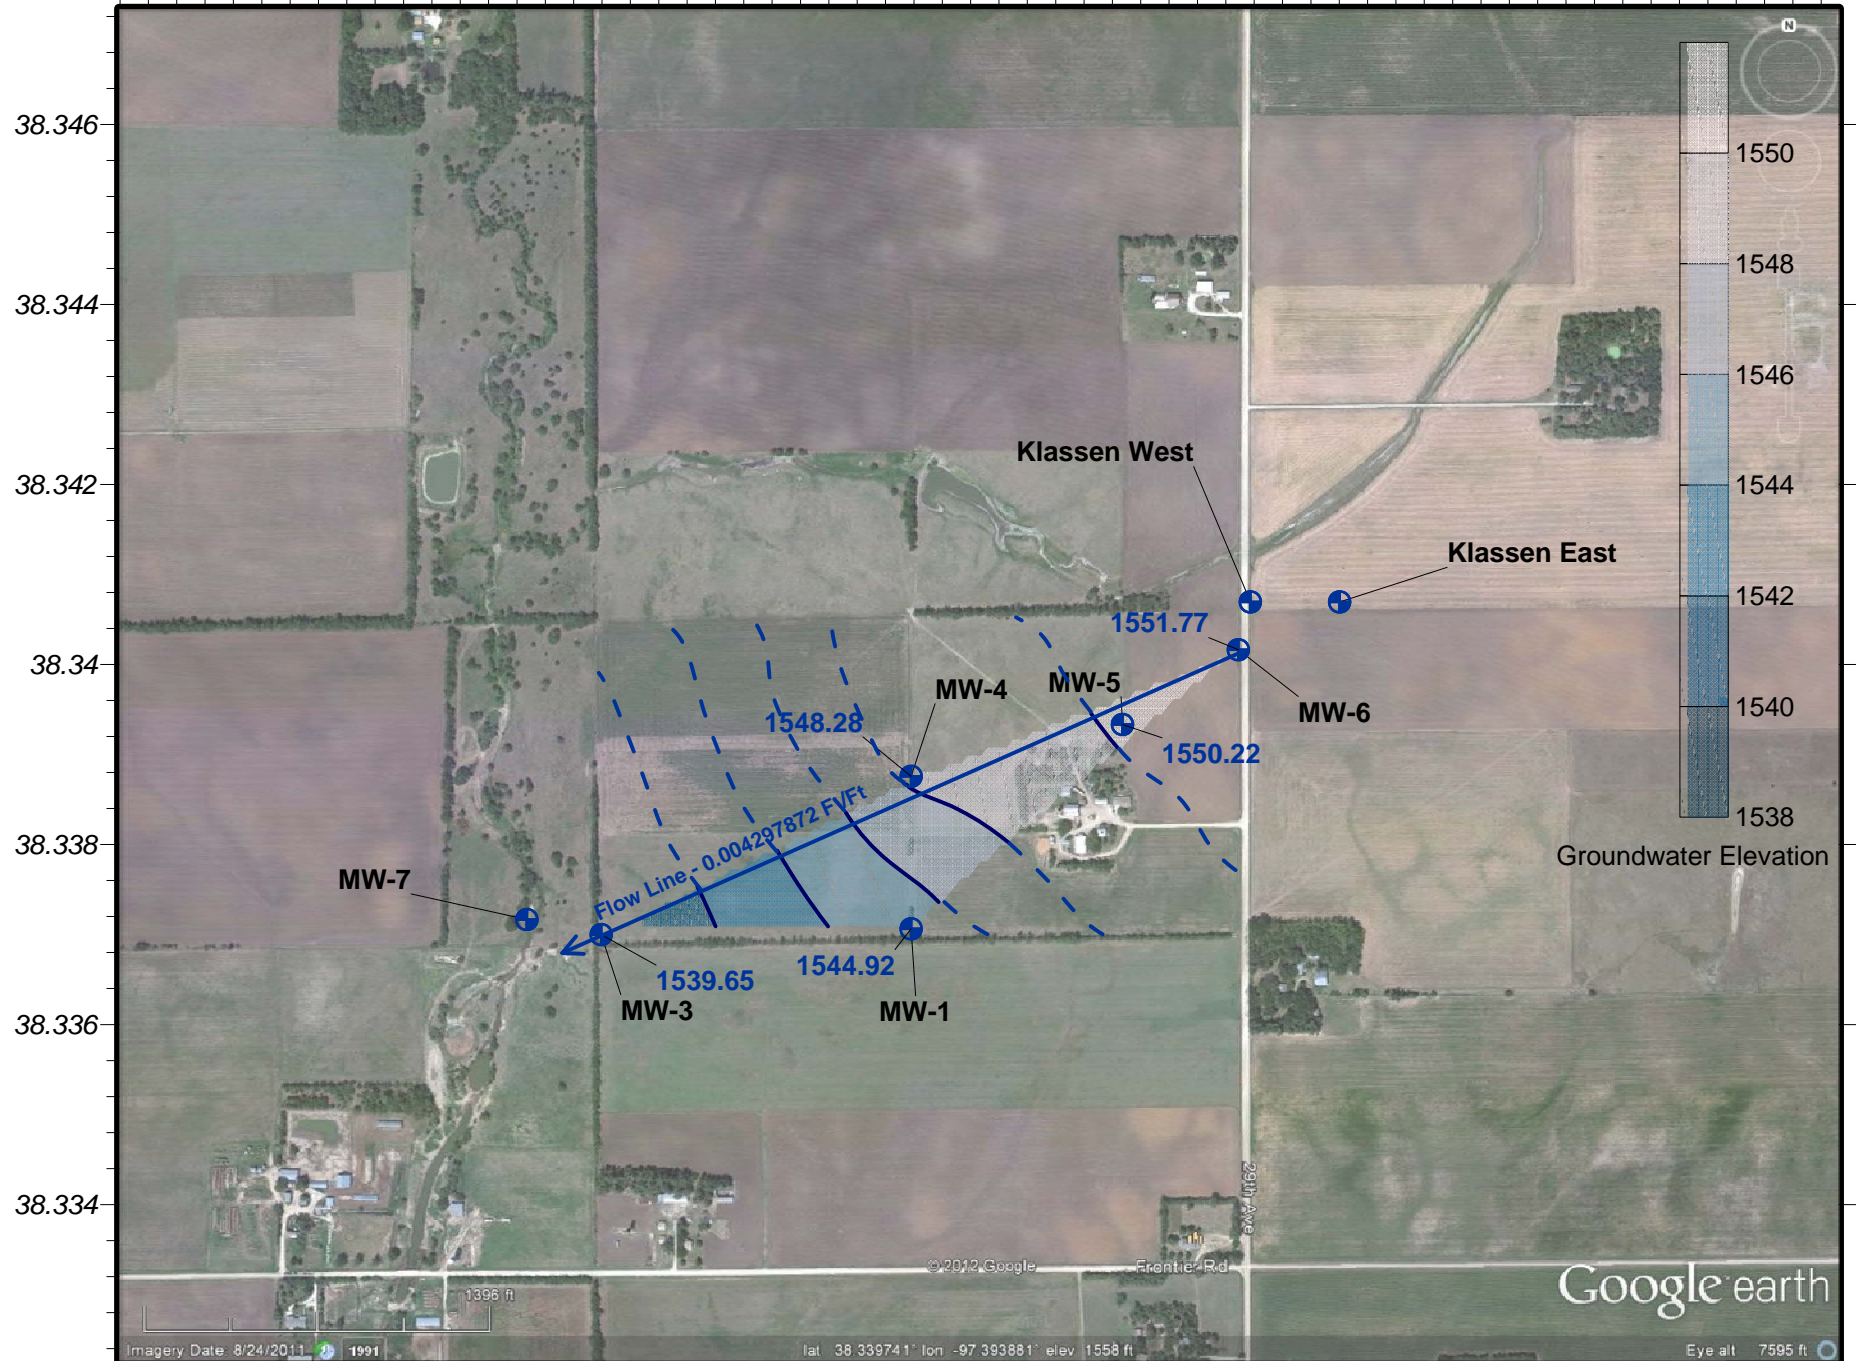
**Selzer-Bitikofer Contamination Site**  
KCC Control #9700093-00 - District #2 - Map Drawn on 9/27/2013 by D. Bollenback  
**Static Groundwater Elevation Map**  
Sections 1 & 2, T20S and R1W, McMpherson County, Kansas

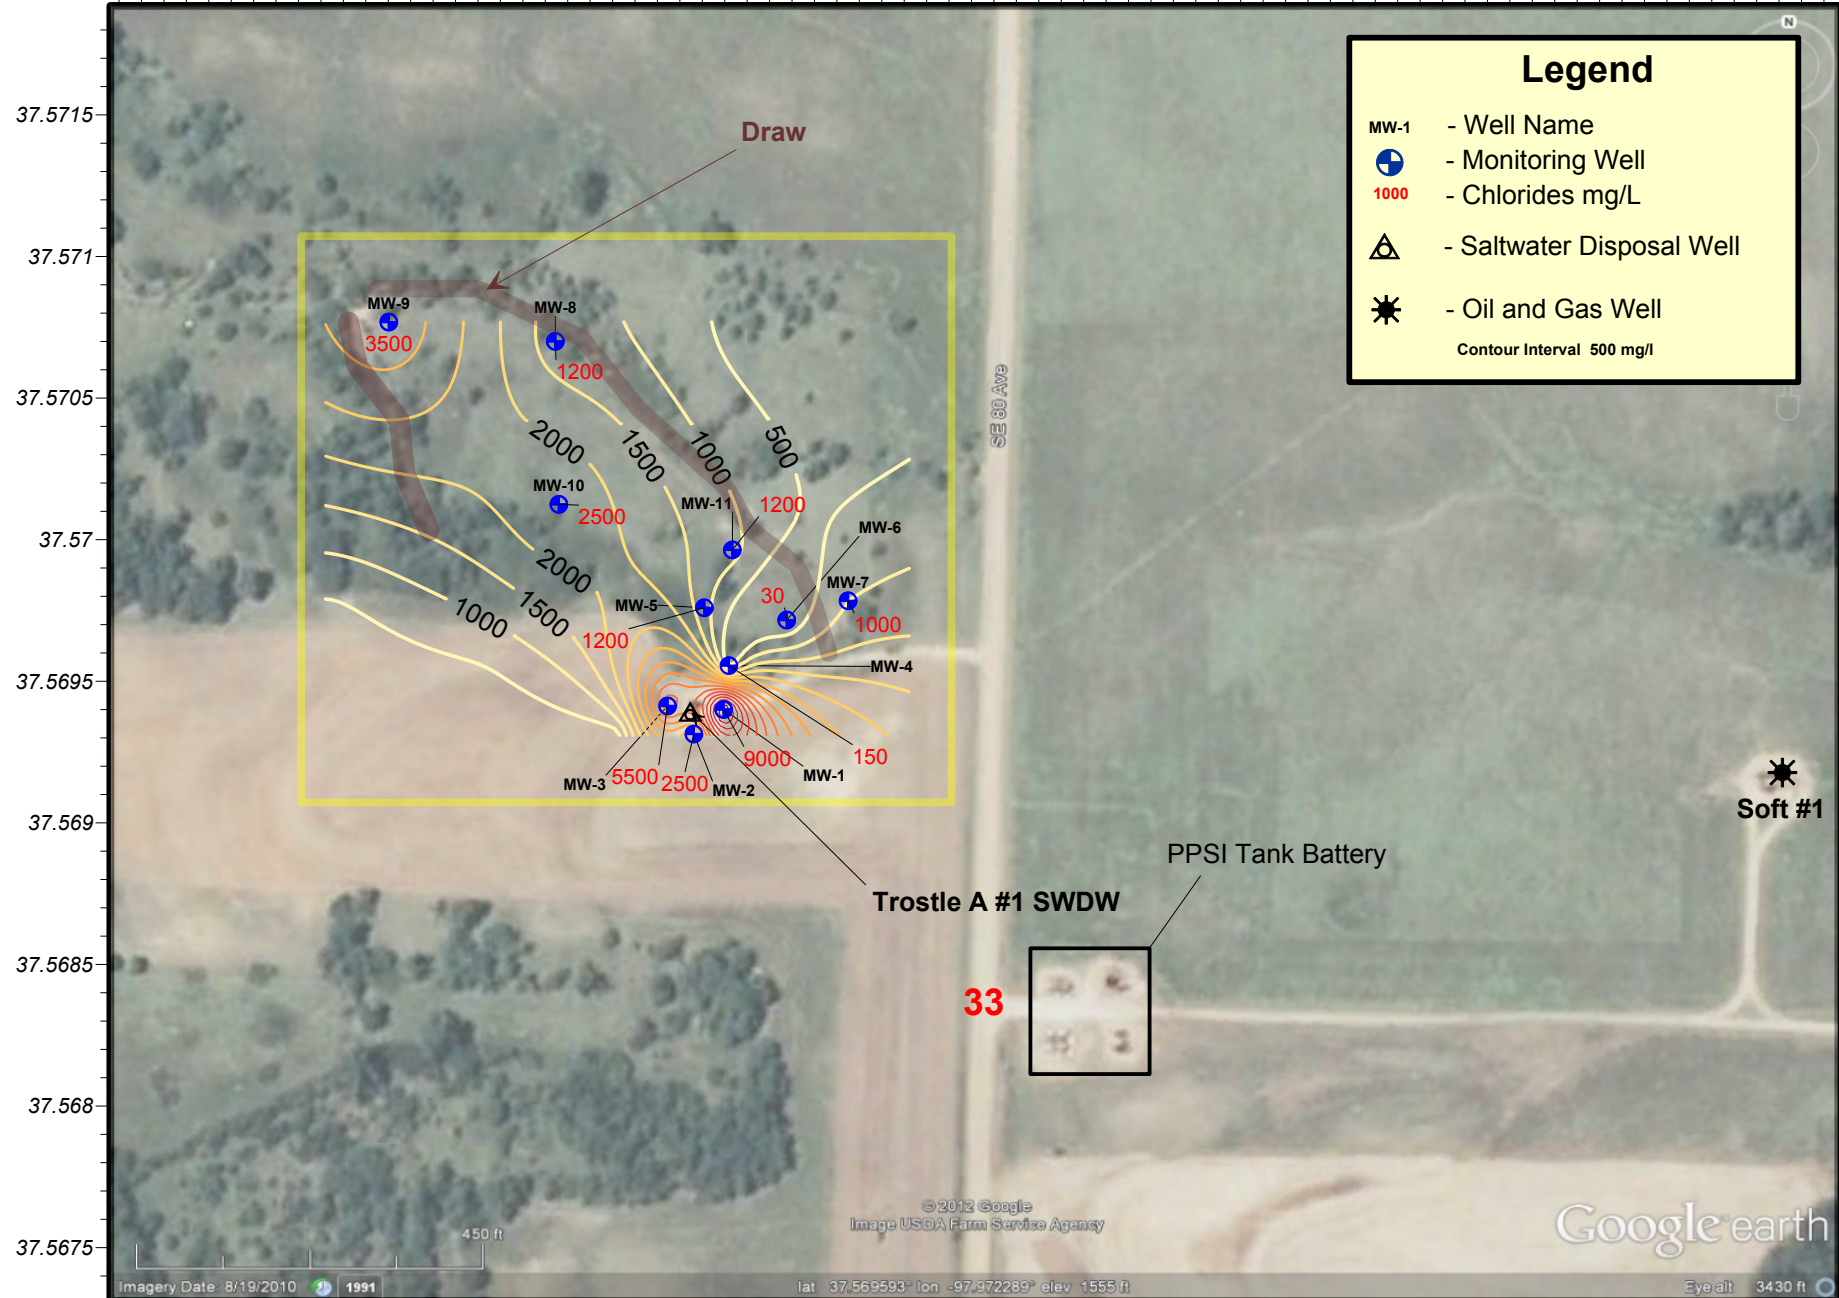
**Trostle Contamination and Monitoring Site**  
 2013 Groundwater Sampling - Chloride Concentration Isopact  
 Section 33 of T28S and R6W, Kingman County, Kansas  
 KCC Control Number:#980038-001 - Map Drawn 9/20/2013 by B. Milner

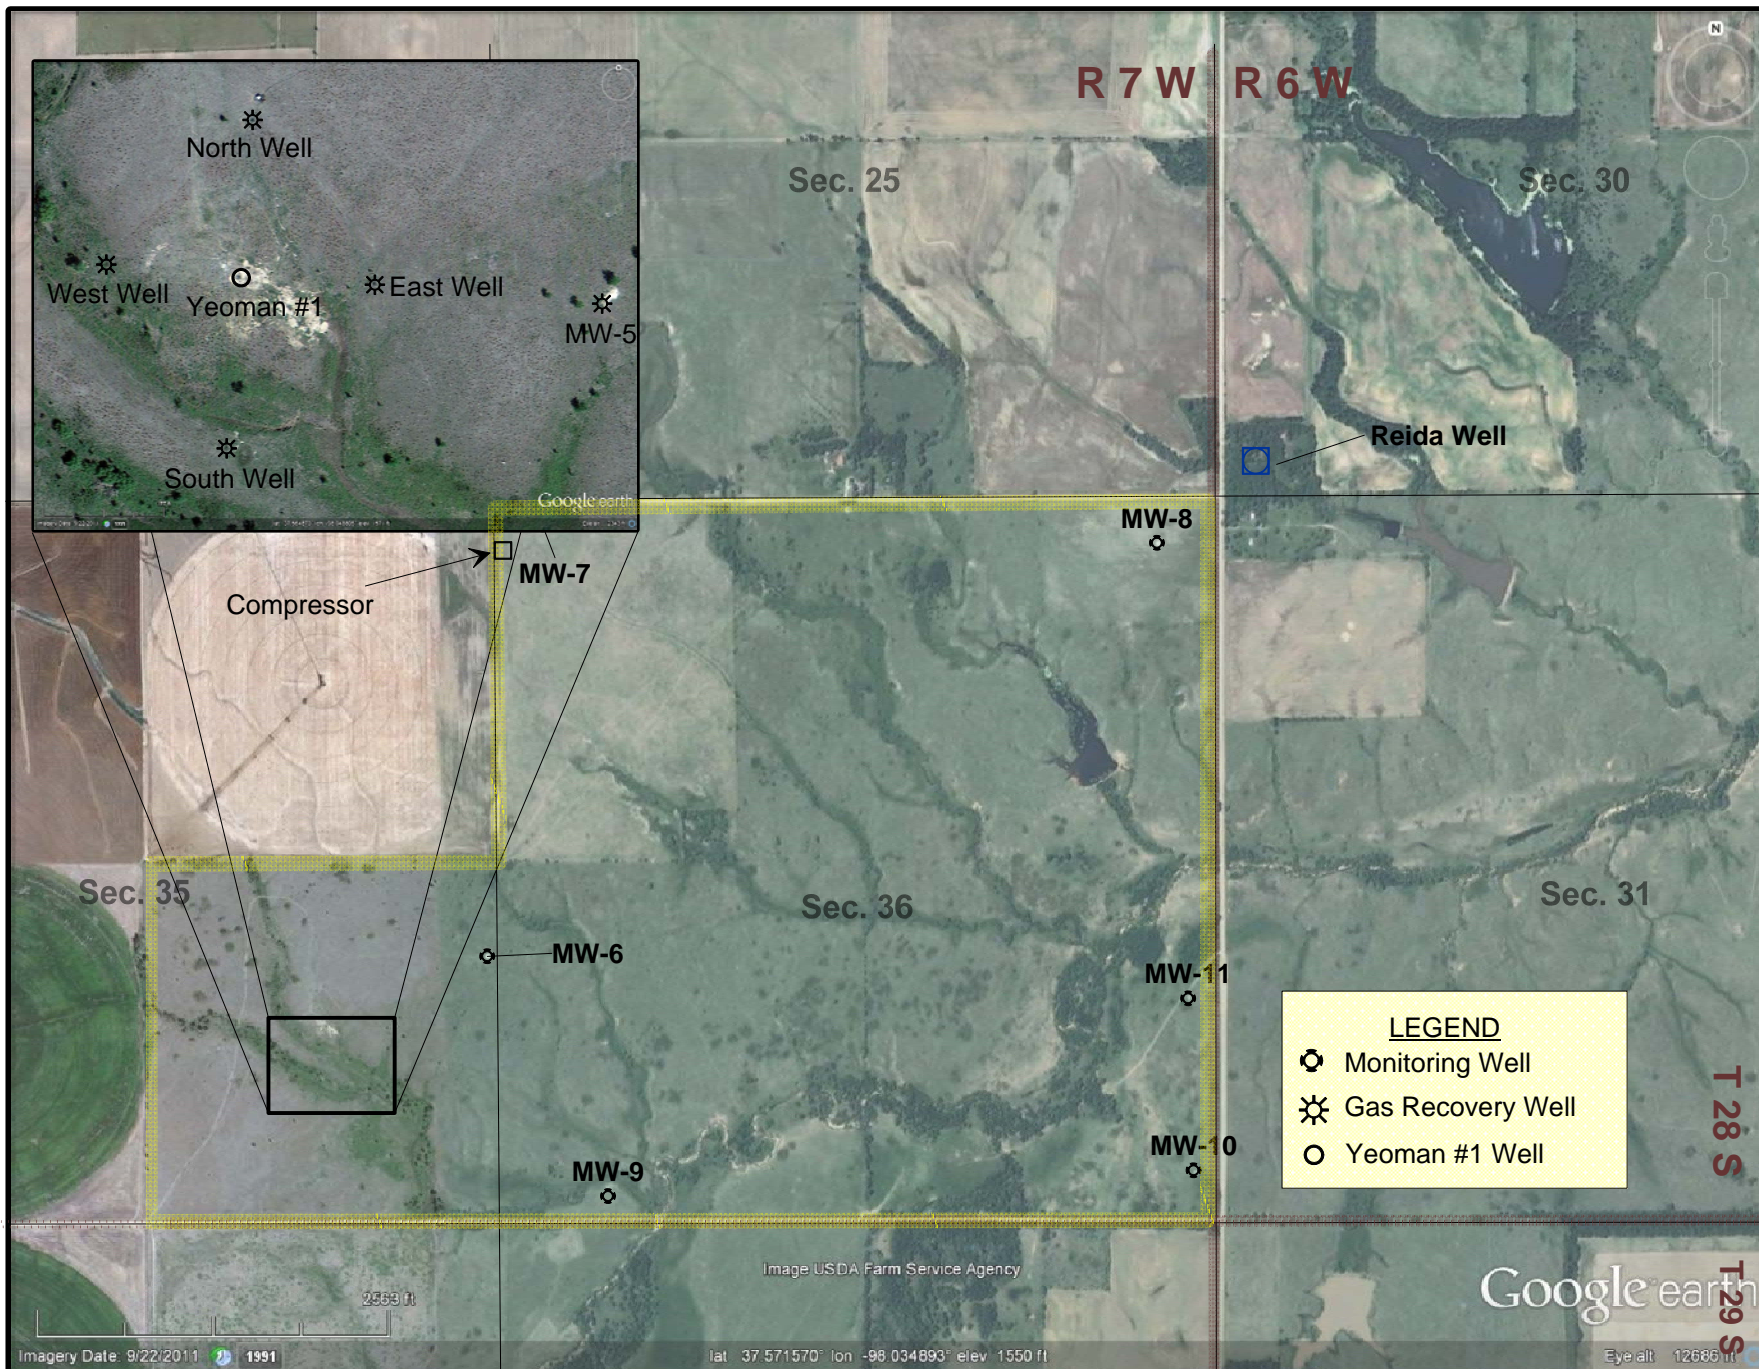
**Yeoman Escaped Shallow Gas Site**  
**SE/4 of Section 35 and All of Section 36-T28S-R7W, Kingman Co., KS**  
**Site Map for 2013-14 Legislative Reports**  
**District #2 Control No. 20060021-001 9-19-2013 D. Bollenback**

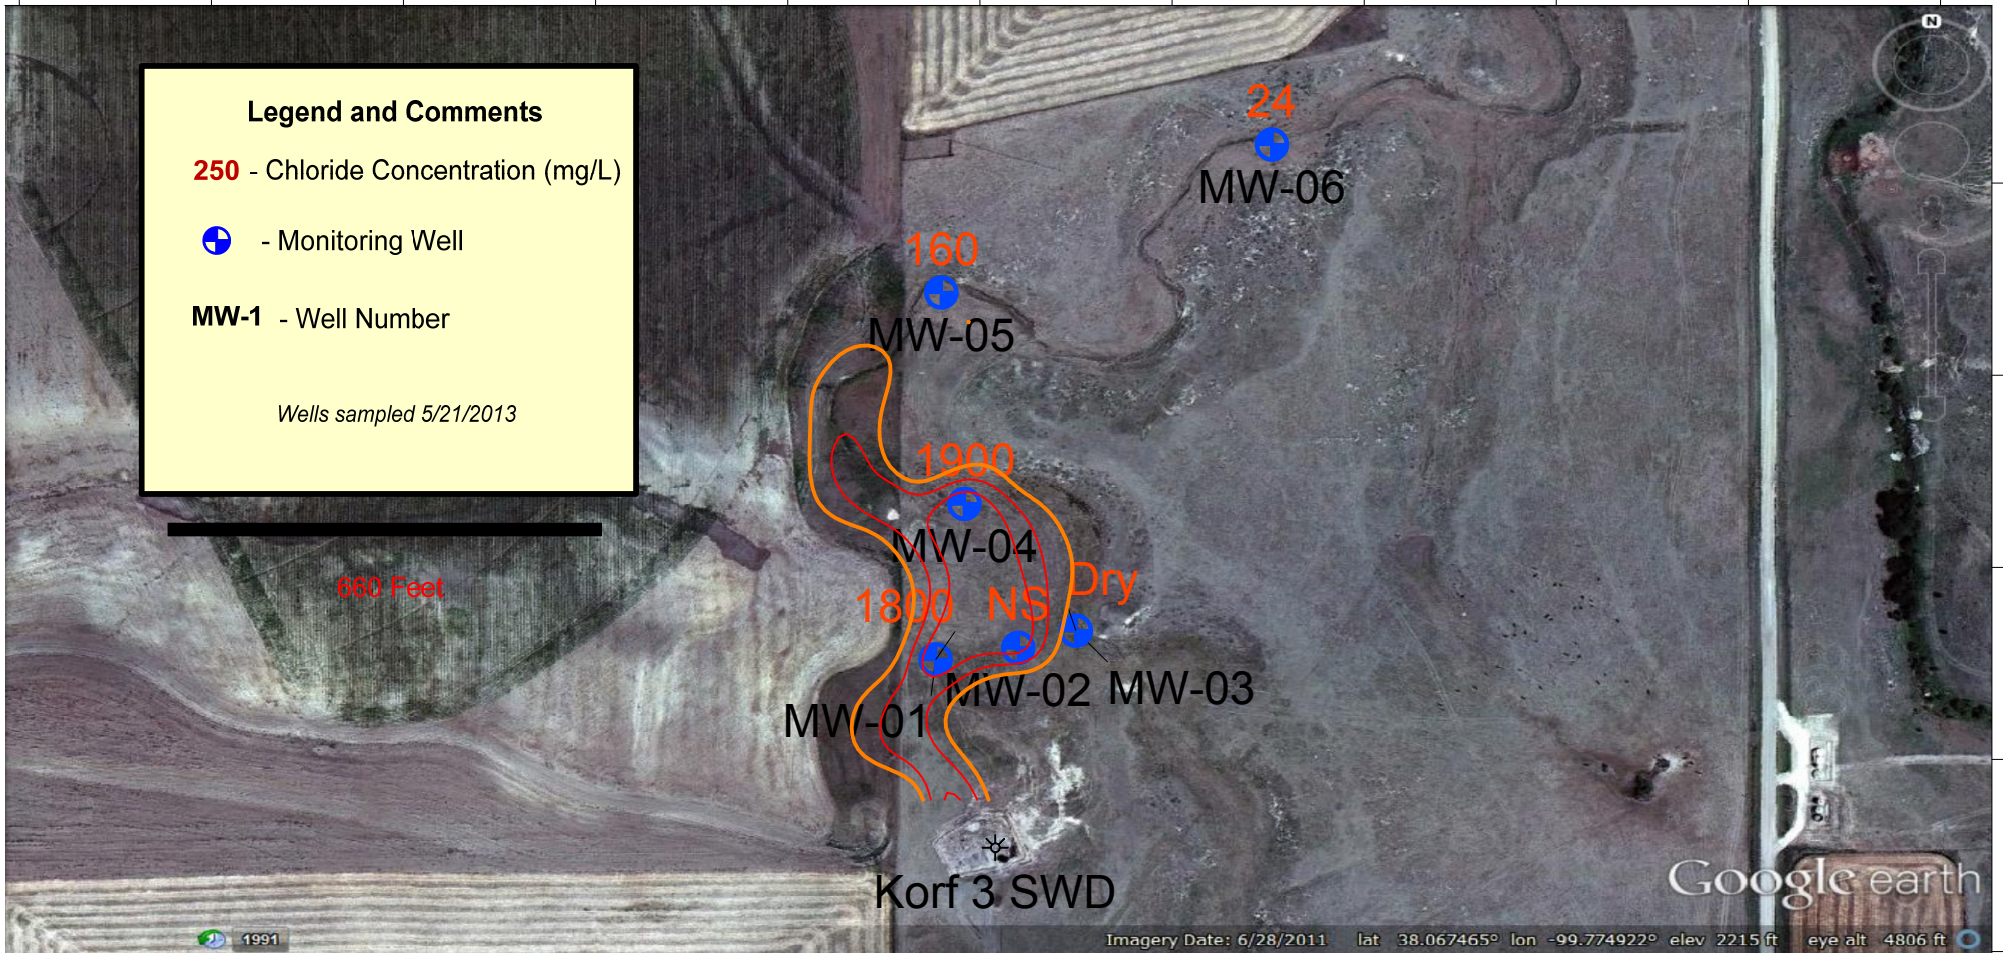
**Korf Site**  
 Sections 7-T-23S-R22W  
 Hodgeman County, Kansas  
**2013-2014 Area Map with Chlorides**  
 KCC Control # 20140017 District 1  
 D. Sellers 9/24/13
