KANSAS CORPORATION COMMISSION2024 | OIL & GAS REMEDIATION SITE STATUS

KCC Conservation Division Quick Reference

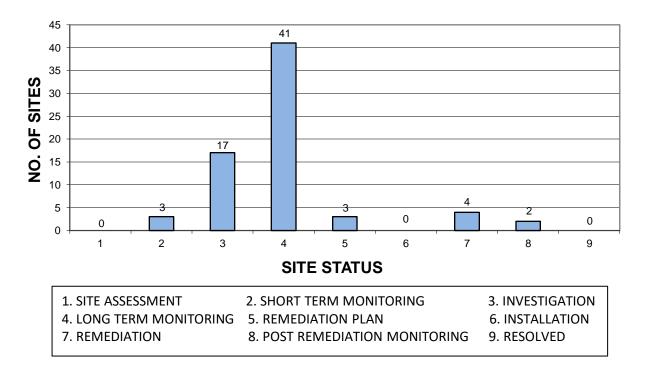
STATEWIDE DISTRIBUTION OF SITES BY STATUS

In general each contamination site has a definable life cycle. This cycle begins with, then follows a sequence of investigatory and possible remedial activities which move the site towards ultimate resolution. The first phase of the cycle is the site assessment. This phase defines general site parameters and conditions forming the basis for additional efforts at the site. Once the assessment is complete the site moves on to a new phase. This next phase may be short term or long term monitoring followed by resolution of the site. Another scenario might include an extensive investigation phase followed by the installation of a monitoring system whose sample results may indicate the necessity for certain remedial activities and additional post remediation monitoring prior to resolution of the site. The following graphs depict the current status of the 47 listed sites on a statewide and KCC District basis.

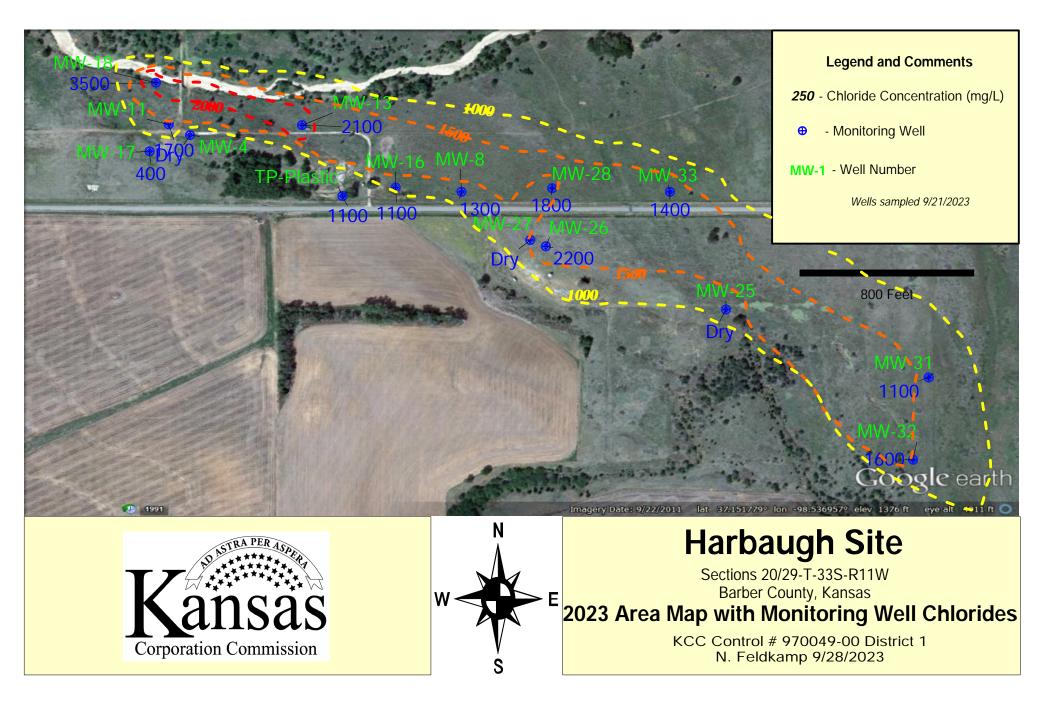
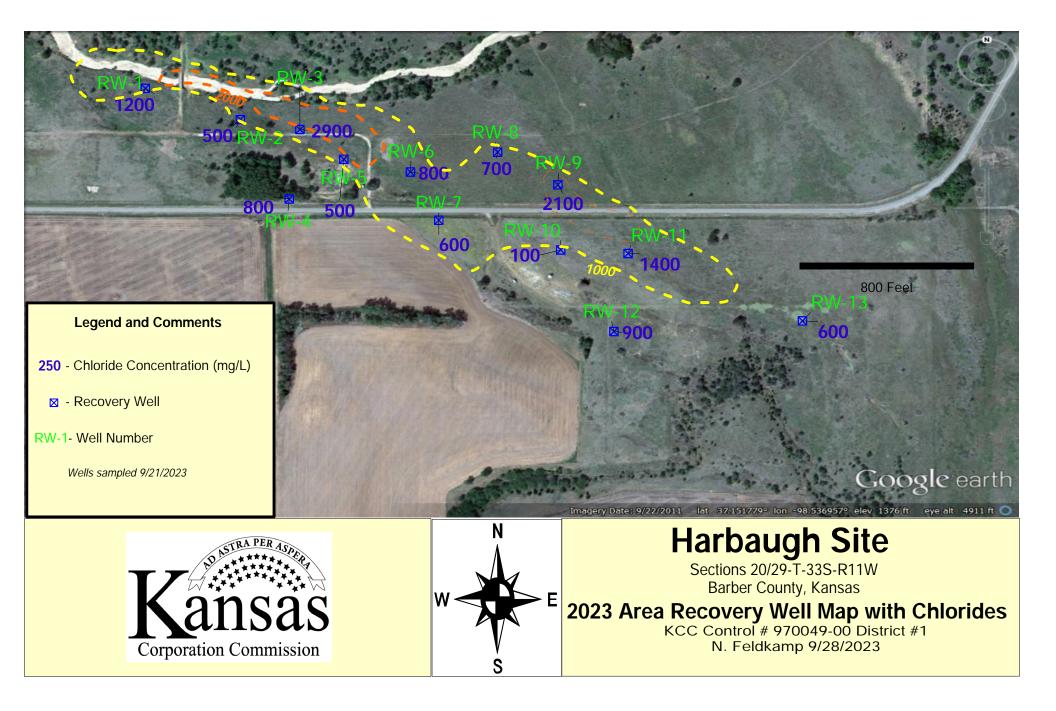
Control No.	Staff Hours/Expenditures	Fund Expenditures				
970049-00	11 Hrs. / \$327.77	FY 2023/24 Total \$3,128.70 \$710,253.92				
Current Contaminate Level: 100 ppm Cl- to 3,500 ppm Cl-						
Status:						
1. Site Assessment	2. Short Term Mo	nitoring X 3. Investigation				
🗶 4. Long Term Mon	itoring 5. Remediation Pla	an 6. Installation				
7. Remediation	8. Post Rem. Mon	itoring 9. Resolved

Recommendation for Future Work: Make the necessary repairs to return the recovery system back to operation. Review the data to continue taking a targeted approach at remediating the site. The plugging of more monitoring wells that are outside of the plume as well as recovery wells that are unusable will look to be plugged. Repair wells MW-4, MW-25 & MW-27.

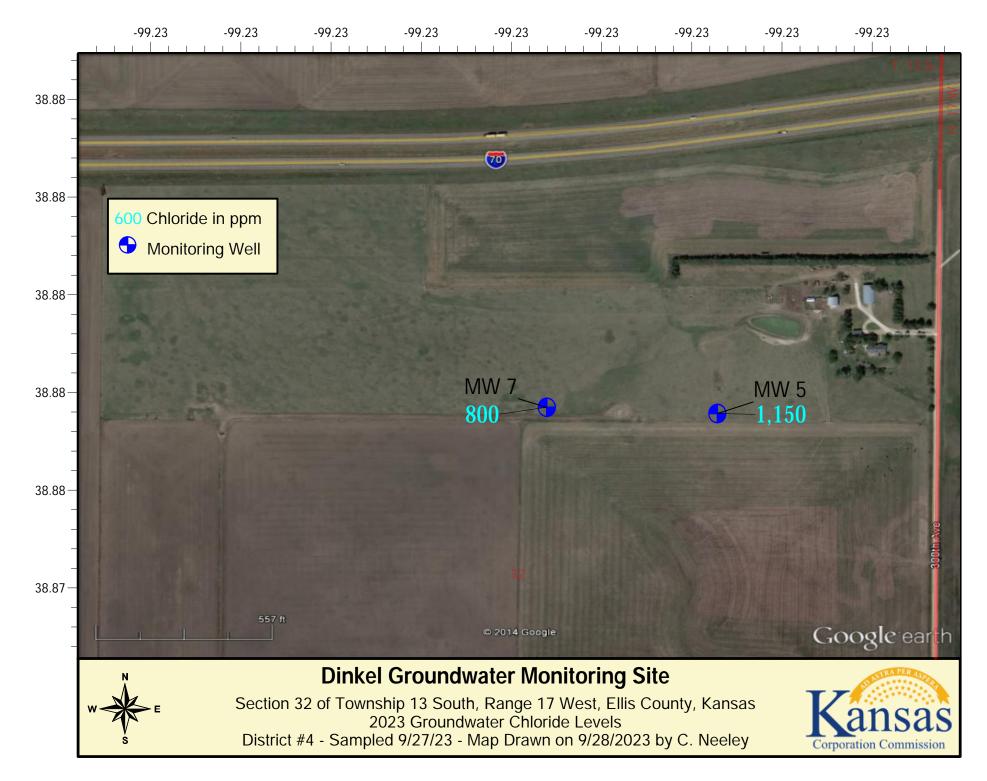
Control No.	Staff Ho	urs/Expenditures	Fund Expenditures FY 2023/24 Total		
970035-00	3 Hrs. / \$	\$99.10	r i 2023/24 - 10tai		l
Current Contaminate Level: 800 ppm Cl ⁻ to 1,150 ppm Cl ⁻					
Status:					
1. Site Assessment	t	2. Short Term Mon	itoring	3. Invest	tigation
🗙 4. Long Term Mo	nitoring	5. Remediation Plan	n [6. Instal	lation
7. Remediation		8. Post Rem. Monit	oring	9. Resol	ved

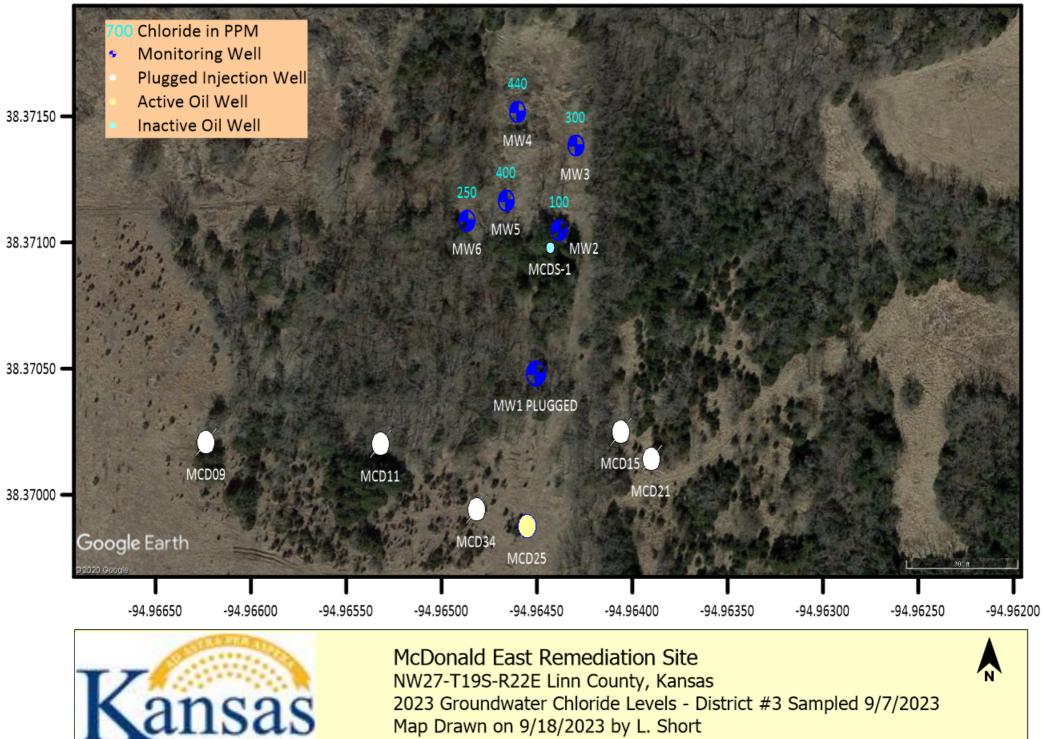
Map Drawn on 9/18/2023 by L. Short Project 970070-00

Control No. Staff Hours/Expenditures		Fund Expenditures FY 2023/24 Total
970070-00	9 Hrs. / \$283.43	
Current Contaminate	e Level: 100 ppm Cl- to 440 ppm (C l-
Status:		
1. Site Assessment	2. Short Term M	onitoring 3.Investigation
🗙 4. Long Term Mon	itoring 5. Remediation P	lan 6.Installation
7. Remediation	8. Post Rem. Mo	nitoring 9.Resolved
