**2025**

OIL AND GAS  
REMEDiation SITE STATUS

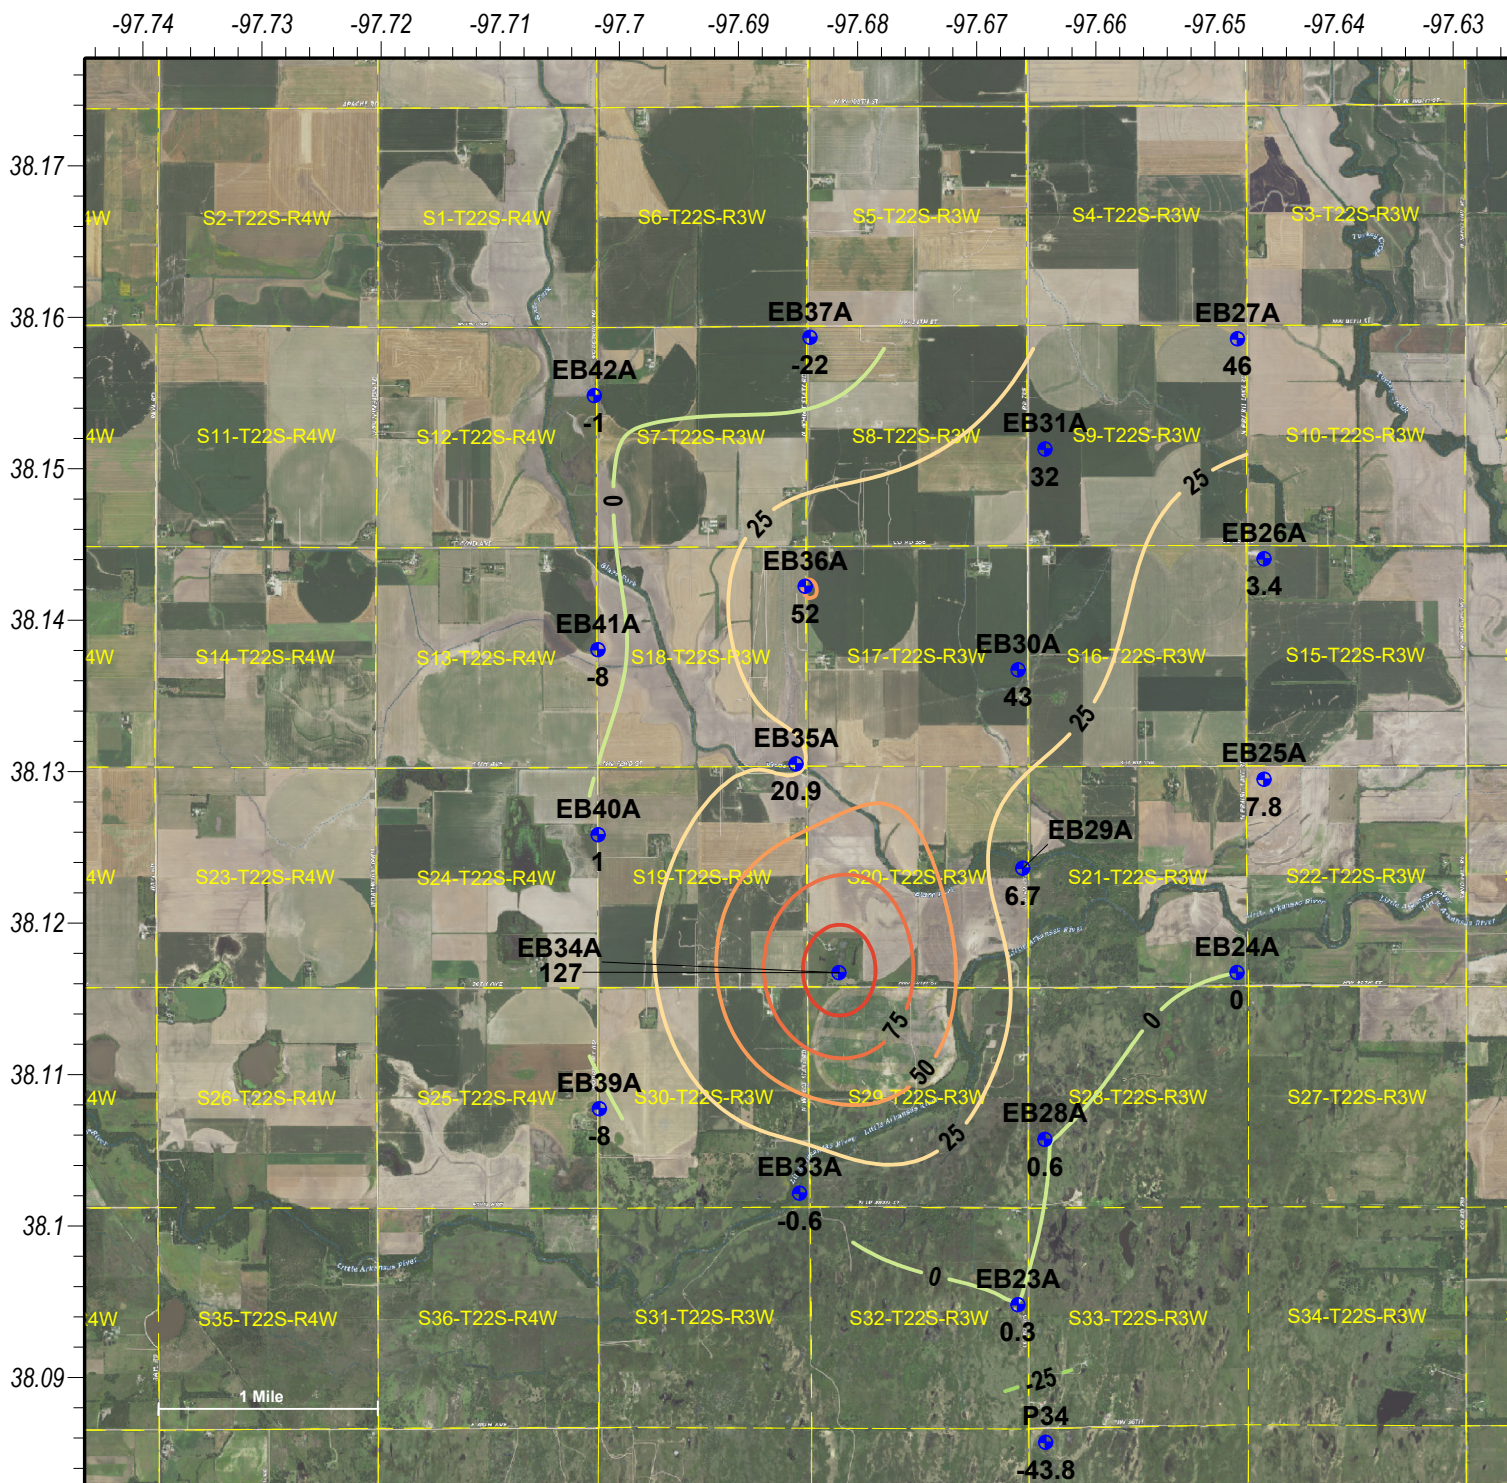
A Zone wells had modest chloride increases through the site's middle and northeastern edge. EB-34A, historically the highest chloride well, rose the most by 127 mg/L from 2023. Local drought conditions have probably influenced this rise. B Zone wells had similar changes, but solely down the middle three wells, EB-34B, EB-35B, and EB-36B. All monitoring well increases were moderate and not over 100 mg/L since 2023. These wells historically are within the heart of the plume. Outside of these wells, the levels remained stable, with slight decreases found except for EB-25B, which showed a slight increase of 6.2 mg/L.

**Recommendations for Future Work:** KCC should continue to collect data from GMD #2 annually for monitoring purposes. The highest chlorides appear centered on EB-34 in all vertical zones. This has always been the case with the Hollow-Nikkel site. Adding new monitoring wells near EB-34, the heart of the plume, could help define the highest chlorides for successful remedial action. With the city of McPherson currently planning on installing a long-term public water supply source just south of the area, additional monitoring wells to the south may be necessary to supplement the monitoring wells installed by the city. In addition, monitoring wells added north of the current site could further investigate the source of higher chlorides seen over the last five years in the northern wells.

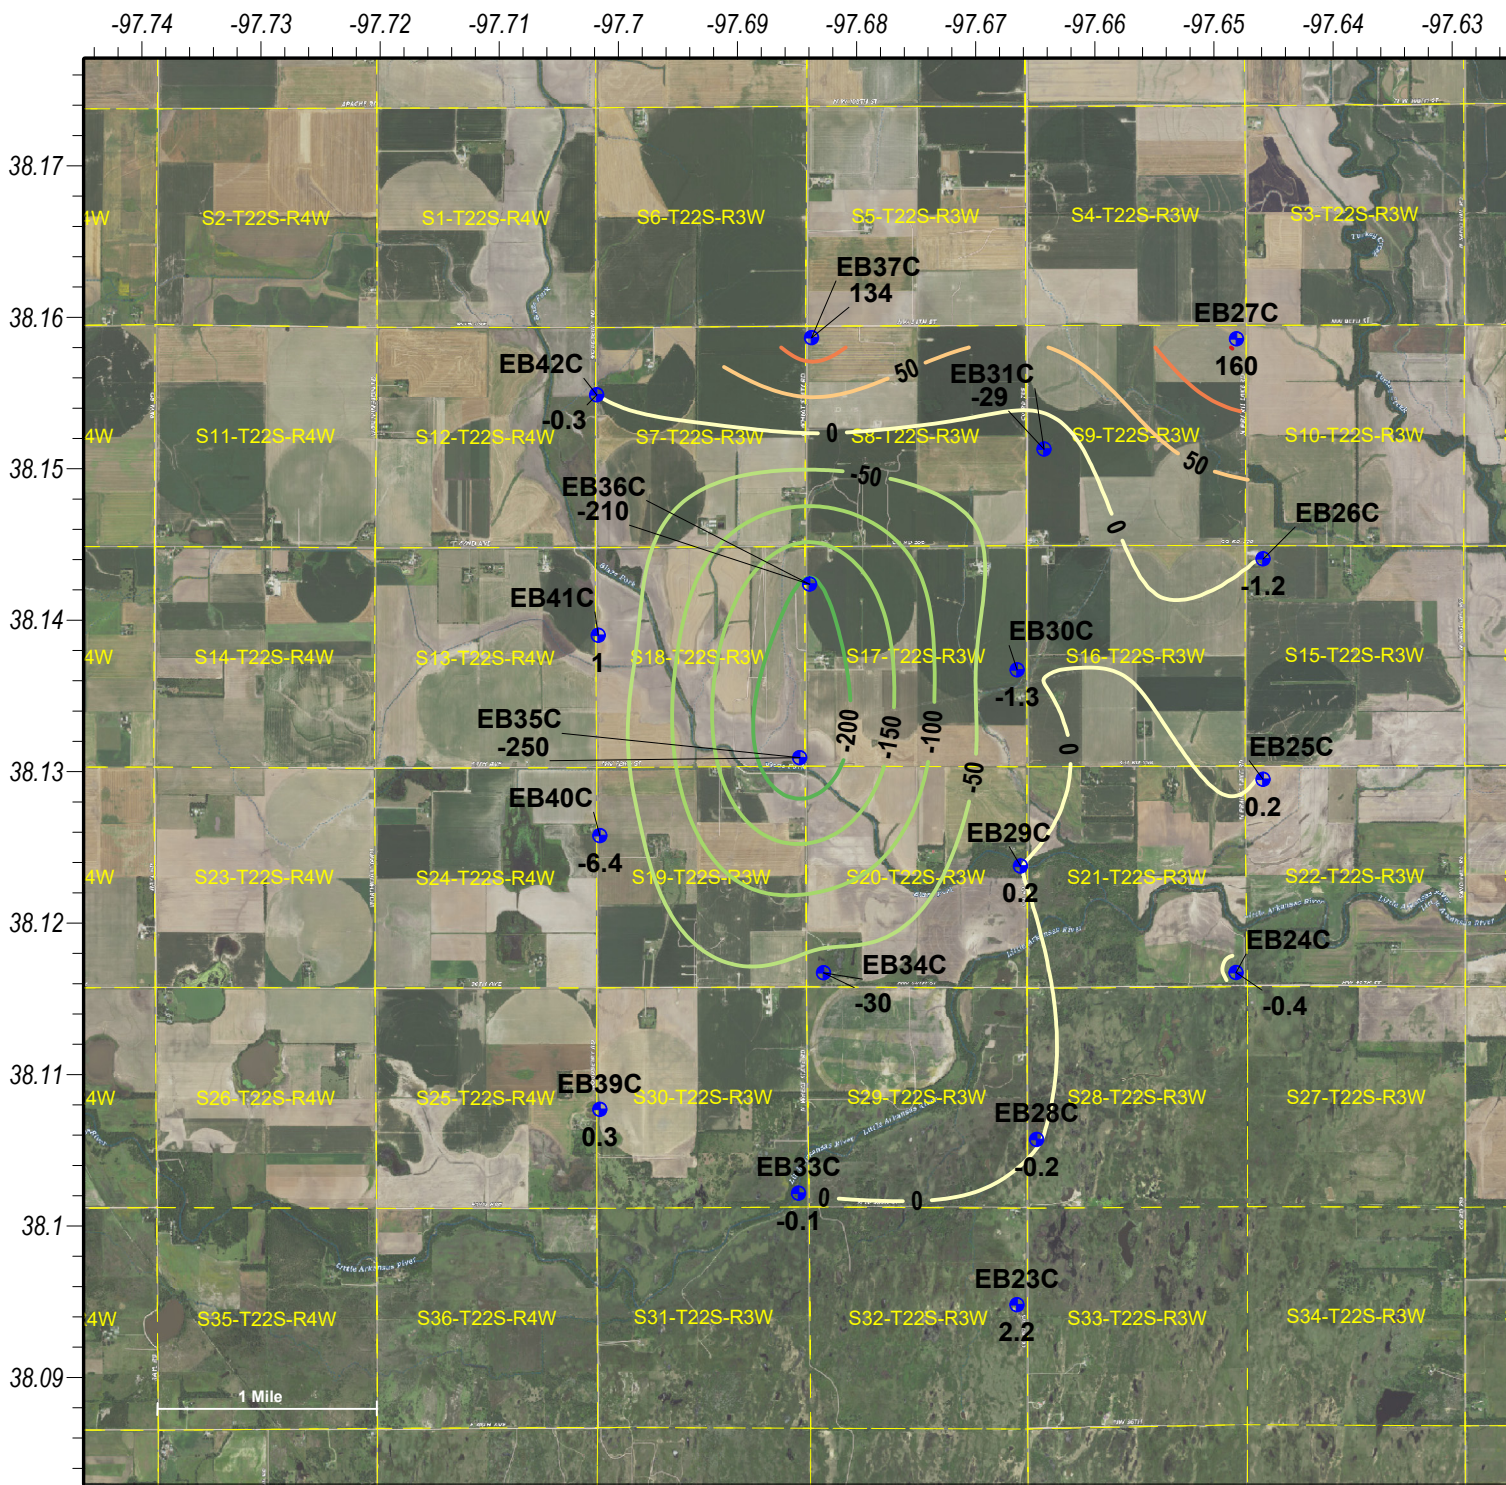
C Zone wells were found to be different, with the middle historical plume monitoring wells decreasing by as much as 250 mg/L. However, increases in the north and east were noted, with increases at EB-37C and EB-27C of 134 and 160 mg/L, respectively. The north and northeast edges of the site should be monitored for future increases as they are along the outskirts of the monitoring well matrix and, thus, will no longer be delineating wells with continued increases.

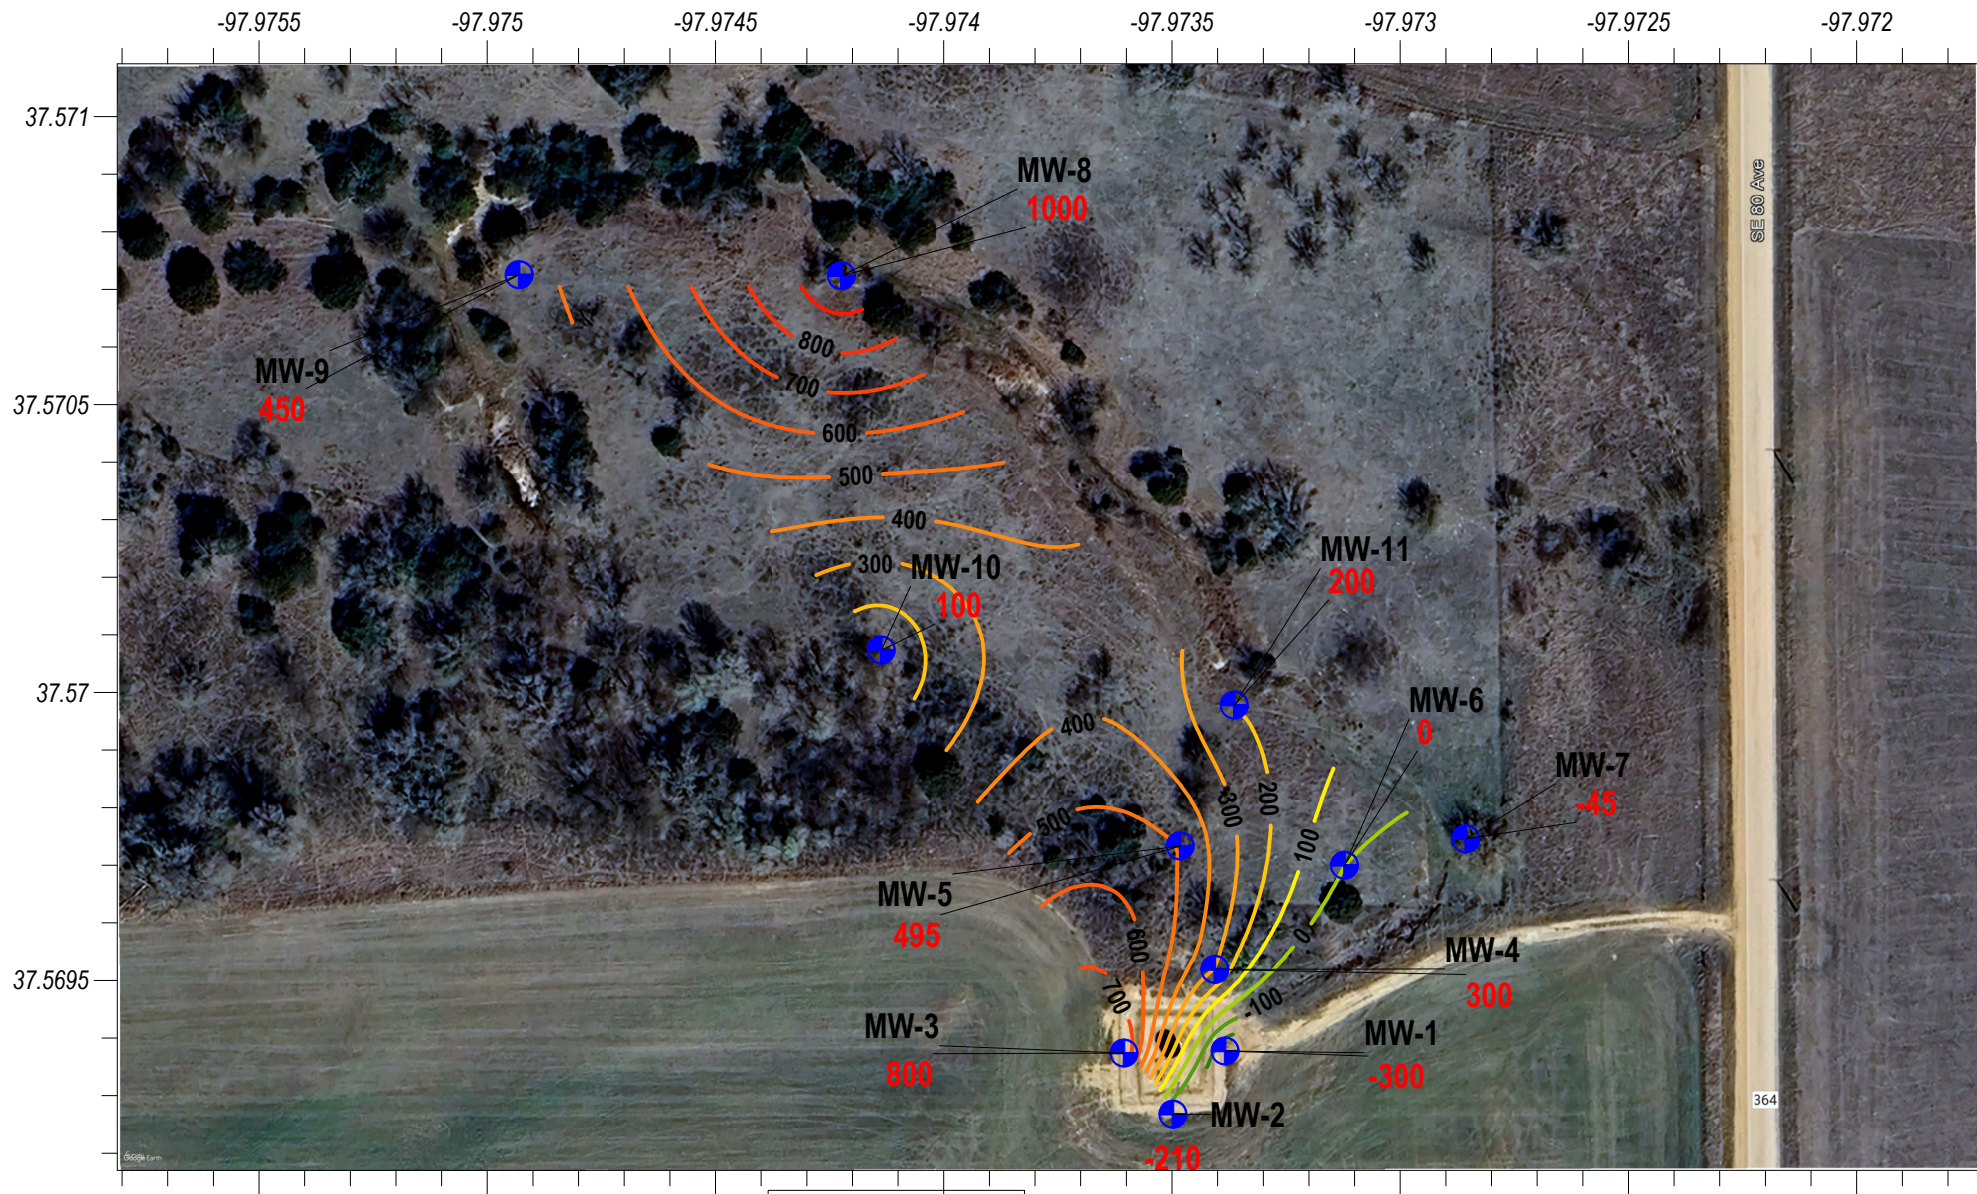
**Trostle Brine Contamination Monitoring Site**  
 Section 33 of Township 28 South and Range 6 West, Kingman County, Kansas  
**Chloride Change from 2023-2024**  
 KCC District #2 Field Office - Control #980038-001  
 Wells Sampled on 9/26/2024 - Map Drawn on 10/10/2024 by D Bollenback

Laboratory results showed higher chloride levels down gradient of the tank battery, mainly MW-8, which increased by 1000 mg/L from 2023. MW-3 along the west side of the battery also showed an increase of 800 mg/L. Slight chloride drops along the southern and eastern edges were noted. 2022, 2023, and 2024 were extremely dry in the region. The static water levels in the wells dropped, averaging 0.28' lower across the site from last year. Most wells had less than 3 feet of groundwater, and some wells had less than 1 foot of water. Water levels were lower than any sampling event in the last ten years.

**Recommendations for Future Work:** Due to the limited amount of water resources affected and the recent data, KCC recommends continuing to sample the Trostle annually. KCC does not recommend expanding the monitoring well matrix, currently. A small, low-volume recovery system is an option, but KCC is uncertain about how beneficial a system would be due to the aquifer's low deliverability. Higher precipitation rates may help flush out the local system, though KCC expects to see higher chlorides down gradient if that occurs.
