Kansas
Corporation Commission

OIL & GAS REMEDIATION SITE STATUS

ANNUAL REPORT 2020

Abandoned Oil and Gas Well / Remediation Site Fund
Remediation Sites
Status Report

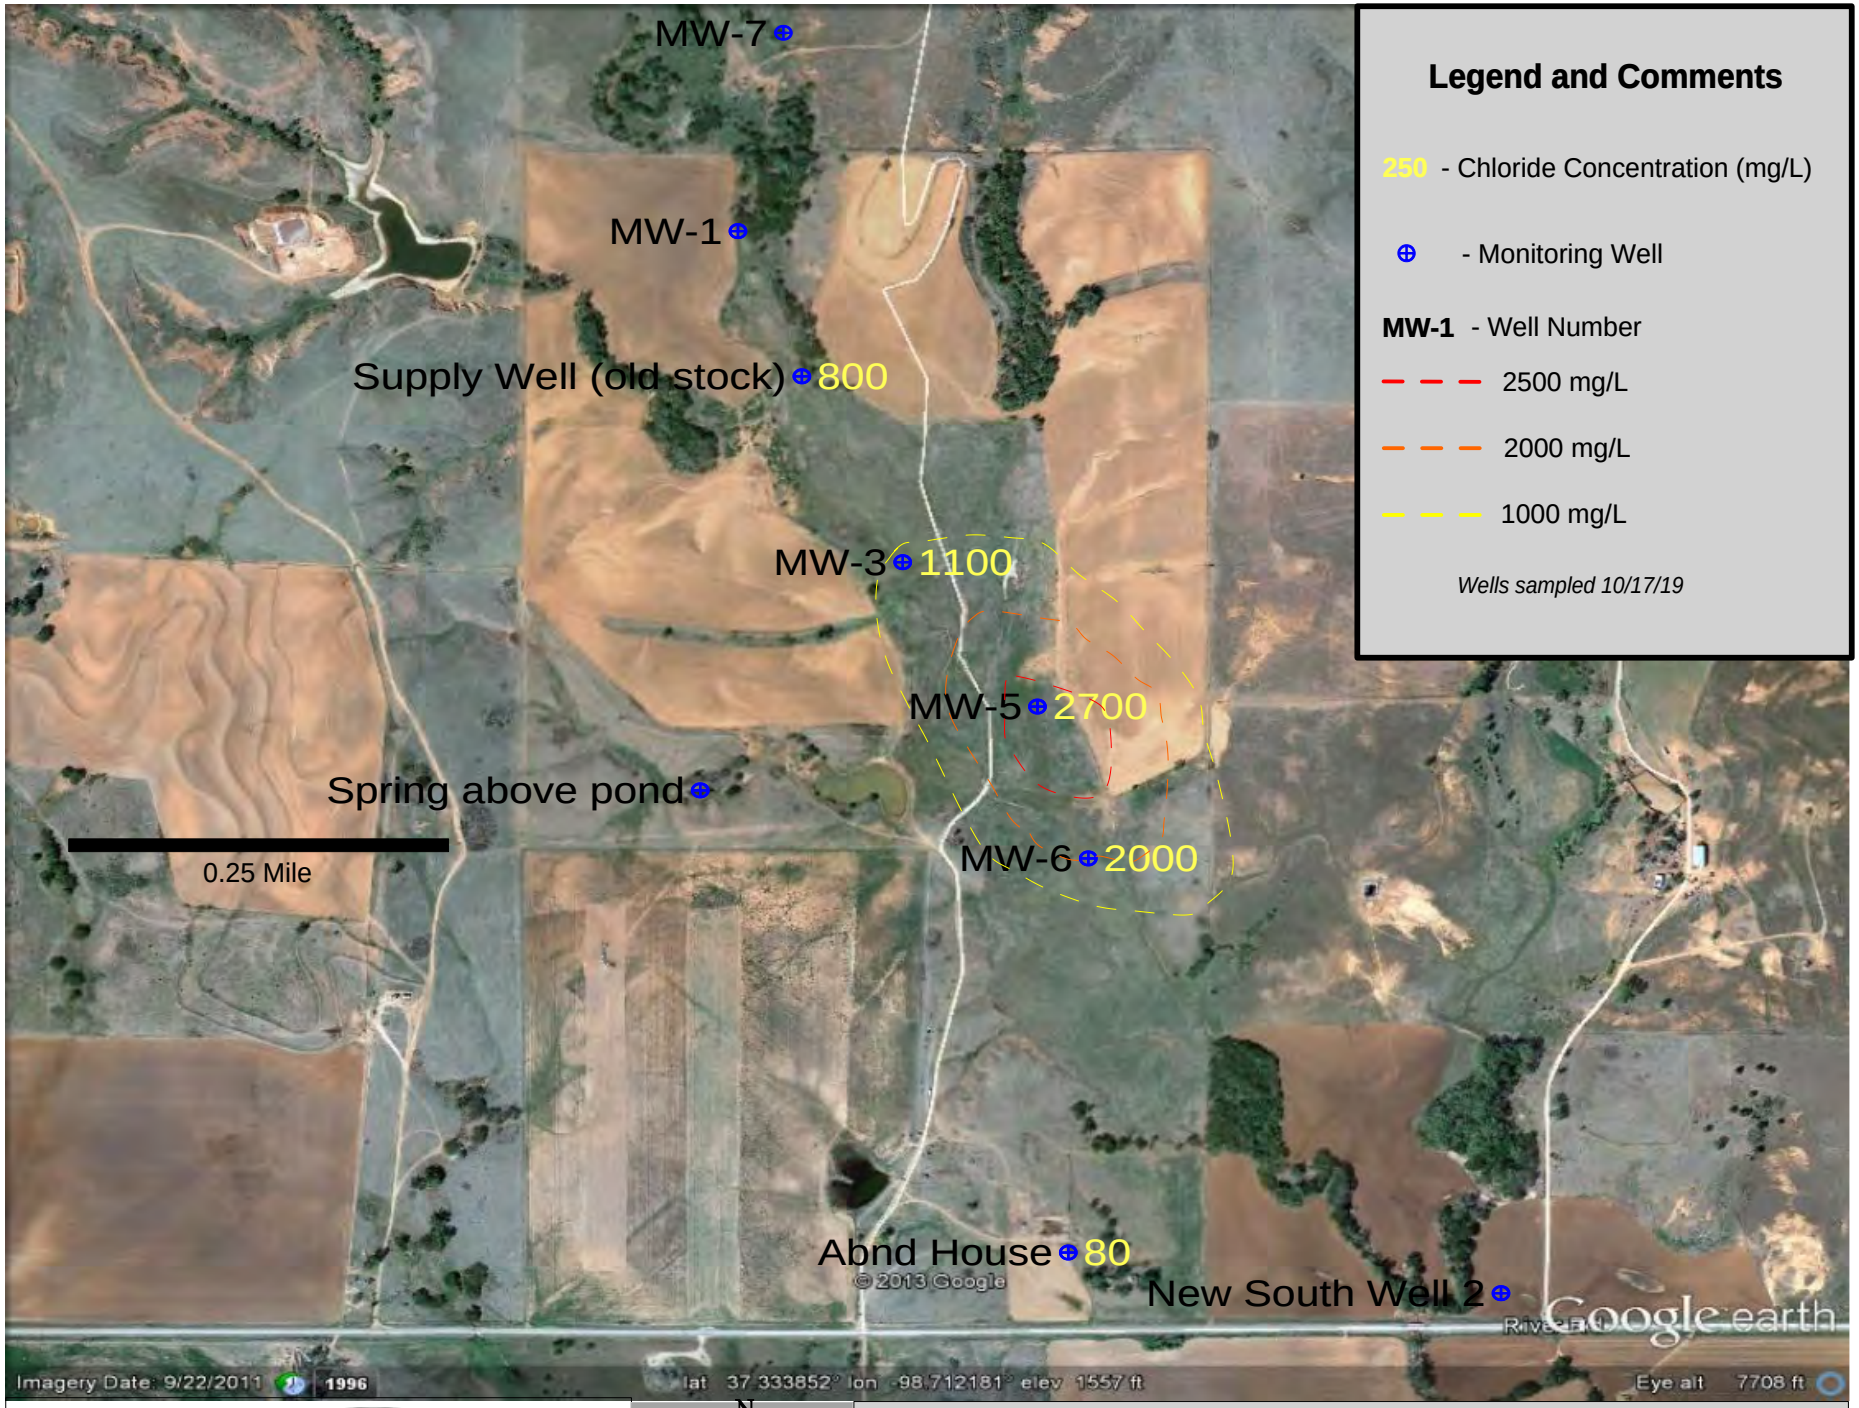
Site Description: The salt-water plume is moving to the south away from the Packard #1 oil well. It has contaminated the water supply well and could possibly damage the domestic well at the abandoned house, the supply well in the SE/4 of section 23, and the spring to the southwest.

Recommendation for Future Work: Monitoring will continue on an annual basis as the area continues to be remediated by natural attenuation. As the groundwater in this area is relatively shallow, several holes may be augured in order to gather more comprehensive data on the size and whereabouts of the chlorides. Depending on the information gathered, additional permanent monitoring wells may need to be installed. Analytical may need to be run on the new south supply well in order to determine if the chlorides are of a natural source, or from oilfield activities.

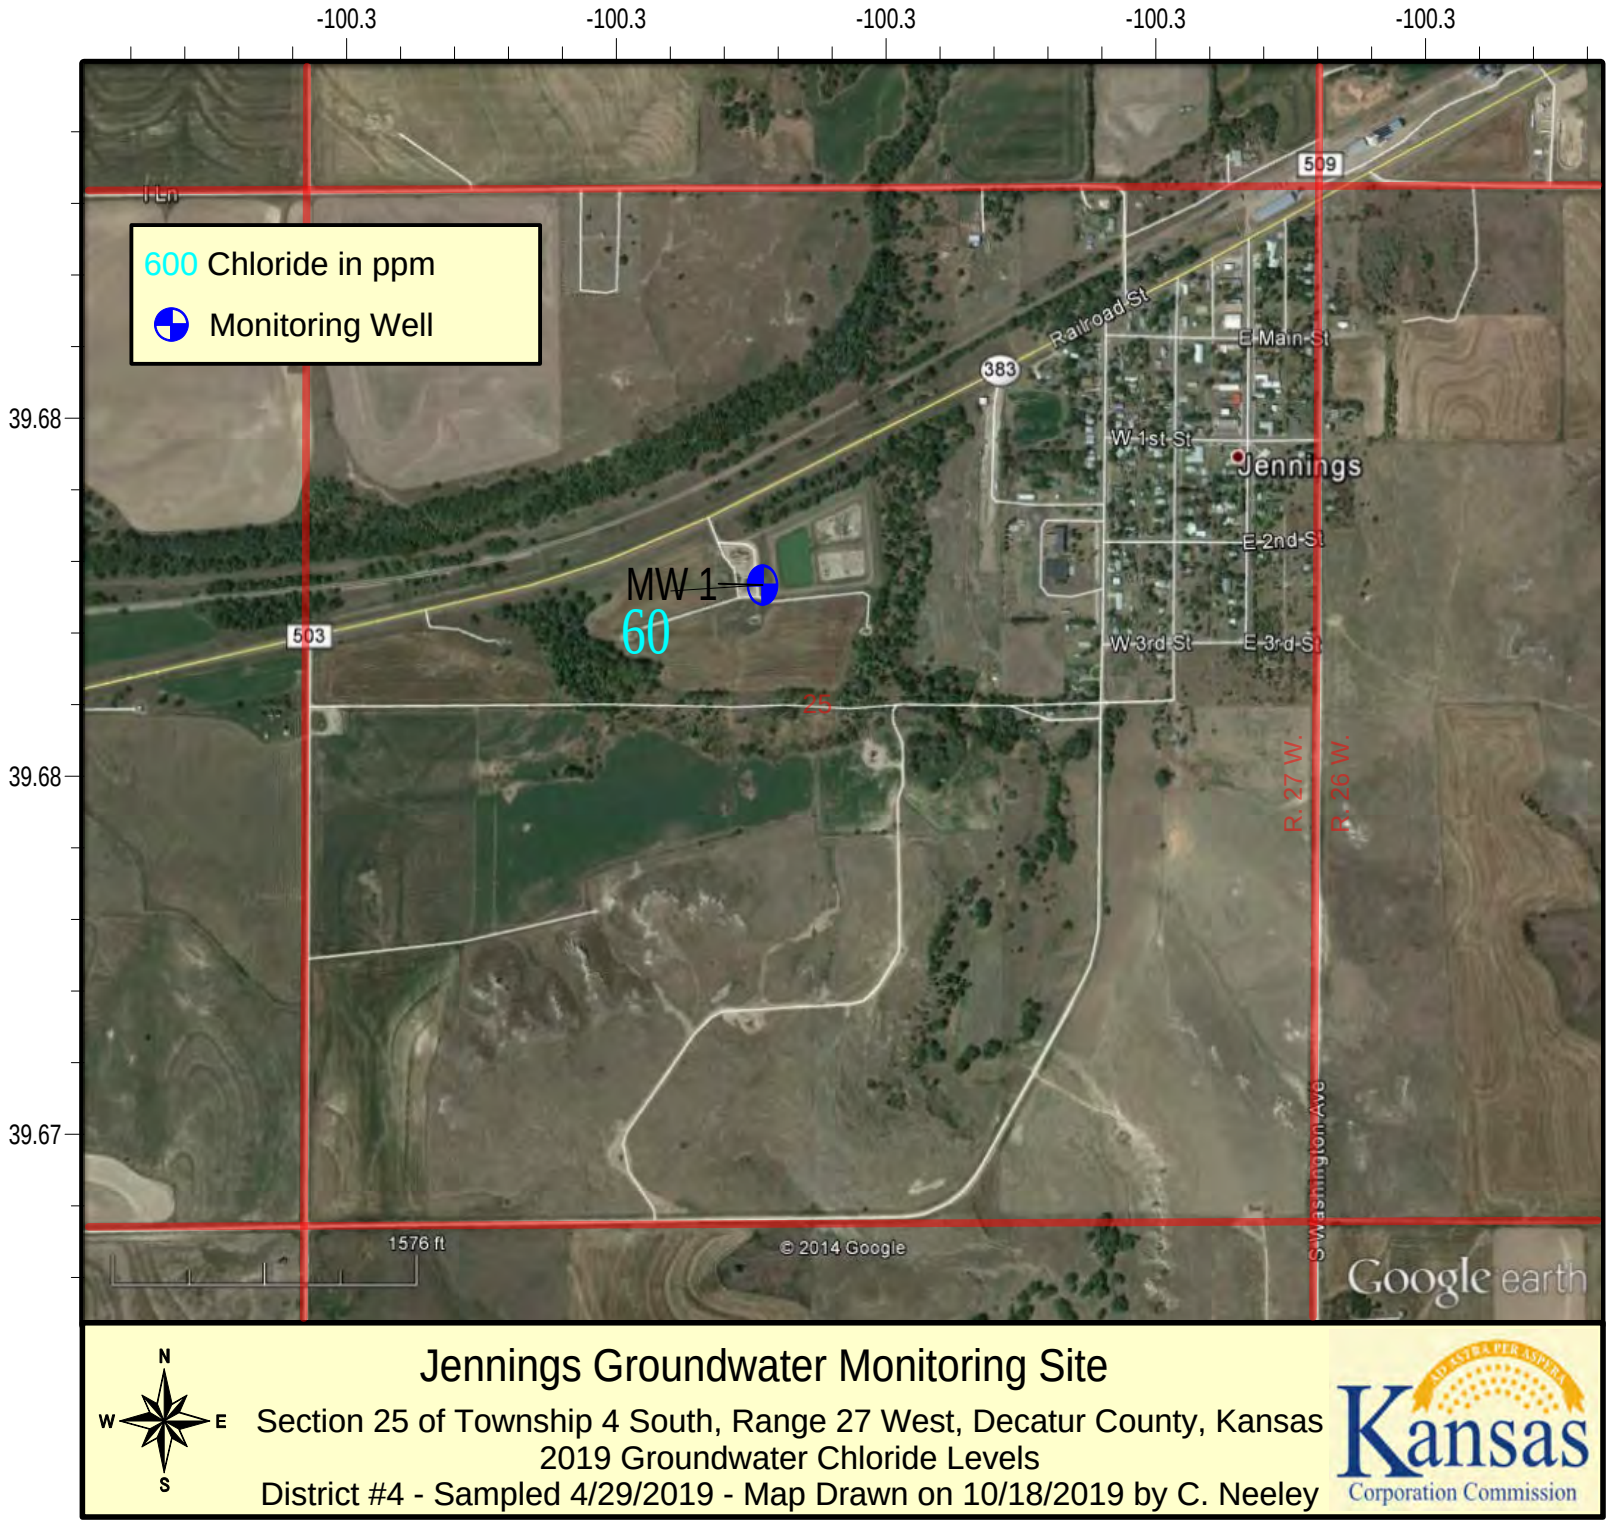
Impact/Immediacy: Groundwater contaminated by poor oil field practices including discharges at the injection pump site and brine line leaks since the 1950s. Two public water supply wells inside the city limits have experienced elevated chloride levels of varying intensity. Immediacy level is rated as low to moderate.

Site Description: The current city water supply well is located west and upstream of the tank battery and injection plant area, and has not been impacted by oil field pollution. The contaminated wells within the city limits are used for purposes other than human consumption, such as lawn and garden, and bulk water load-out. The site is situated within the stream valley of Prairie Dog Creek. The monitoring well has been drilled into this alluvium, and the soils are Munjor sandy loam. This allows rapid infiltration of spilled fluids into the groundwater, and spikes in the chloride level seem to correlate to reported spills at the tank battery area.

Recommendations for Future Work: Monitor on an annual basis. Additional data needs to be acquired through the sampling of additional wells down gradient of the existing monitoring well. District staff will work to establish a cooperative relationship with the operator regarding lease practices, and the implementation of safeguards to prevent pollution of the aquifer.

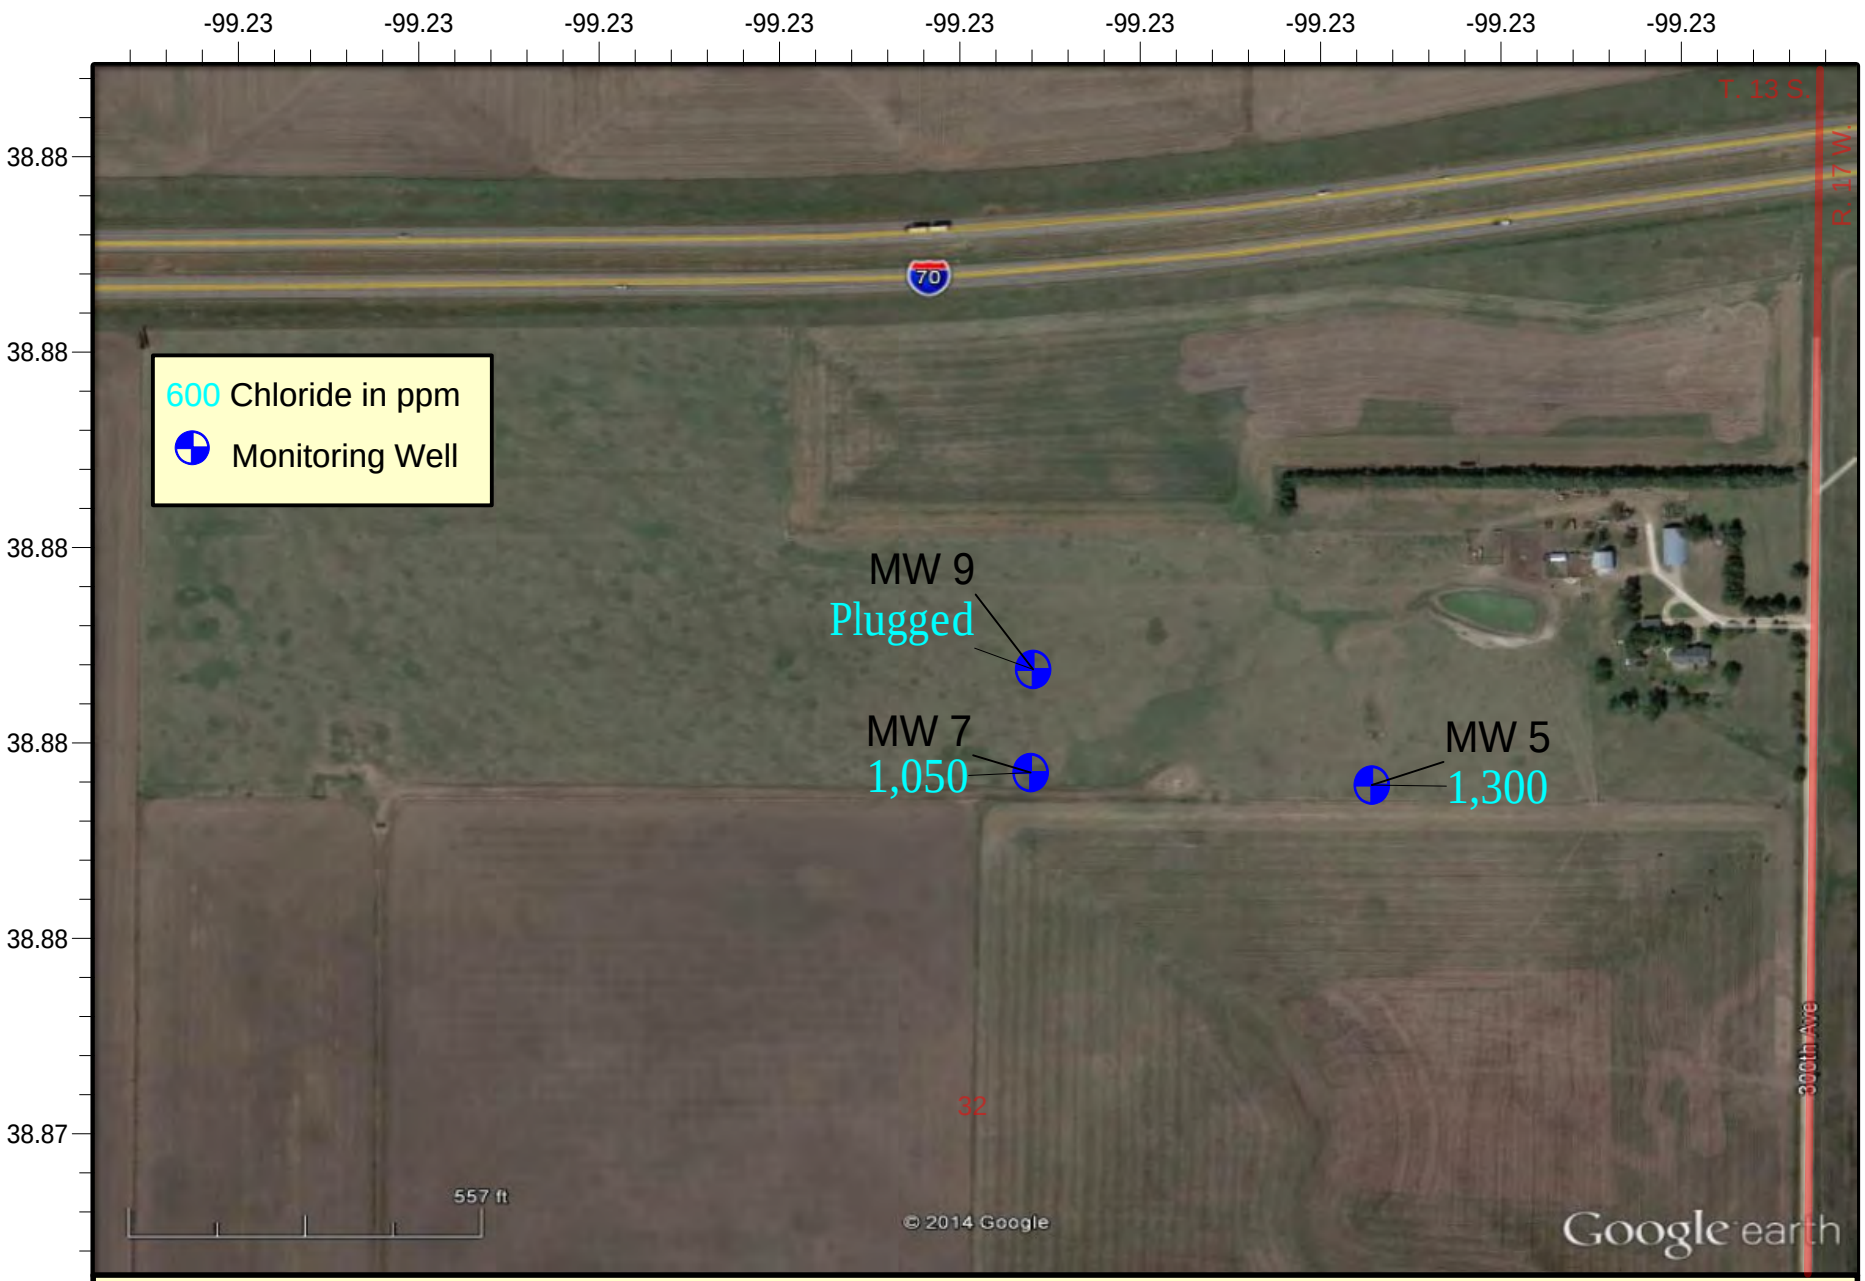
Dinkel Groundwater Monitoring Site

Section 32 of Township 13 South, Range 17 West, Ellis County, Kansas
2019 Groundwater Chloride Levels
District #4 - Sampled 4/24/2019 - Map Drawn on 10/18/2019 by C. Neeley

Impact/Immediacy: The Ruder Creek Alluvial Aquifer has been impacted by brine intrusion due to surface ponds, shallow disposal wells in the Cheyenne Sandstone, and numerous leaks. The Immediacy level for this site is rated as moderate.

Status of Project: Presently, the chloride concentrations in the monitoring wells range from 1,100 ppm in MW1 at the northern end of the site, to 275 ppm in the southern monitoring well near the Smoky Hill River. This north-south chloride gradient has persisted for many years. Appreciable decreases in chloride contamination have not been observed throughout the duration of sampling, and it is unknown if the input of additional contaminants has been halted by the closure of surface pits, plugging of flowing wells, and general improvement of lease practices. A test hole augured in 2018 approximately 100' north east of the northern monitoring well (MW1) produced water with a concentration of only 600 ppm. It is not yet known if this is representative of the groundwater north of this well, and further work will be conducted to determine if MW1, which was not completed in alluvium, is anomalous.

Recommendations for Future Work: Conspicuous potential sources of pollution have been identified on a historical aerial photograph, and a conductivity survey will be carried out and combined with additional groundwater sampling. This site will continue to be monitored on an annual basis, and resources will be compiled to identify other possible sources of pollution.

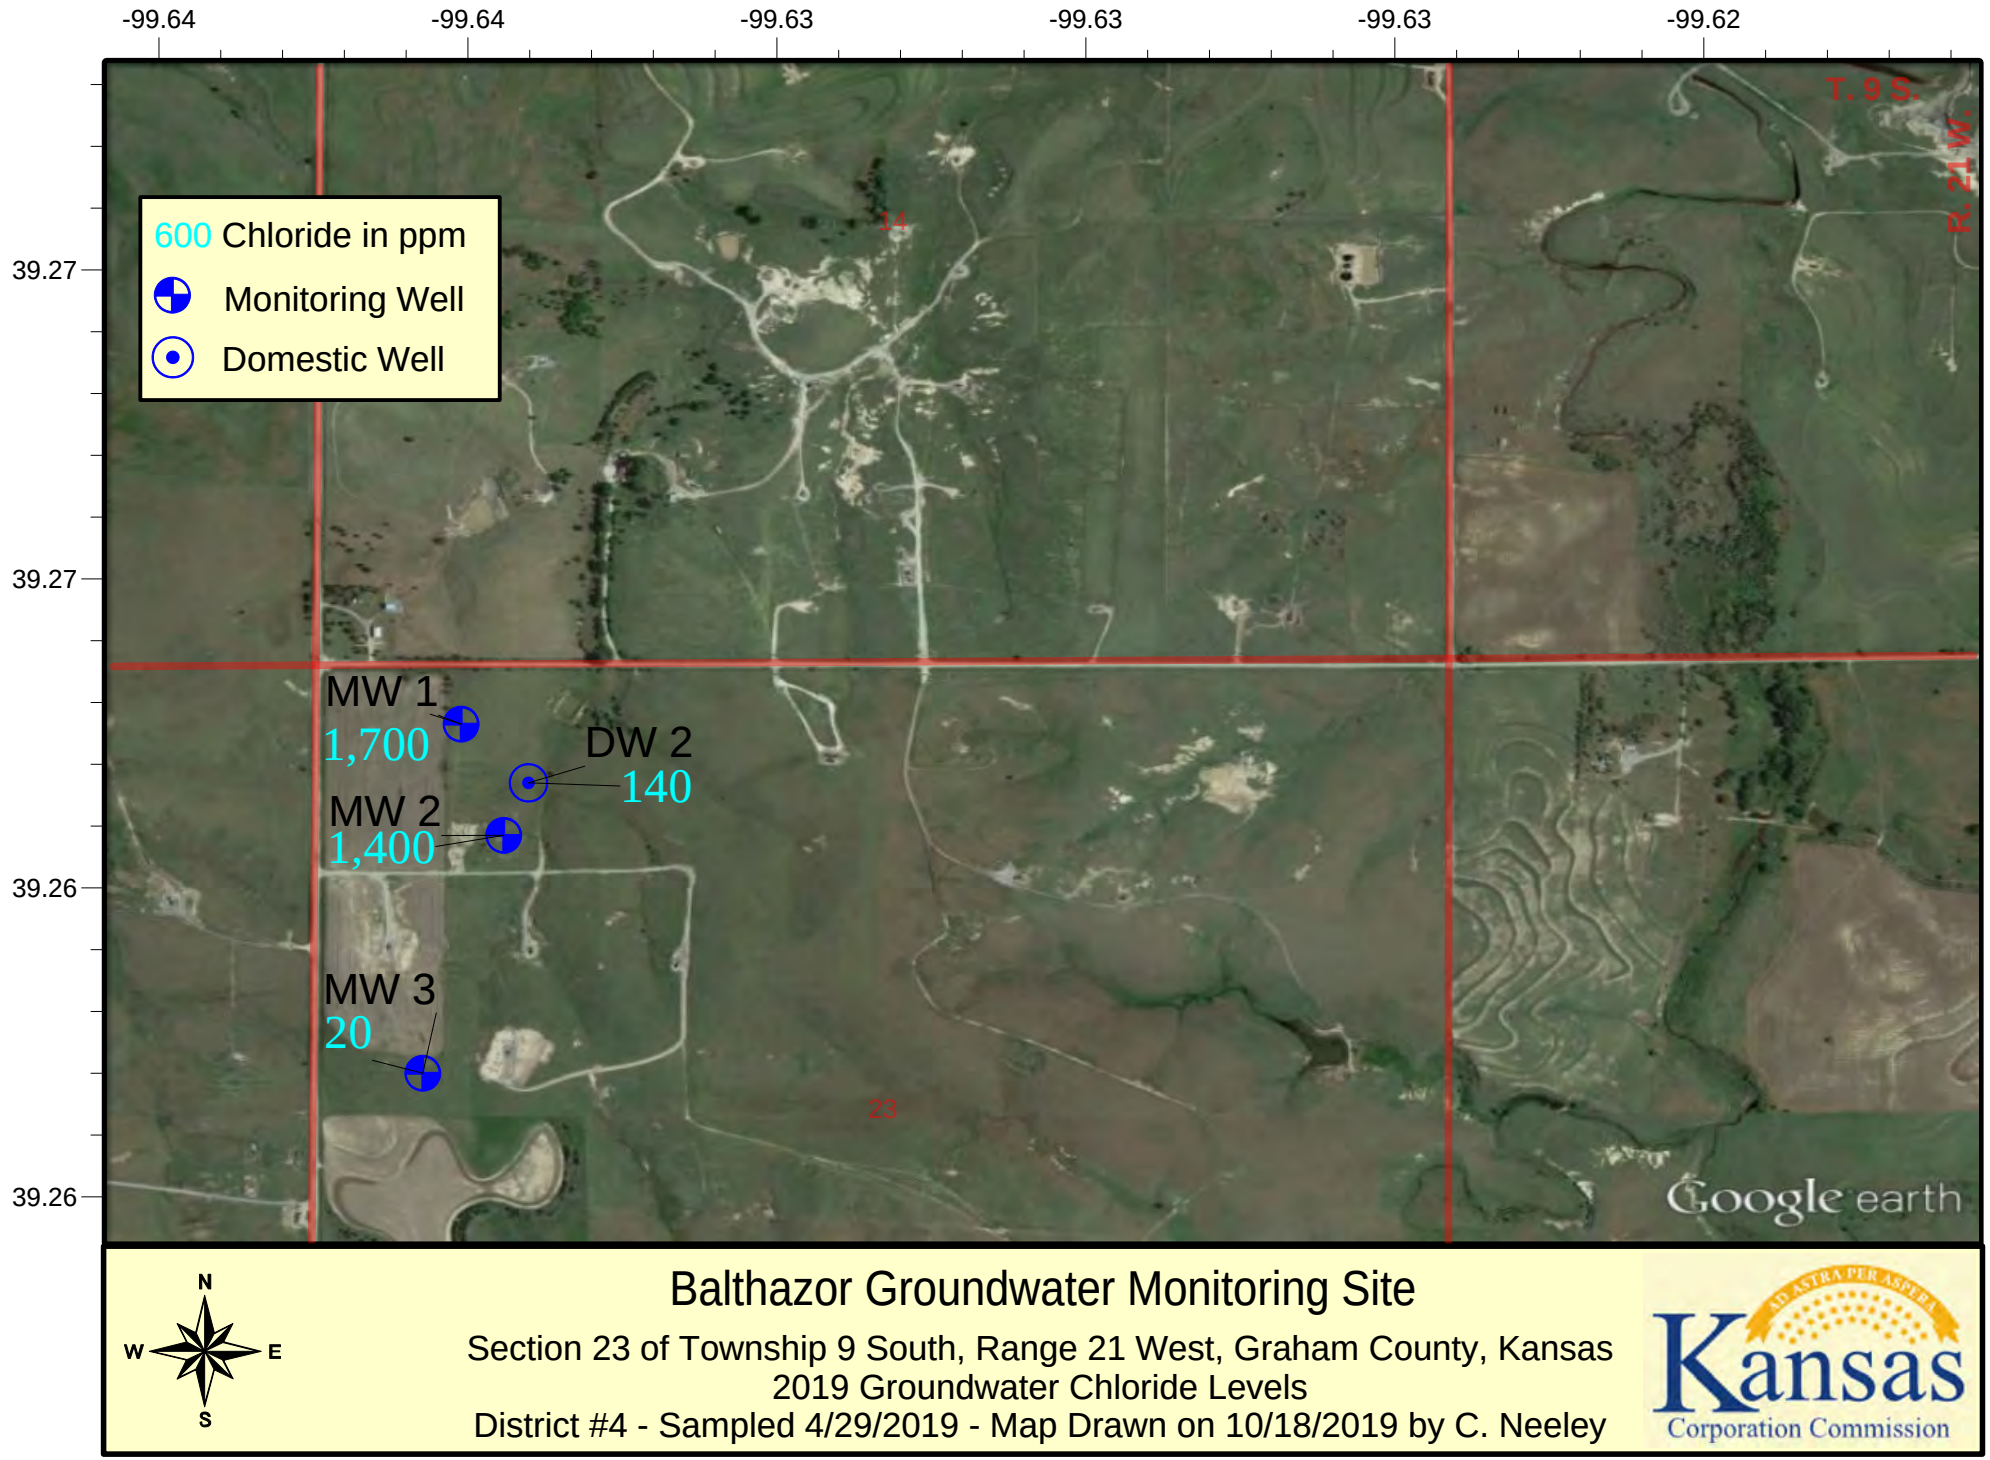
Balthazor Groundwater Monitoring Site

Status of Project: When the new domestic well was drilled in 2011 the chloride level was 2,300 ppm. After an initial decline to 600 ppm, the concentration increased slightly in 2015 to 750 ppm. In 2019 the concentration fell to 140 ppm. The three monitoring wells on the location have remained relatively stable with a subtle overall decrease in contamination. The contamination levels in 2017 were 1,500 ppm in MW #1, 1,450 ppm in MW #2, and 140 ppm in MW #3. The results in 2018 followed the trend of stability with only minor fluctuation. The wells were tested and found to be 1,300 ppm in MW #1, 1,400 in MW #2, and 30 ppm in MW #3. In 2019, the chloride levels were found to be 1,700 ppm, 1,400 ppm, and 20 ppm in monitoring wells 1 through 3.

Section 23 of Township 9 South, Range 21 West, Graham County, Kansas
2019 Groundwater Chloride Levels
District #4 - Sampled 4/29/2019 - Map Drawn on 10/18/2019 by C. Neeley

Recommendations for Future Work: The source of the contamination is likely an old brine pit in the NW/4 of Section 23, T.9S. R.21W., and the feasibility of decreasing the contamination level through remediation will be considered, but needs to be weighed against the site parameters. The contamination level will continue to be monitored.

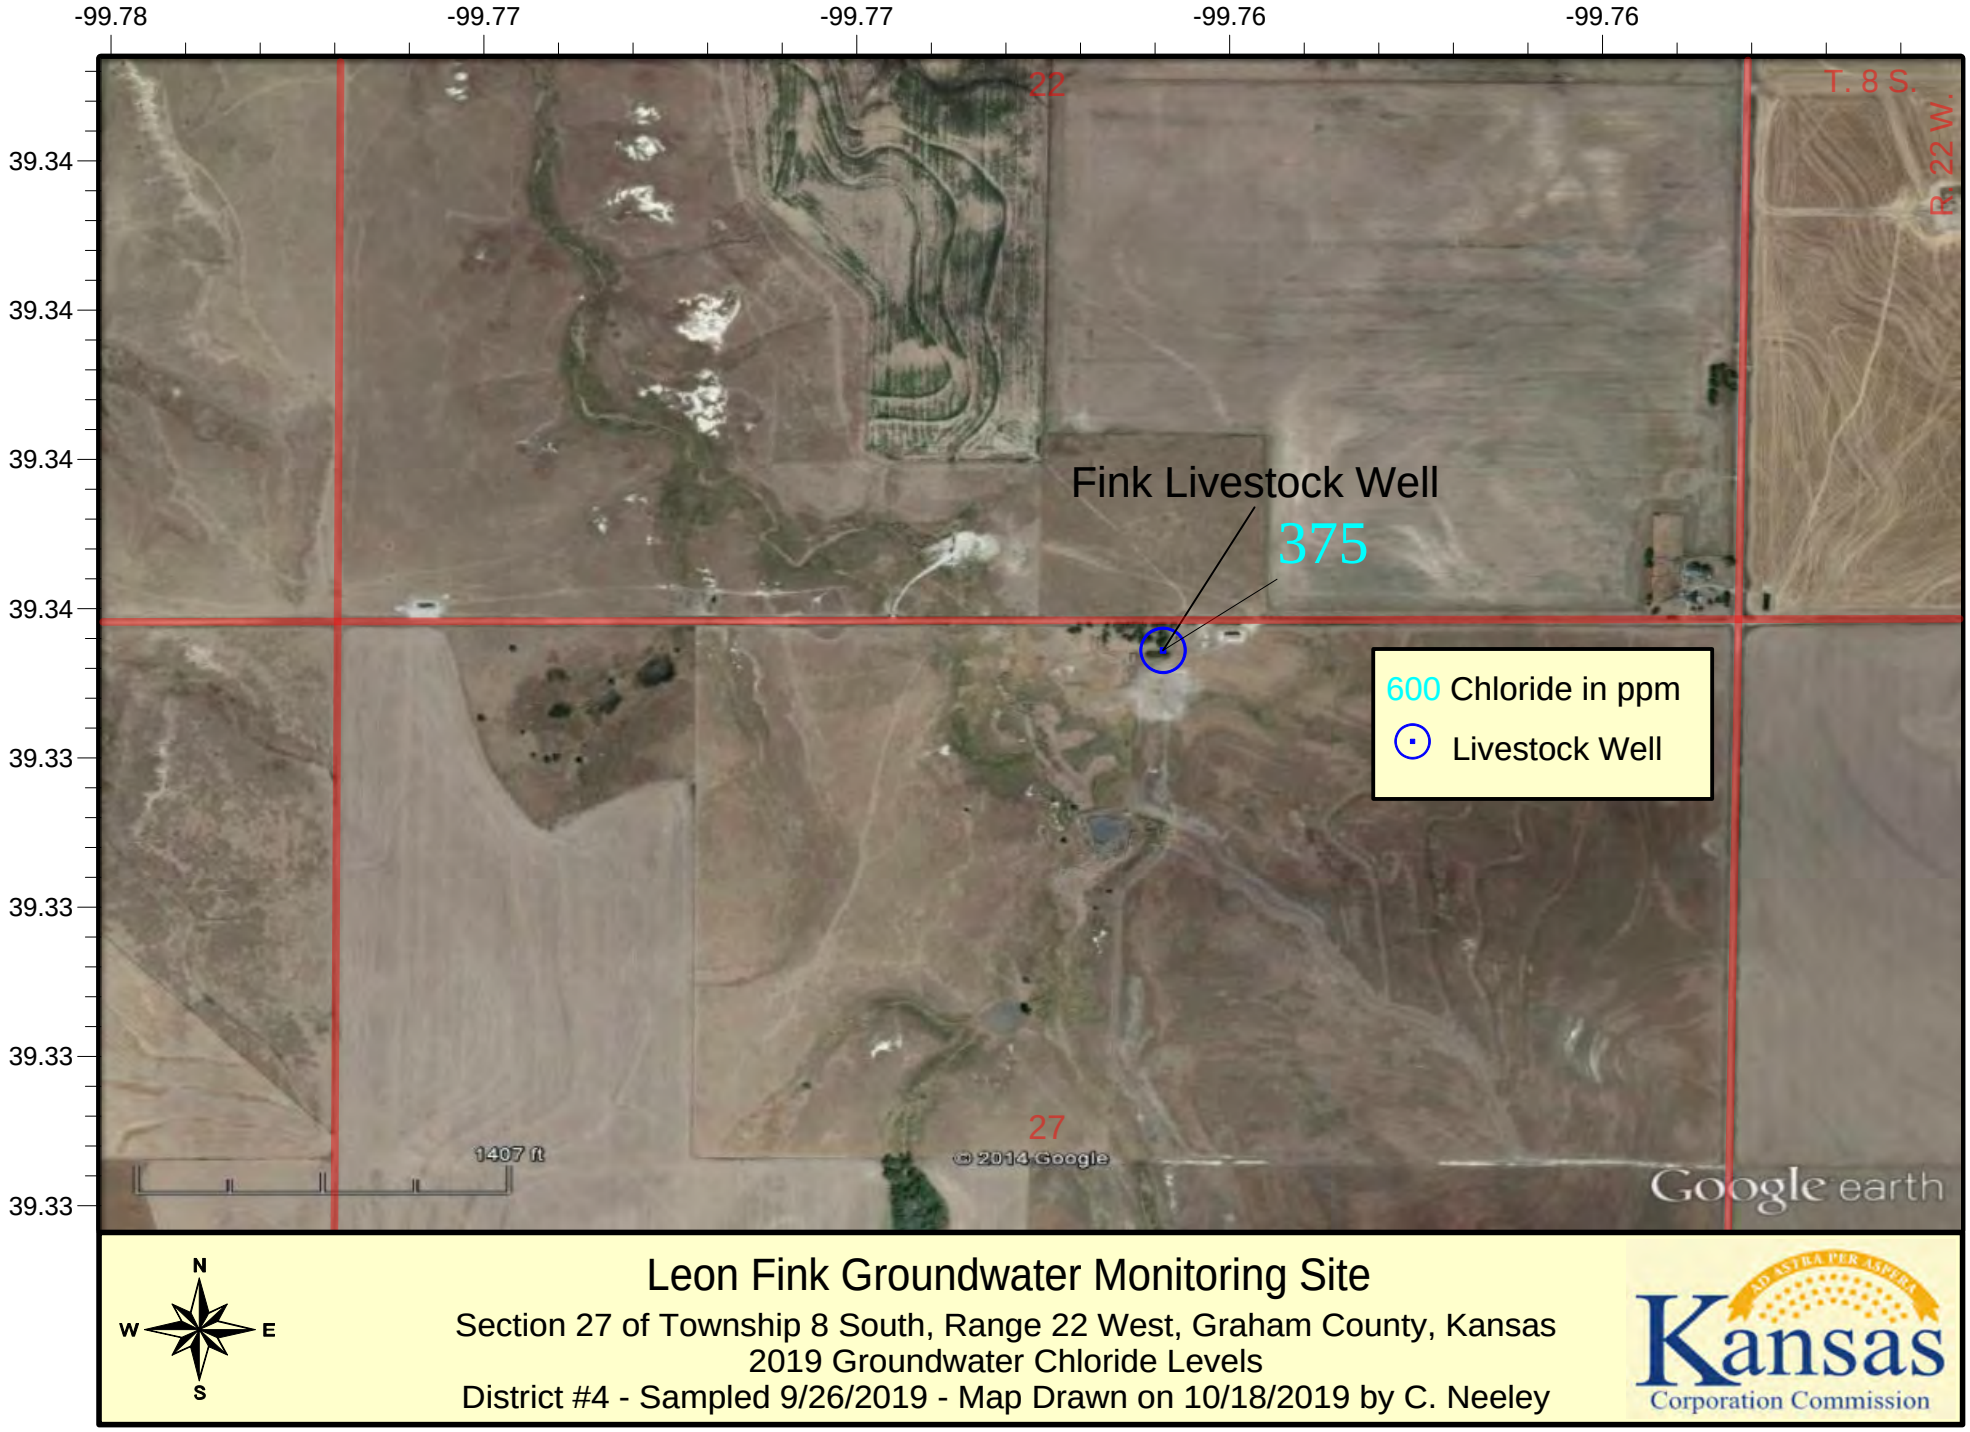
Leon Fink Groundwater Monitoring Site

Status of Project: The domestic well has been abandoned due to a water level that is inadequate for use by the owner, and the house has been demolished. The last sample taken from this source in 2004 contained a chloride concentration of 200 ppm. Samples from the stock well continue to be tested, and the well is presently being utilized for livestock which will contribute to a reduction in chloride concentrations if the source has been eliminated. An overall downward trend has been observed over the history of the site, and the current contamination concentration is at 375 ppm.

Section 27 of Township 8 South, Range 22 West, Graham County, Kansas
2019 Groundwater Chloride Levels
District #4 - Sampled 9/26/2019 - Map Drawn on 10/18/2019 by C. Neeley

Recommendations for Future Work: This site should be monitored short-term to ascertain if the lowered chloride concentration will be maintained.

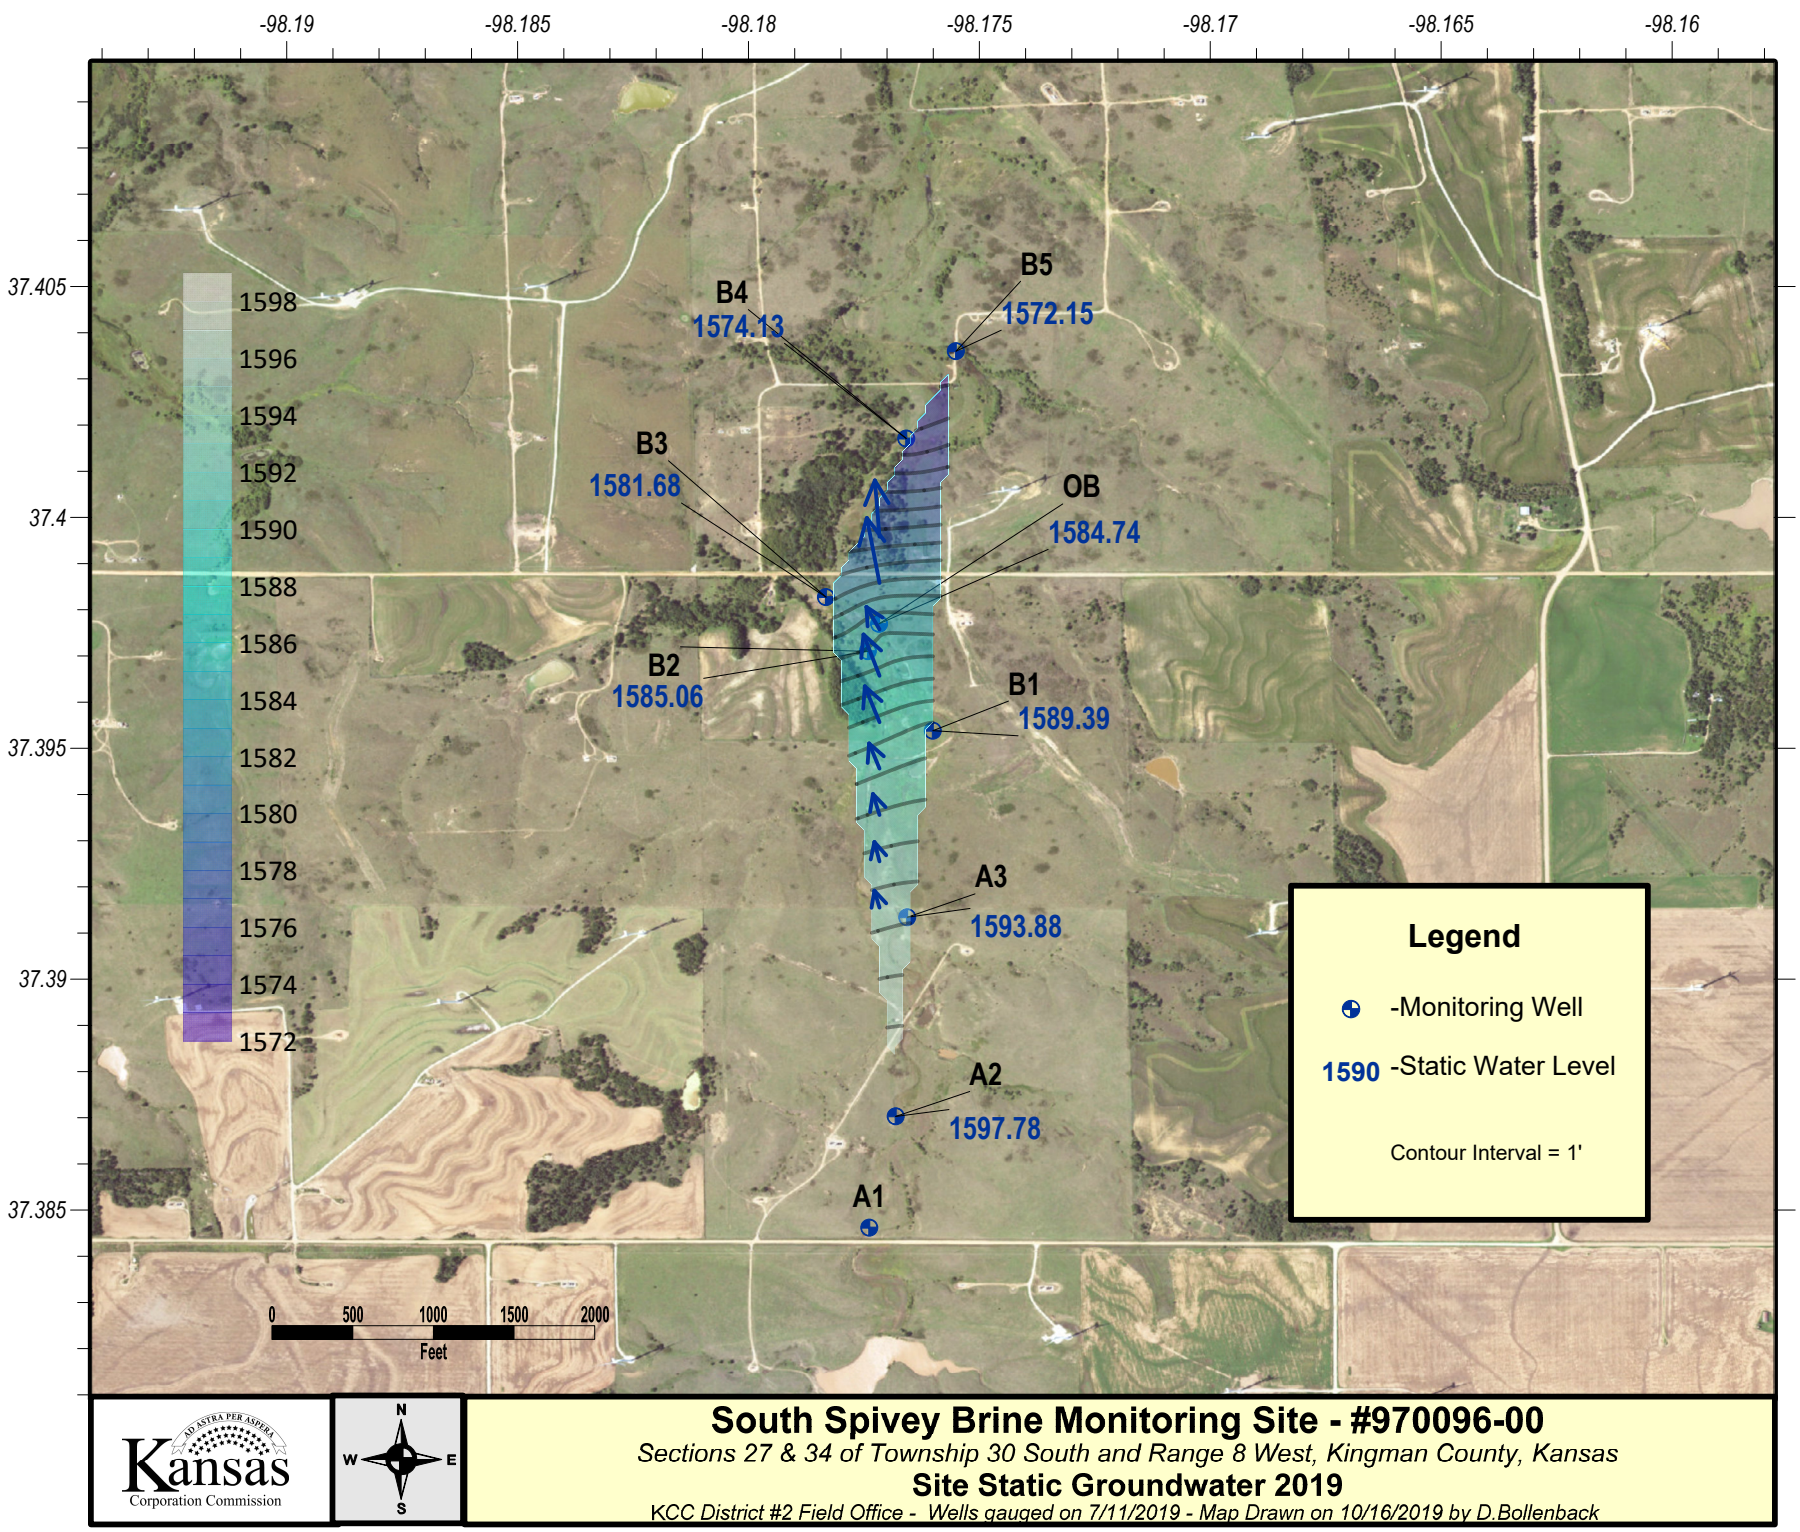
Site Description: The project area lies within an intermittently flowing creek bed within the large Spivey-Grabs oil and gas field. The area is remote and the surface use is primarily the grazing of cattle, oil and gas production, and wind turbines. The geology in the area is unconsolidated Tertiary and Quaternary deposits overlaying the Permian, Nippewalla Group Shale. This Shale can be found exposed along valleys of the Chikaskia River system and its tributaries. The unconsolidated sediments usually consist of poorly sorted sands, silts, and gravels and can be up to 60 feet thick. The Permian erosional surface dips to the north towards the Chikaskia River. Most locations that are overlain with unconsolidated sediments, show good infiltration from precipitation but can vary in horizontal permeability due to poor sorting or heavy silt development. Ground water tends to follow the slope of the Permian erosional surface. This site has been monitored since 1993 when an oil and gas lead line broke and flowed for a period of time. It was unknown at the time how much brine water was lost. There were remedial operations in the past in attempt to remove the brine, but it has been many years since operations ceased.

Recommendations for Future Work: Continue sampling all monitoring wells and surface waters on an annual basis. Two wells still remain over the target level of 750 mg/L Chlorides. MW-A1 is dry most years and could be plugged. No other action is needed at this time as this site has a low immediacy rating. If the MW-A2 well has similar results next year KCC would recommend plugging out the southern wells.

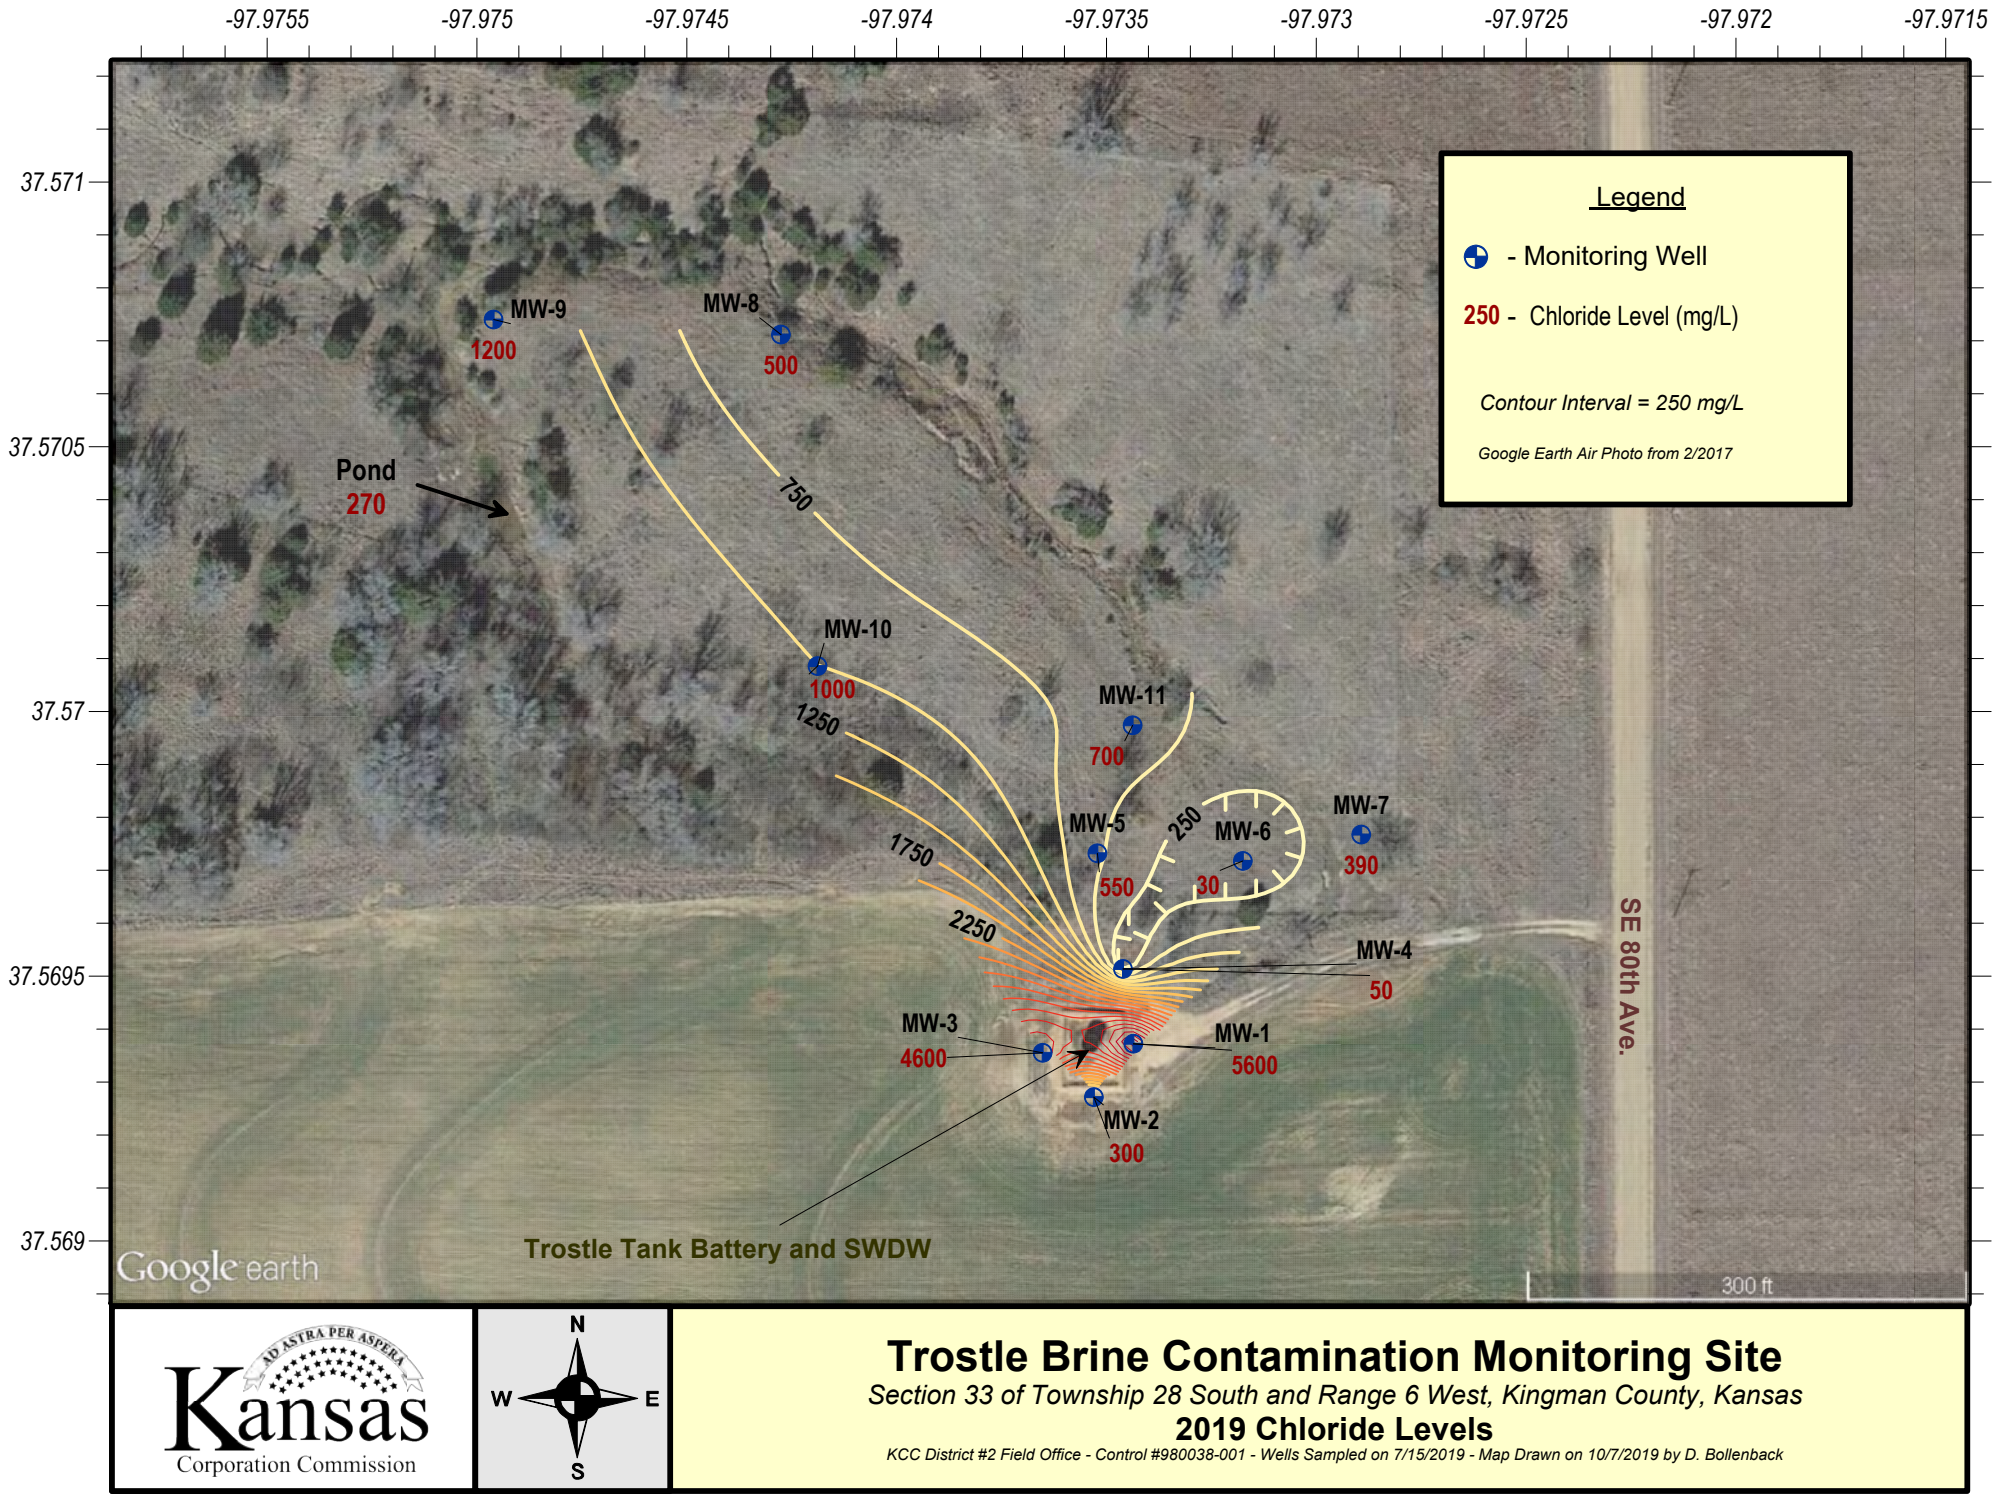
Trostle Brine Contamination Monitoring Site

Site Description: The area most affected historically is around the Trostle salt-water disposal well battery. There are seven monitoring wells below the Trostle salt-water disposal well that also have elevated chlorides. The most likely cause was something related to the salt-water tank such as discharges. This site was historically remediated via an interceptor trench but the system was abandoned after the holding tanks failed and the site was placed into the monitoring phase of investigation. There has only been one reported spill at the SWDW since 2005. Local hydrology is a perched aquifer system. Precipitation that infiltrated the Pleistocene Alluvium moves downward until it hits the impermeable red Ninnescah shale. Groundwater then flows down gradient on top of the shale. The general movement of fluids in the perched water table flows to the northwest-west.

2019 Chloride Levels

KCC District #2 Field Office - Control #980038-001 - Wells Sampled on 7/15/2019 - Map Drawn on 10/7/2019 by D. Bollenback

Recommendations for Future Work: Due to the limited amount of water resources affected and with the recent data, KCC recommends continuing sampling the Trostle on an annual basis. There is evidence of a plume to the west of the site but due to lack of priority KCC does not recommend expanding the monitoring well matrix at this time.
