Kansas
Corporation Commission

OIL & GAS REMEDIATION SITE STATUS

ANNUAL REPORT 2020

Abandoned Oil and Gas Well / Remediation Site Fund
Remediation Sites
Status Report

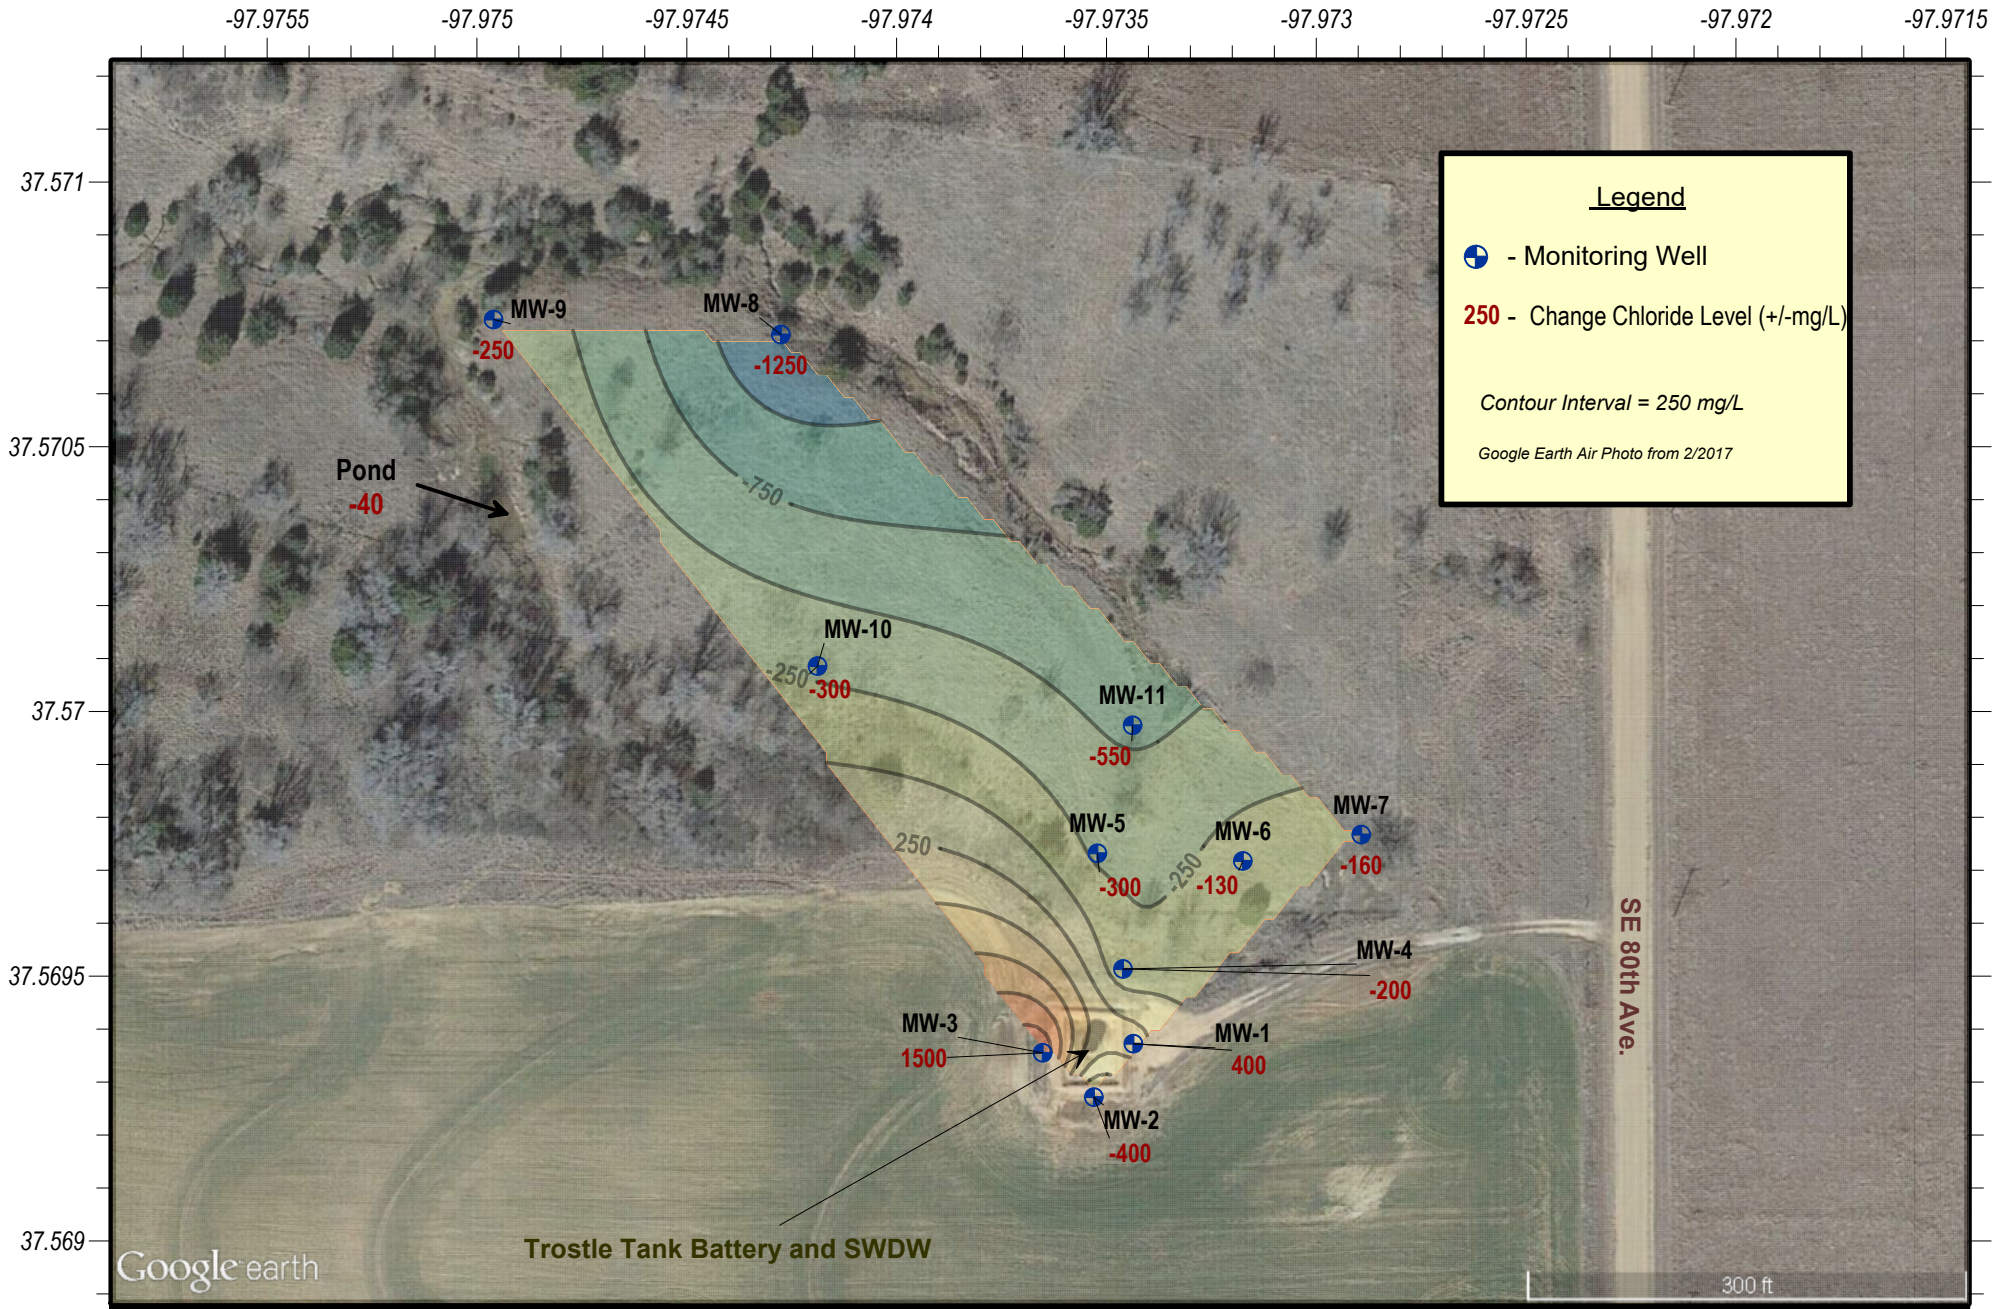
Trostle Brine Contamination Monitoring Site

2019 Change of Chloride Levels from 2018

KCC District #2 Field Office - Control #980038-001 - Wells Sampled on 7/15/2019 - Map Drawn on 10/7/2019 by D. Bollenback

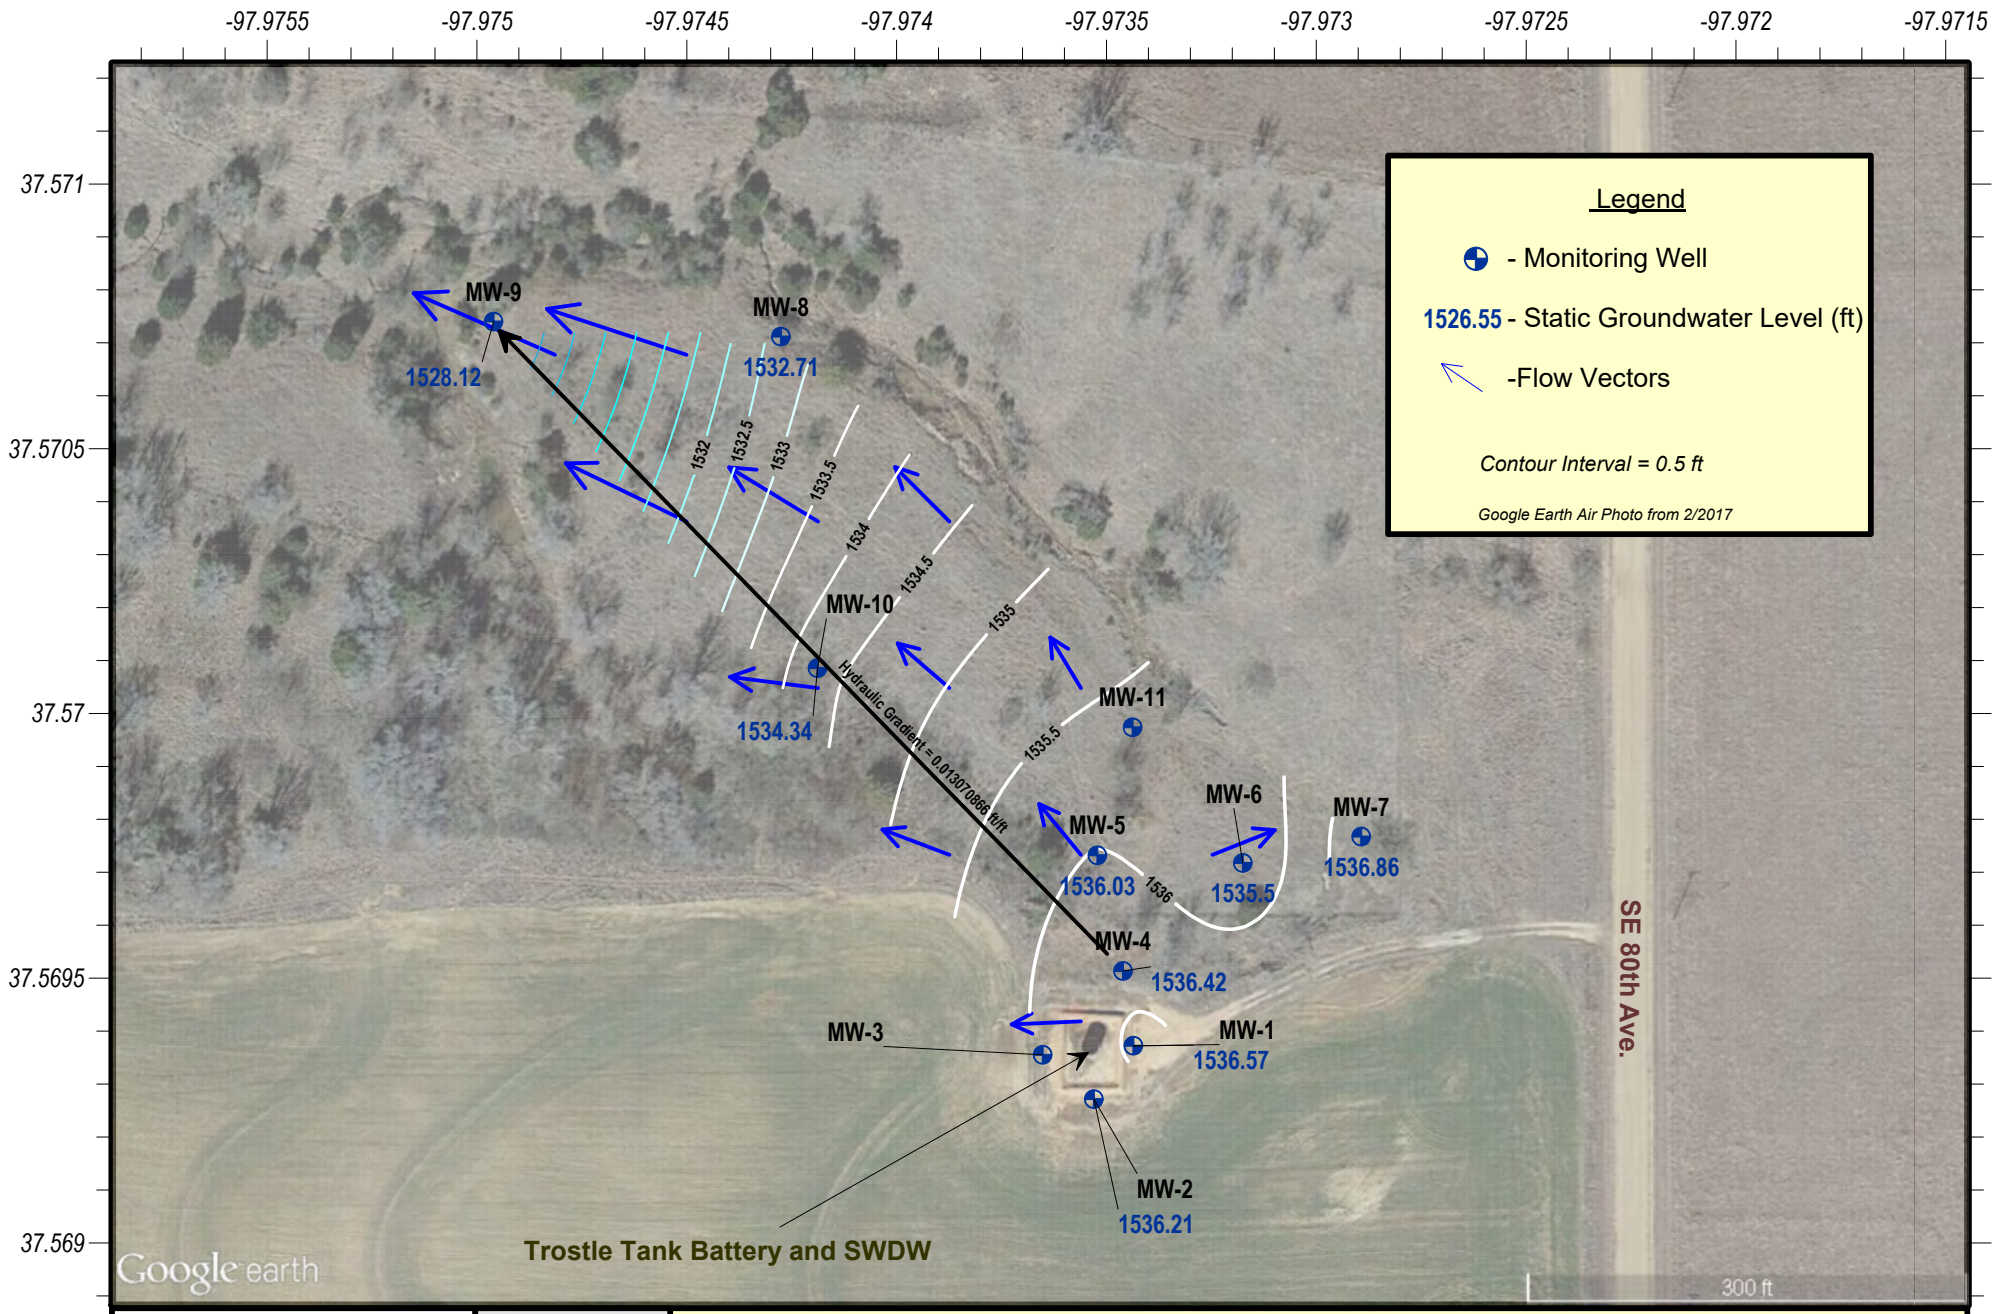
Trostle Brine Contamination Monitoring Site

2019 Groundwater Elevation Map

KCC District #2 Field Office - Control #980038-001 - Wells Gauged on 7/15/2019 - Map Drawn on 10/7/2019 by D. Bollenback

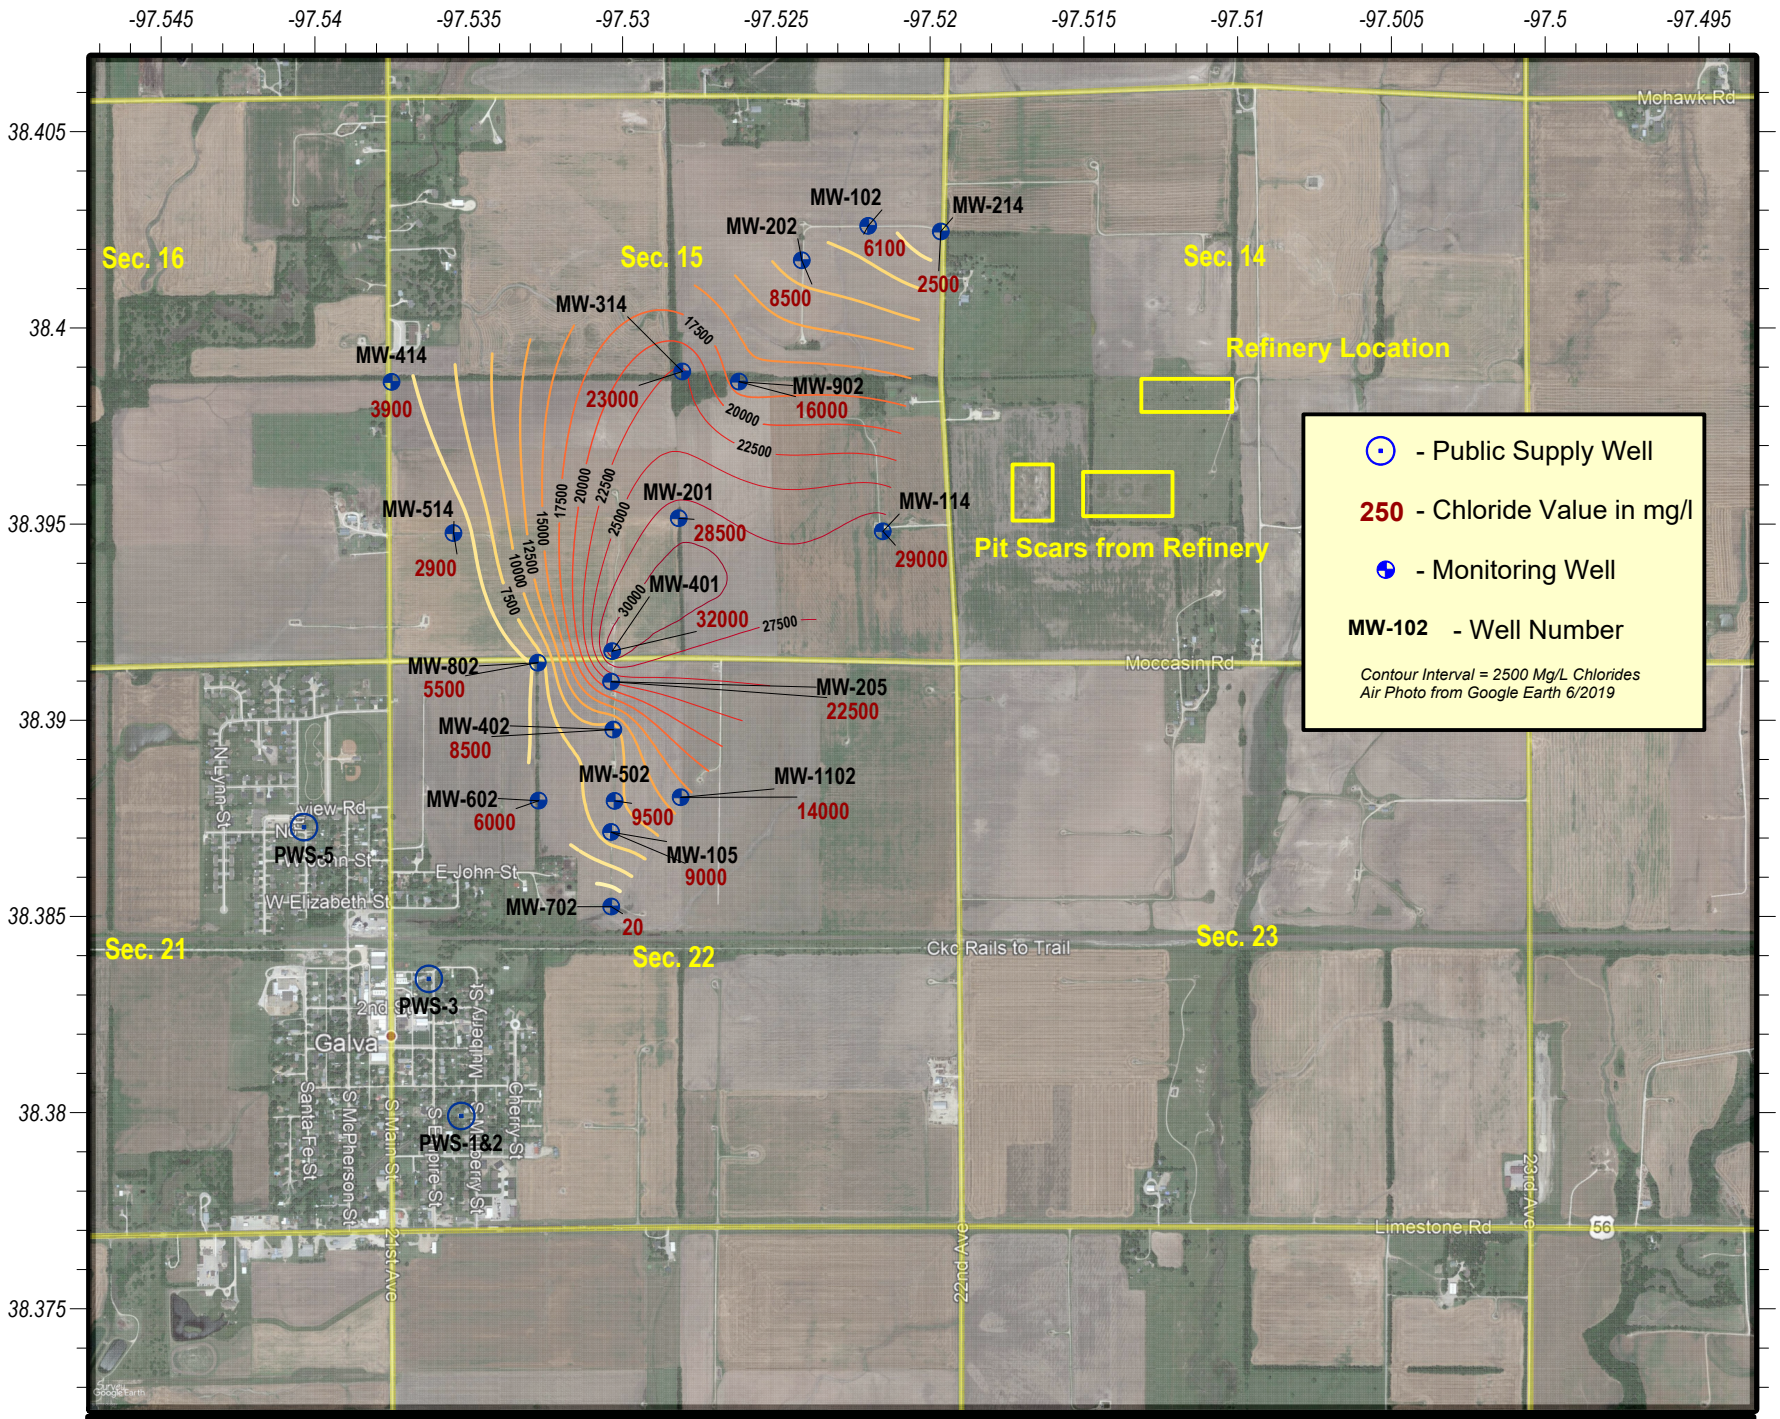
Galva City Brine Remediation Site

2019 Chloride Levels

KCC Control #980033-01 - KCC District #2 Field Office -Wells sampled July 23-24 & October 25th 2019 - Map Drawn on 10/25/2019 by D.Bollenback

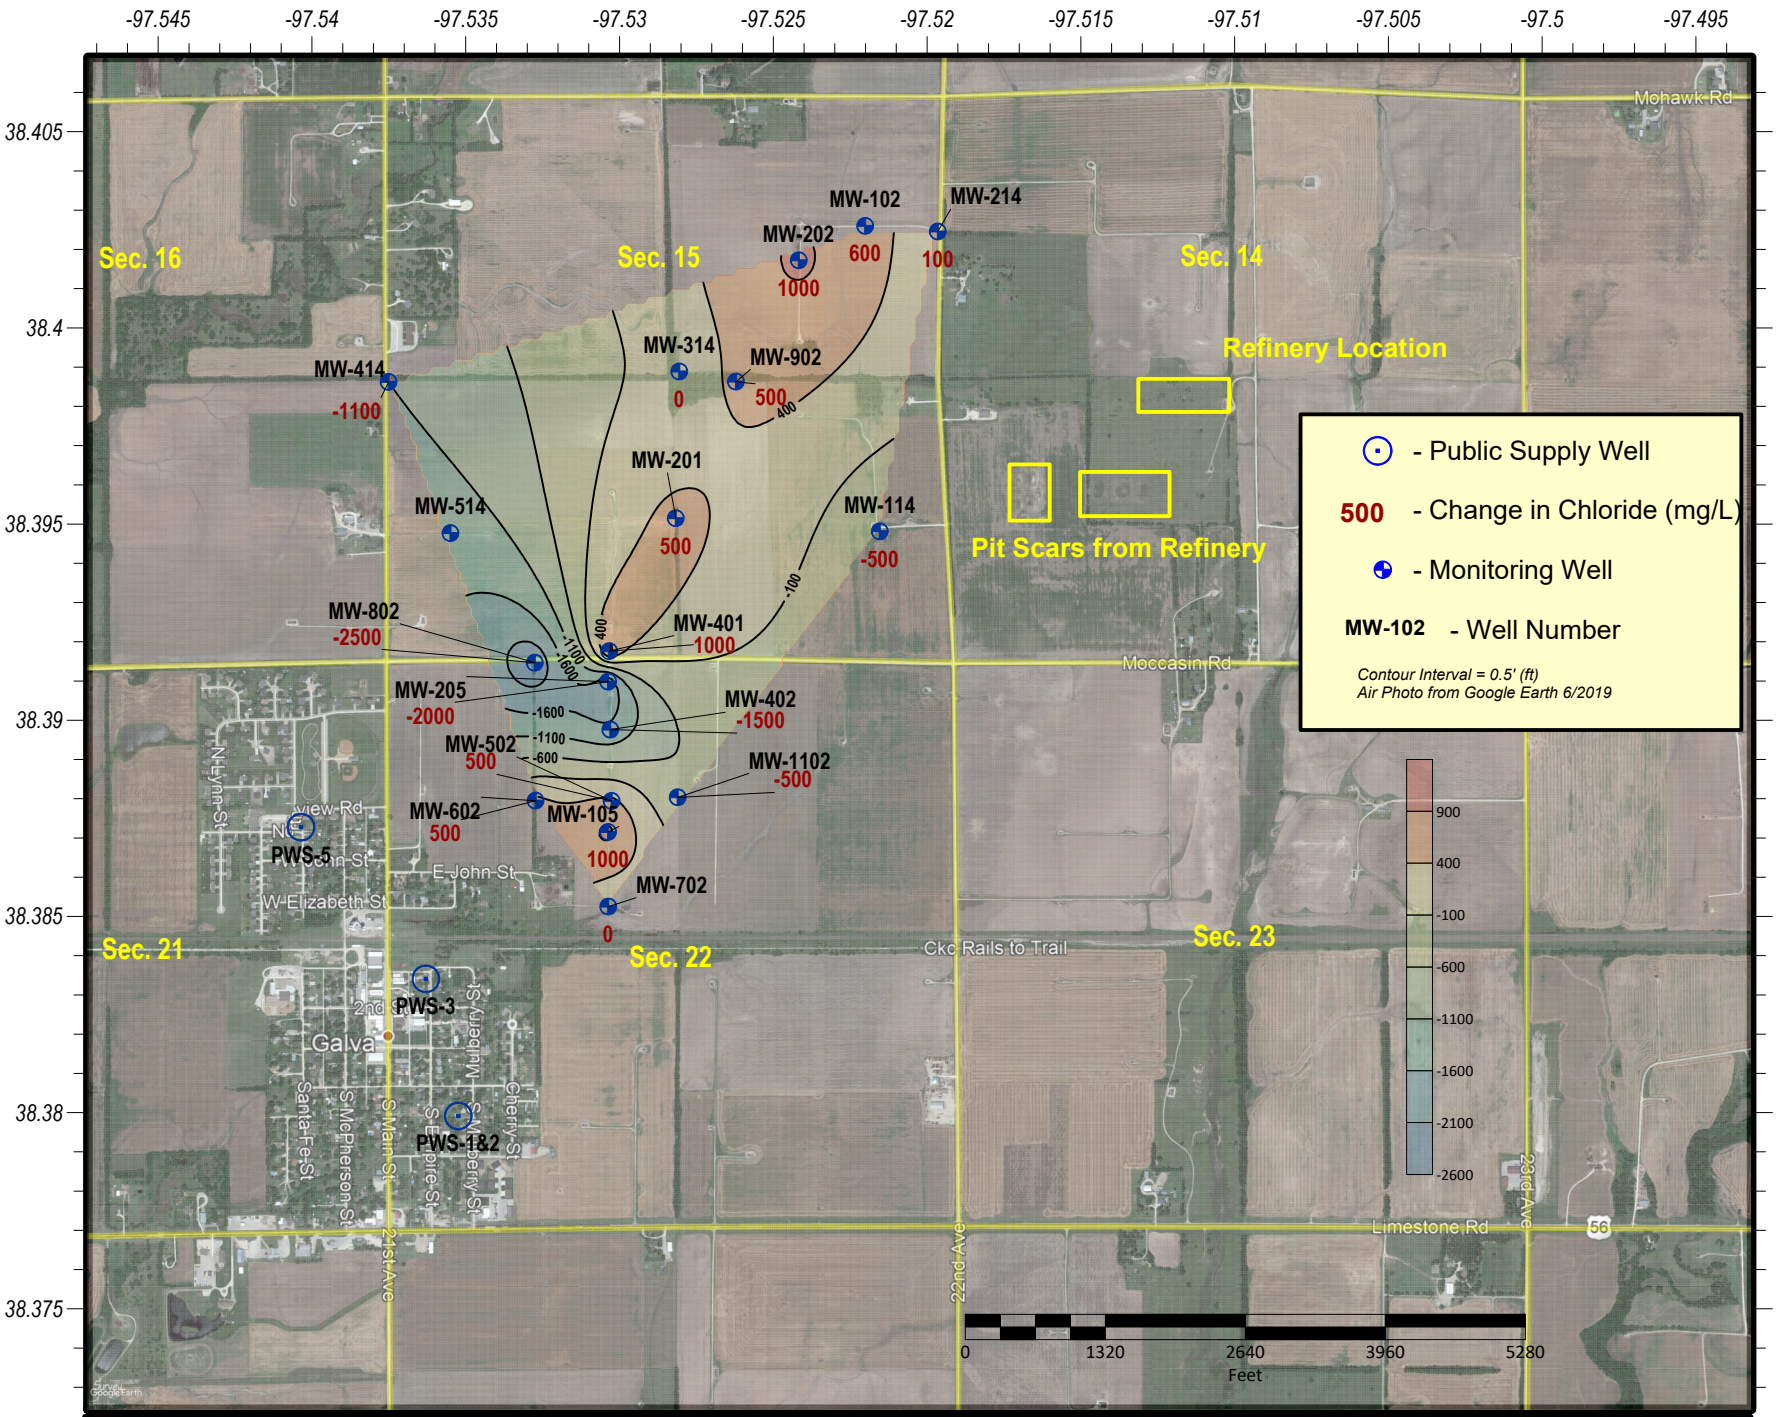
Galva City Brine Remediation Site

Chloride Level Change from 2018 to 2019

KCC Control #980033-01 - KCC District #2 Field Office -Wells Sampled July 23-24, 2019 - Map Drawn on 10/25/2019 by D.Bollenback

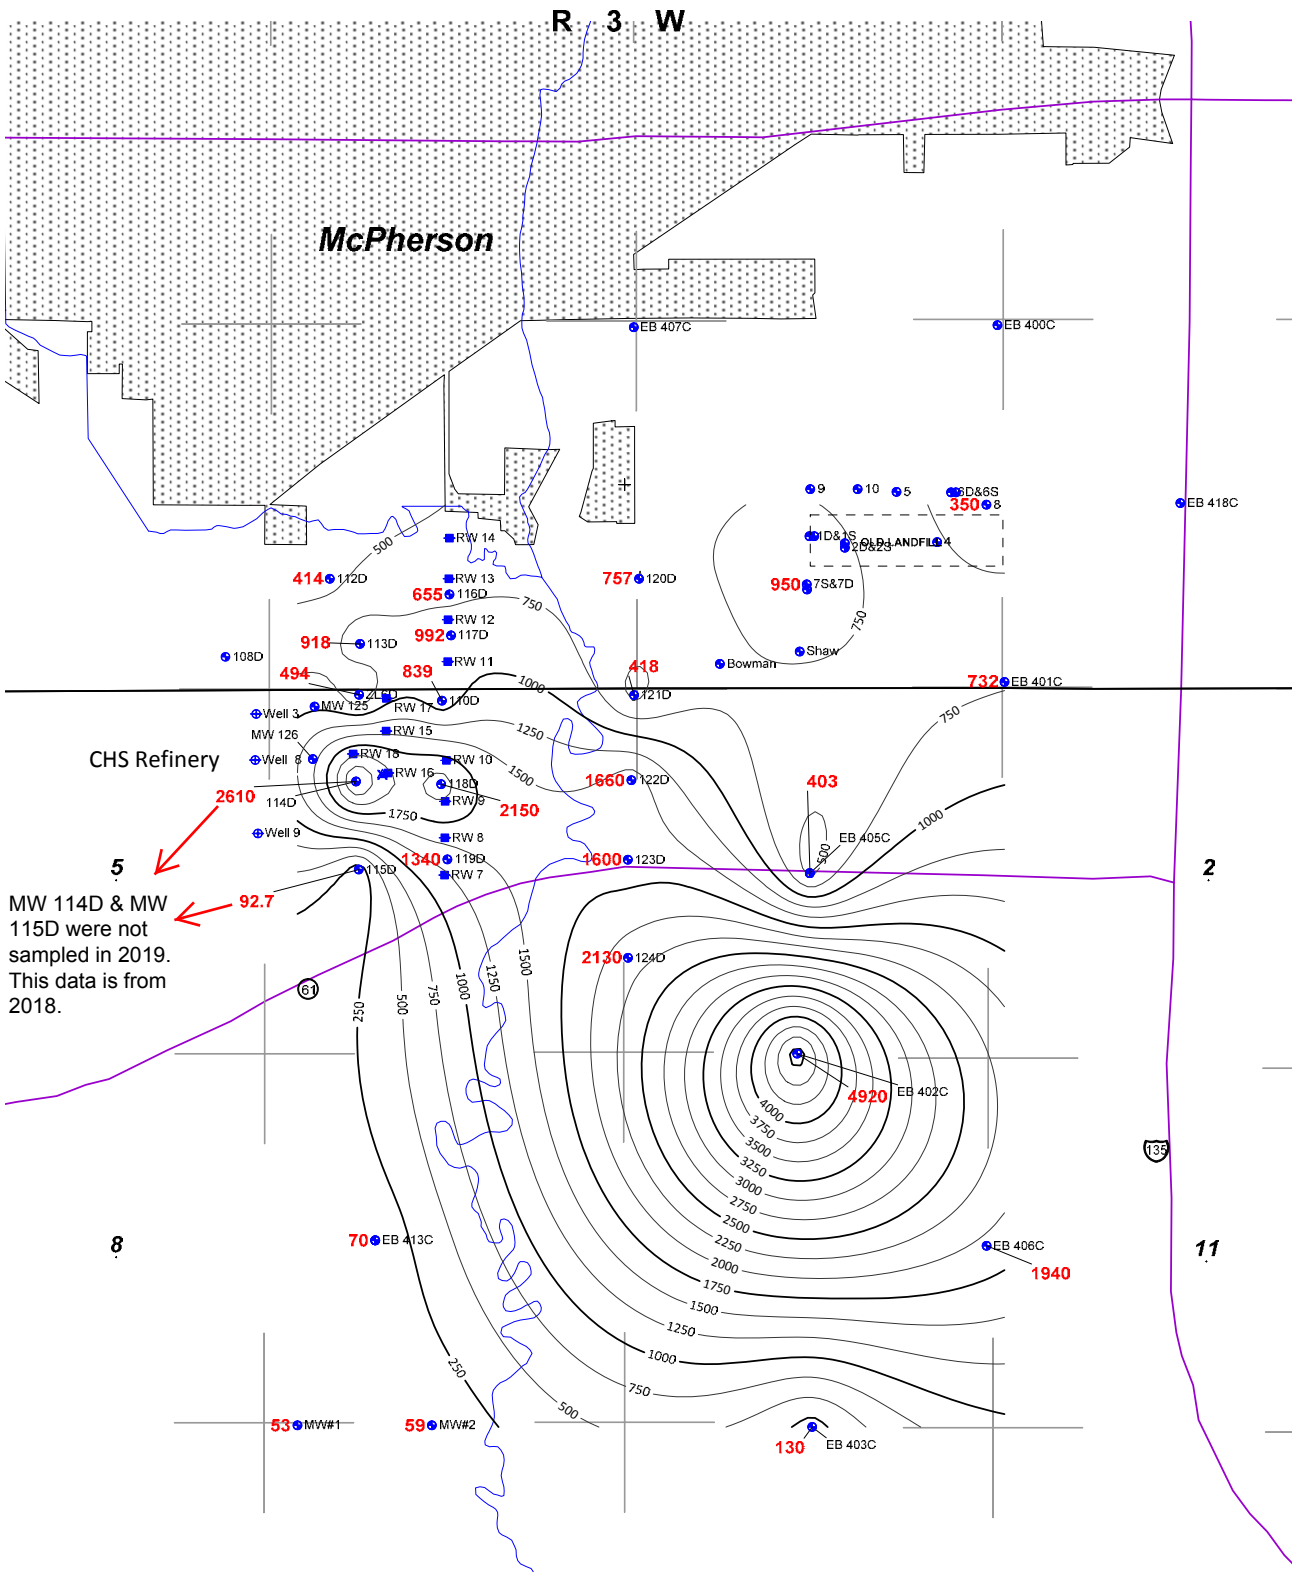
Overall, the August 2019 sampling of 13 deep screened CHS monitoring wells showed very little change in chloride values. (414 – 2,150mg/L) The two areas that continue to exhibit very elevated chlorides are around EB 402C (4,920 mg/L), and MW 114D (2,610 mg/l, 2018 data). Due to muddy conditions during the sampling event this year, MW 114D and MW 115D were not sampled. MW 114D is adjacent to the refinery and most likely affected by the recovery wells pulling in higher chloride waters. The highest impact to groundwater is still around EB 402C that sits off in Section 3, southeast of the refinery, and appears to be trapped chlorides along the bedrock, as those values have always fluctuated between 4,000 to 5,000 mg/L since 2005.

Current Contaminate Level: 53 mg/l (MW-1) to 4,920 mg/l (EB 402C) - 2019
Recovery wells averaged 397 to 1660 mg/l chlorides in 2019
Status:

Recommendations for Future Work: Collect data on an annual basis from CHS, GMD2 and the old landfill.

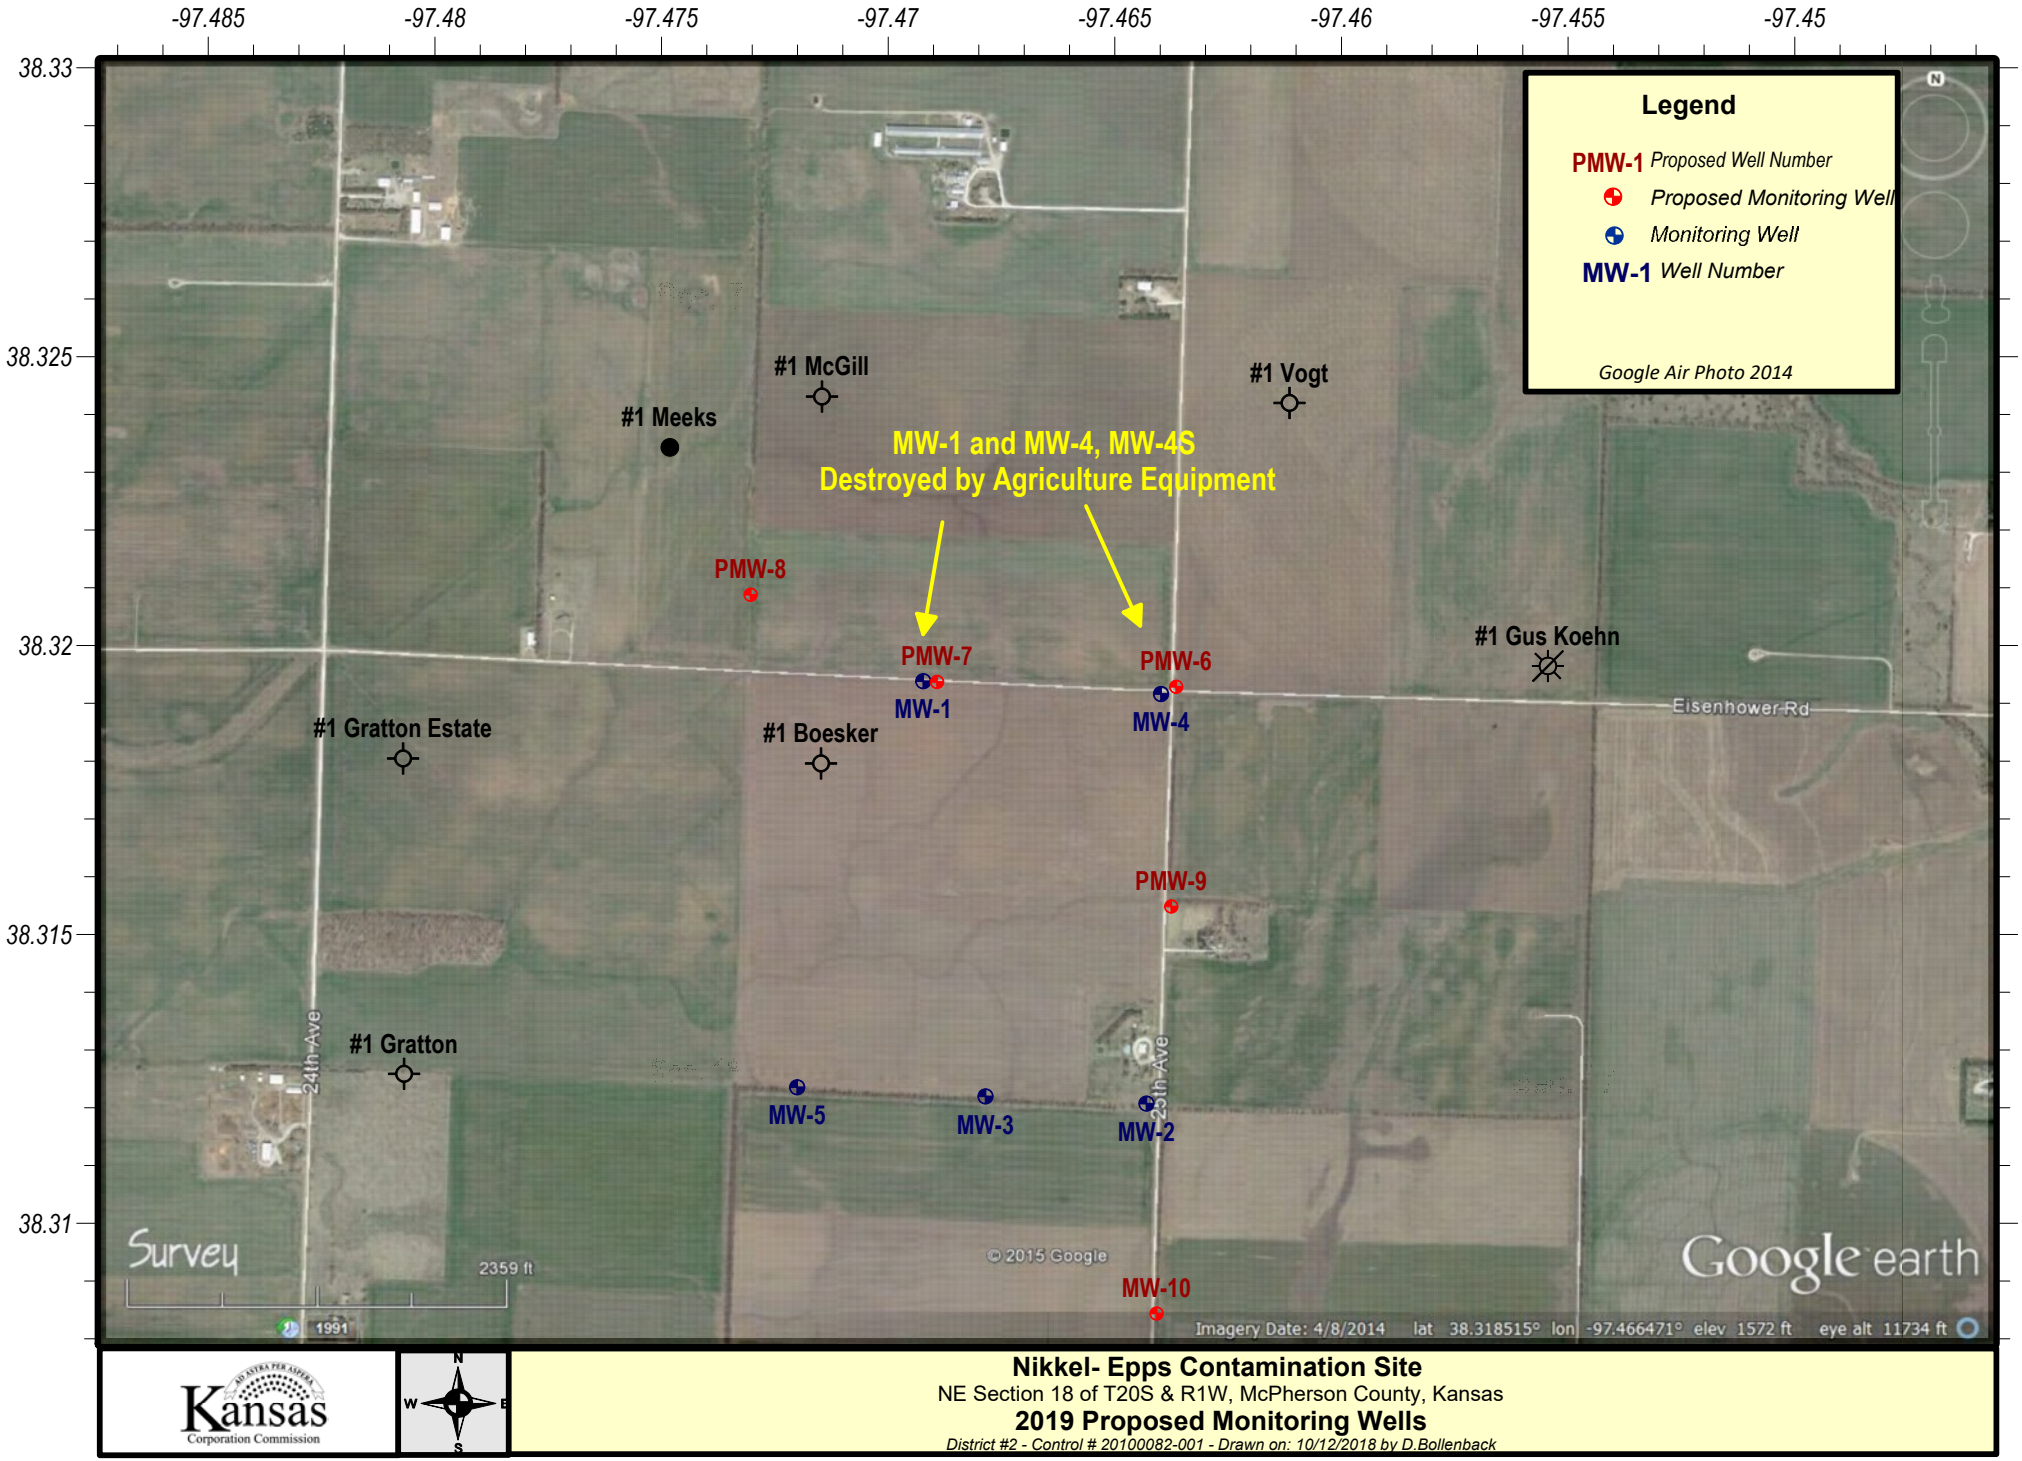
The aquifer resides in the McPherson Formation which consists of two to three sand units separated by clay layers. At the base of the aquifer lies the Wellington Shale. The aquifer appears to contain several possible aquitards, which are impermeable clays separating the sands. It is unknown if these clays are continuous throughout the area. Due to the depth that the saltwater has been found it is assumed that potential pathway/s down to the Wellington Formation exist. The land surface is flat irrigated farmland. Chlorides seem to be settling along the Wellington Shale contact. The top of the Wellington is an erosional disconformity which can allow for high relief channels and bumps with in the shallow aquifer. Evidence suggests that the main brine plume has a source(s) in section 7 up gradient to the site.

Recommendations for Future Work: KCC has not replaced or added new wells to the Nikkel-Epps investigation, but hopes to put out for bid and drilling package near the end of 2020. Without the northern monitoring wells, the site is currently hard to interpret in regards to chloride migration. The Ratslaff domestic well has tested over 1,000 ppm the last few years. (Not used for drinking purposes.) For these reasons, the Nikkel-Epps Site is now higher on the priority list. Currently there is no delineation to the north or down gradient south of the site. At the minimum, five wells are recommended to be installed as a Phase II study, which will enable the KCC to devise a suitable remediation plan if feasible and assist the Ratslaff homestead in finding a new water source. There are other domestic and irrigation wells in the next section south of the site which could be affected in the future.

Estimated Total Costs: $10,000 to $30,000 to drill the new wells and repair broken wells during a Phase II investigation. The KCC District #2 will also need funding for sampling, research, and report preparation.

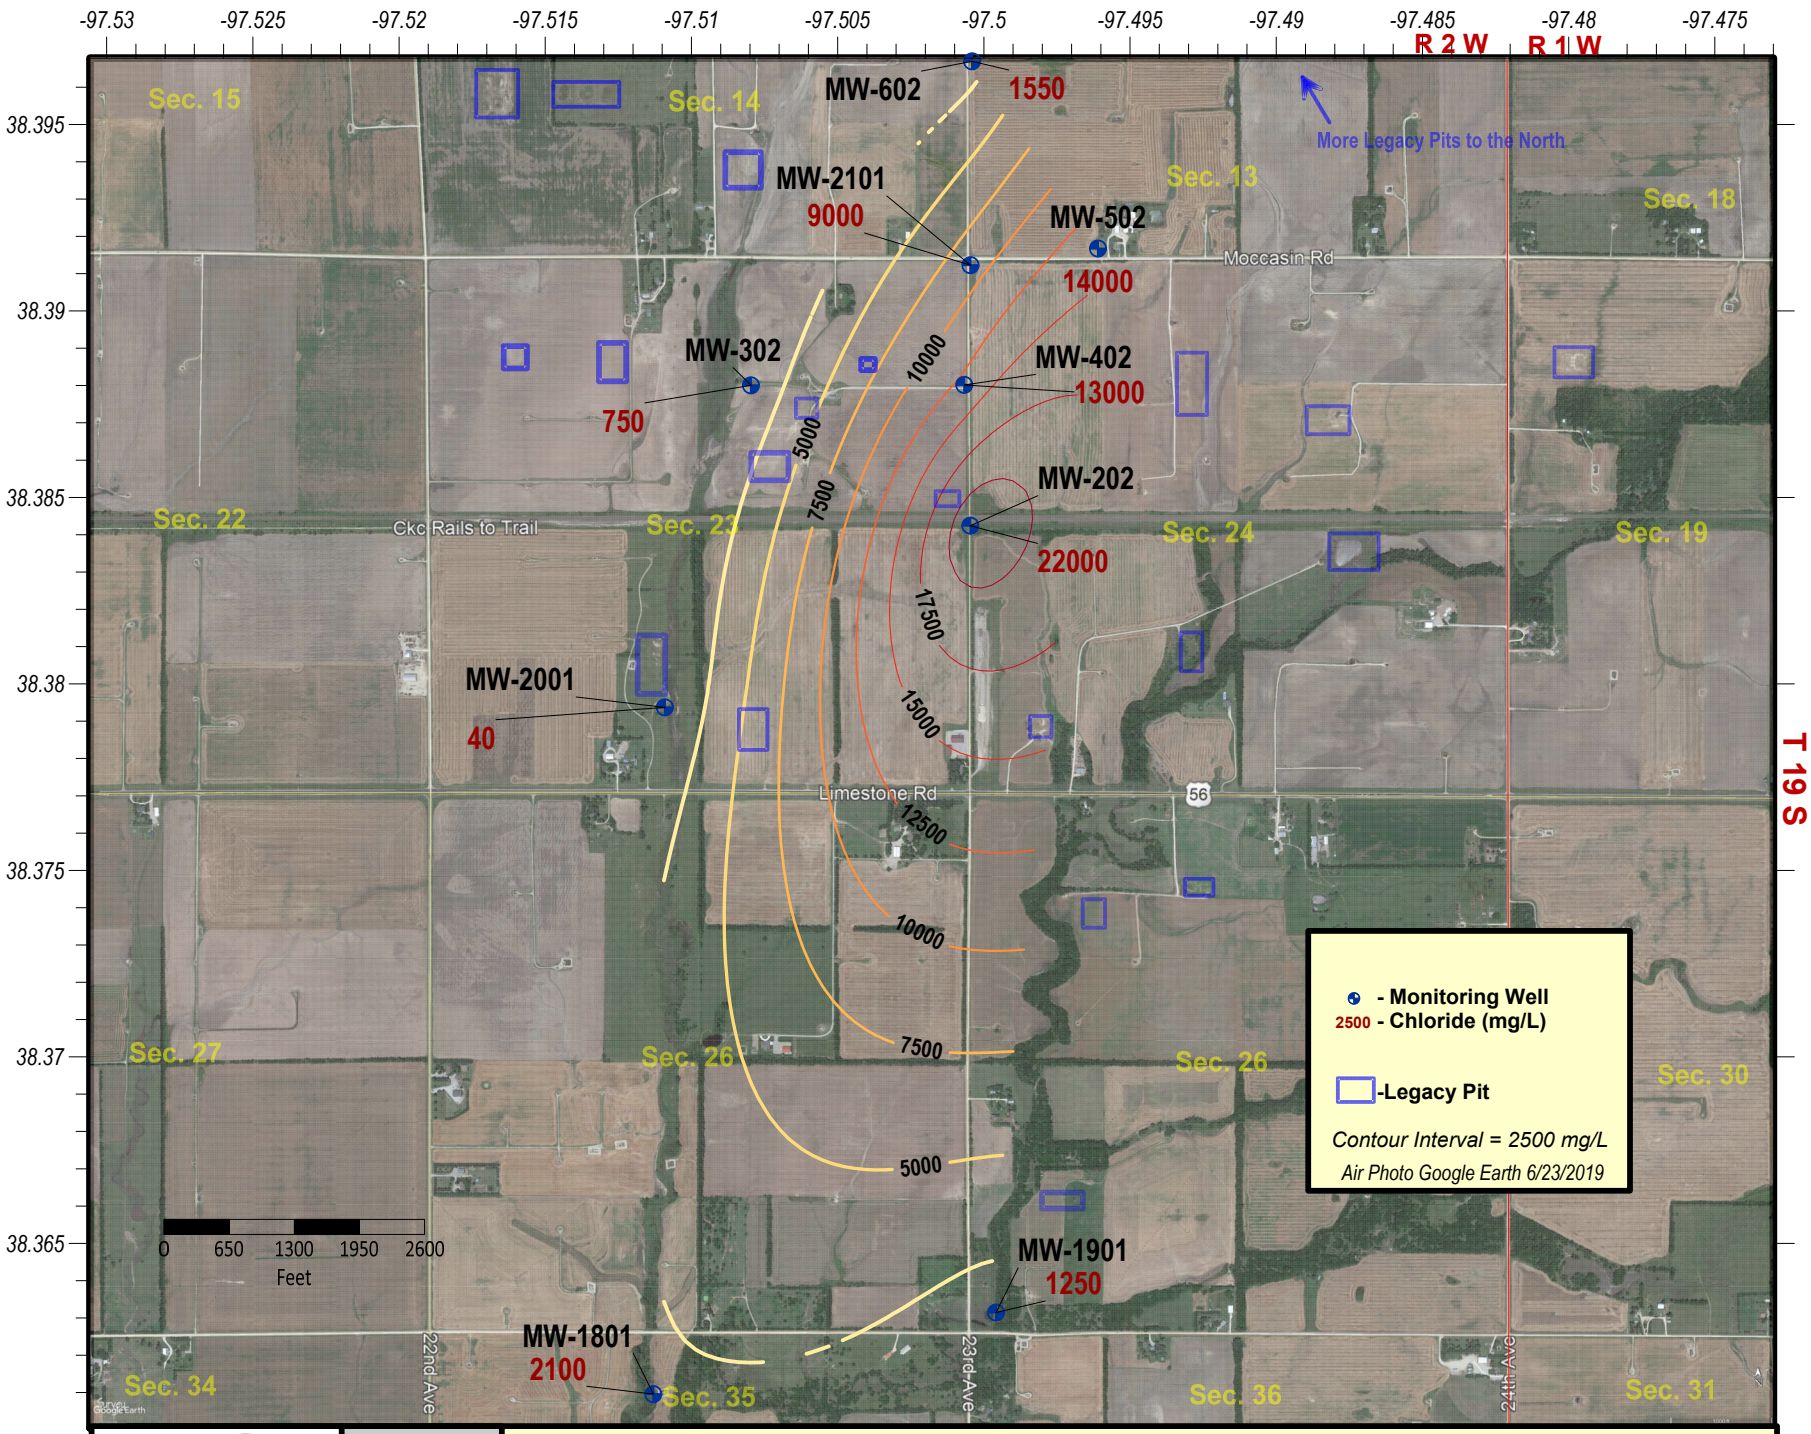
2019 Chloride Levels

Impact/Immediacy: There are no public water supplies within the site but there are many domestic and irrigation wells. Historically, wells are found in areas yet affected by the plume or are completed higher in the aquifer to avoid the majority of chlorides residing along the bedrock. The immediacy rating is moderate to high.

Recommendation for Future Works: KCC recommends the continued annual monitoring of the site as the highest chlorides are still over 20,000 mg/L chlorides. With this high of chloride values, the site is a good candidate for a remedial withdraw system, but it would be a very large economic expense up front and for future operation and management. KCC District #2 has put together a scope of work which would entail the drilling and installation of no fewer than 10 new monitoring wells in order to delineate the very highly contaminated area in the east-northeast part of the plume, and define the down gradient plume. KCC hopes to have this work scope out for bid over the winter of 2019-20, and have work commence during the summer of 2020. It is unclear if the down gradient plume is related, or if there are more sources south of the main plume.

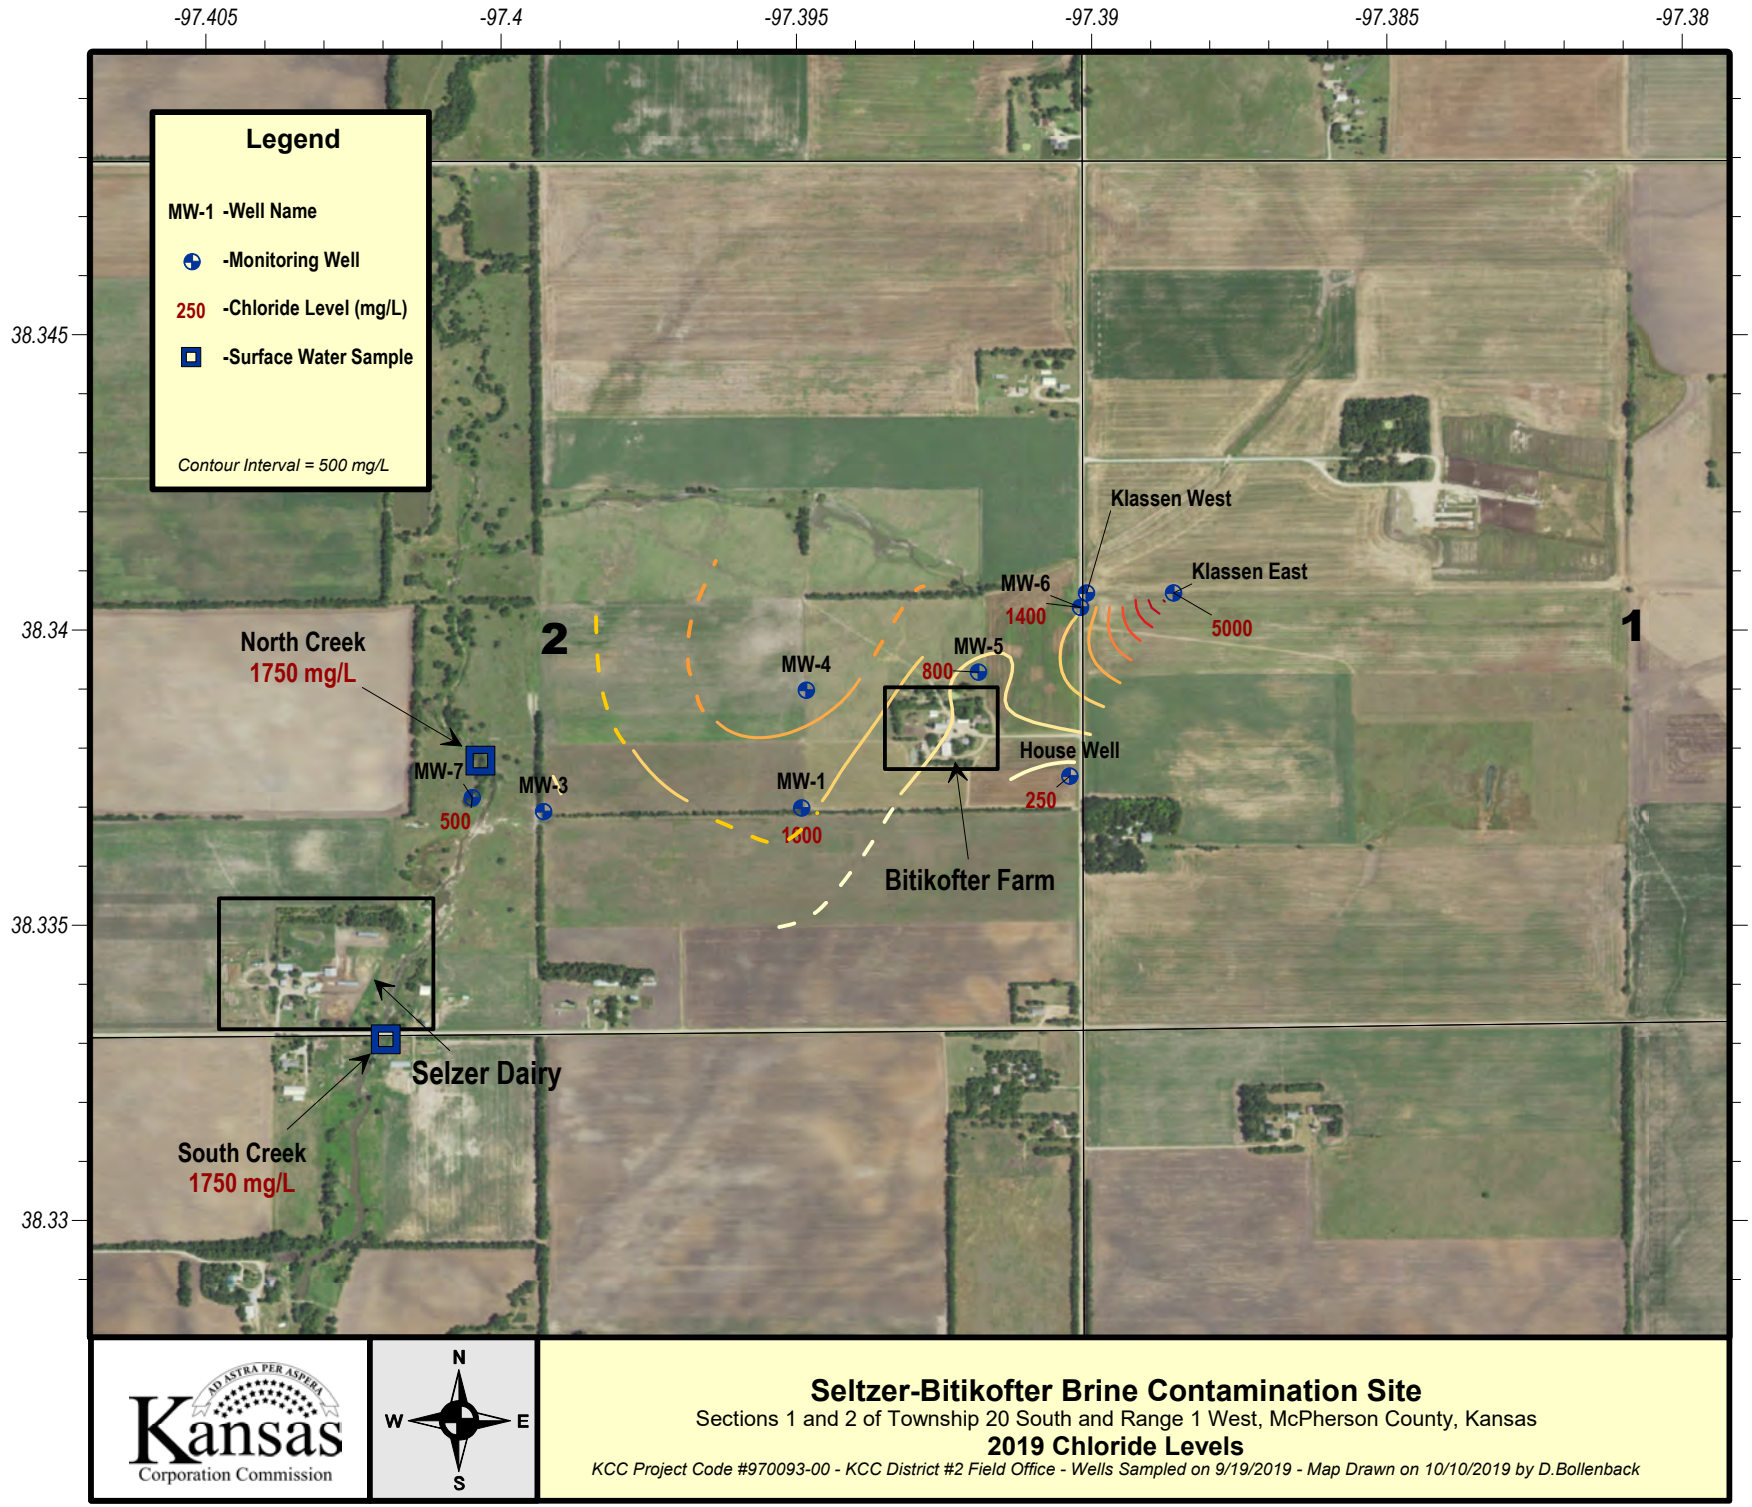
2019 Chloride Levels

Status of Project: On September 19th, 2019, five groundwater monitoring wells (MW-1, MW-5, MW-6, MW-7, and Klaassen East) were gauged and sampled. The Klaassen East Well was found to be damaged by agricultural equipment and was not sampled. MW-4 has broken at the surface as well as down hole and was not sampled. Each sample for this monitoring event was analyzed for the presence of Chloride by United States Environmental Protection Agency Silver Nitrate Buret Titration Method 8225. All monitoring wells were found to be at or above 500 mg/L chlorides, ranging from 500 to 5,000 mg/L. Chlorides appear to have moved along the gradient in aquifer due to the very heavy rains in early 2019. The eastern wells went up in chlorides, but the central wells either dropped or remained stable. The big increase in chlorides at the Klaassen East well could be the beginning of movement of more chlorides from the east. The northern stream sample was 1,750 mg/L, which is a 750 mg/L increase from 2018. The southern creek tested 1,750 mg/L which shows the creek has stabilized at the time of sampling. The Bitikofter domestic water well was tested to be 250mg/L, which is significantly lower than years past. This could be the results of the heavy early 2019 rains.

Recommendations for Future Work: In 2017, MW-3 was found to be broken and full of sediment. MW-2 was found by the landowner after many years of not being sampled, but was also found to be full of sediment. MW-4 cannot be sampled below 15' and also need to be replaced in order to collect a representative sample at the base of the aquifer and is now compromised at the surface. It is unknown yet if the Klaassen West well can be salvaged, but KCC hopes to repair it during the winter of 2019-20. Delineation of the multiple plumes to the north and east needs to be done. KCC plans to produce another phase of work with the installation of multiple monitoring wells and investigatory borings. KCC also plans to perform a surface water survey of West Emma creek in order to delineate the chloride extents up stream once water levels decrease. It is believed that chlorides are flowing out of the groundwater into the creek where the aquifer intersects the surface. Chlorides are exceptionally high in northern section 1 and with the possibility of plume movement into section 2. KCC feels that the Bitikofer Farm is endangered of losing its only water source. KCC recommends that new monitoring wells to the north and east of the current well matrix are necessary to delineate and predict the future for the chloride migration at the Selzer Site. A deep soil boring down to the Kiowa Shale would be beneficial in order to increase our knowledge of the local geology. There are some questionable historical oil and gas wells in section 36, north of the site, which may need to be investigated for plug integrity.
