Kansas
Corporation Commission

OIL & GAS REMEDIATION SITE STATUS

ANNUAL REPORT 2020

Abandoned Oil and Gas Well / Remediation Site Fund
Remediation Sites
Status Report

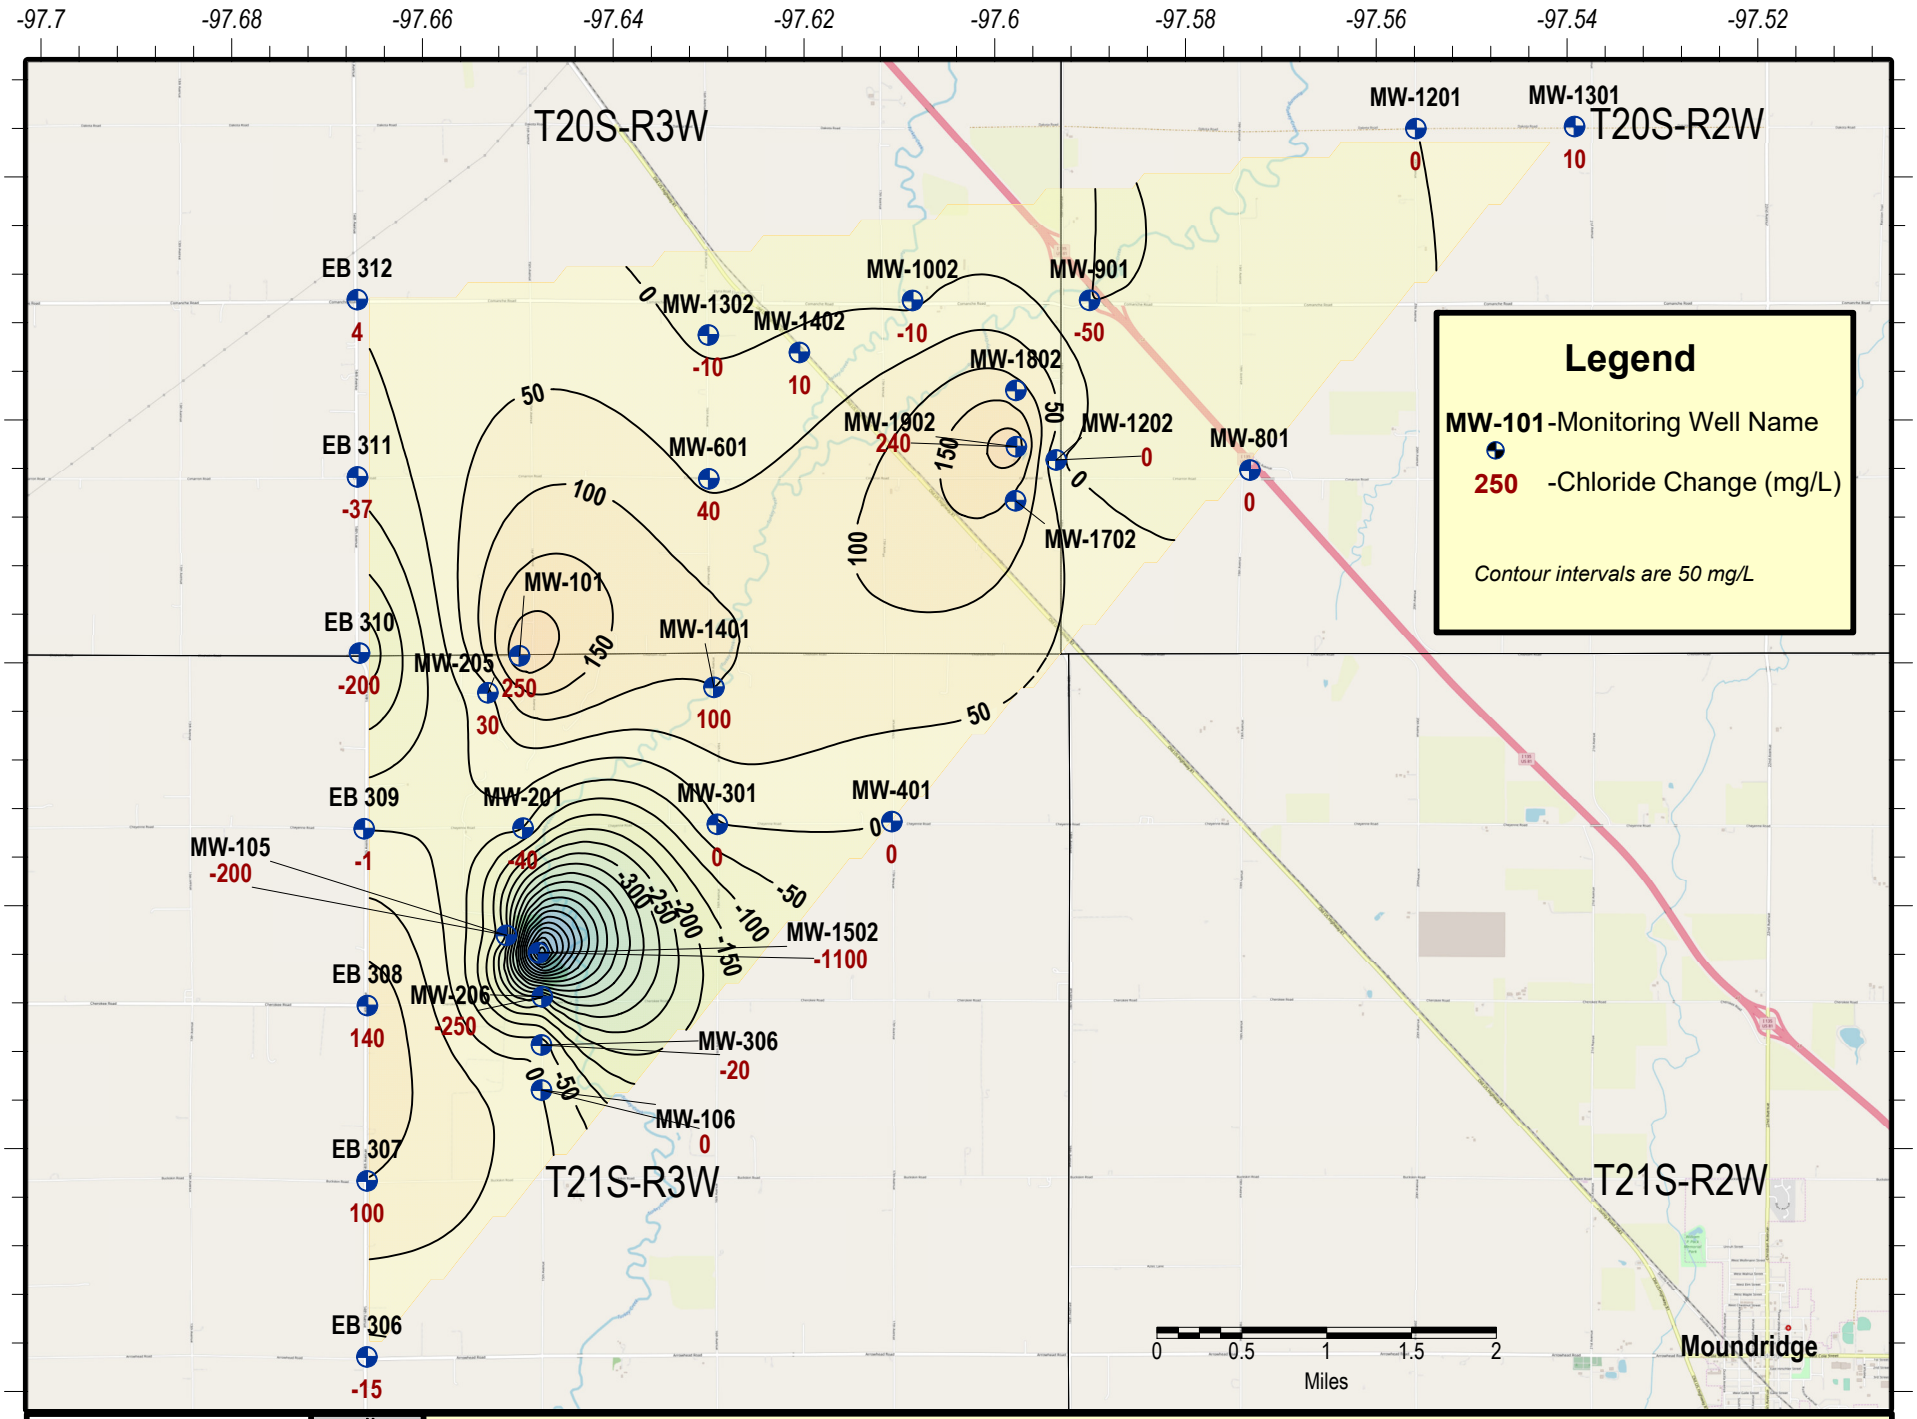
***Change from 2019 to 2018* Chloride Level Map**

Unusual Problems: Movement of the chloride plume toward irrigation wells can be somewhat accelerated by the effect of large irrigation well pumping. The plume will continue to migrate toward the McPherson channel located to the west of the Voshell Oil Field as long as there is deep pumping of the Equus Bed aquifer. New irrigations wells are drilled every year in the immediate area, and can cause erratic hydraulic movements of the plumes.

Recommendation for Future Work: KCC has discussed with GMD #2 about adding additional monitoring wells on the west edge of the site, and both KCC and GMD could join resources in achieving this. Some detail delineating within the site boundaries is also recommended especially near the high chloride plume within the field, and to the north near MW-101. The increase at MW-1902 will be investigated over the 2020 year. KCC will continue to sample the Voshell monitoring wells, and fund the sampling of the GMD2 EB monitoring wells. KCC can put together a multiple well installation scope of work after if deemed necessary. A remedial system could be installed in the southern plume, but costs seem to be too high for the current chloride levels at the Voshell site. Due to the large presence of irrigation wells down gradient of the plumes, reevaluation of potential remedial system installation may be warranted it if these wells show signs of being impacted.

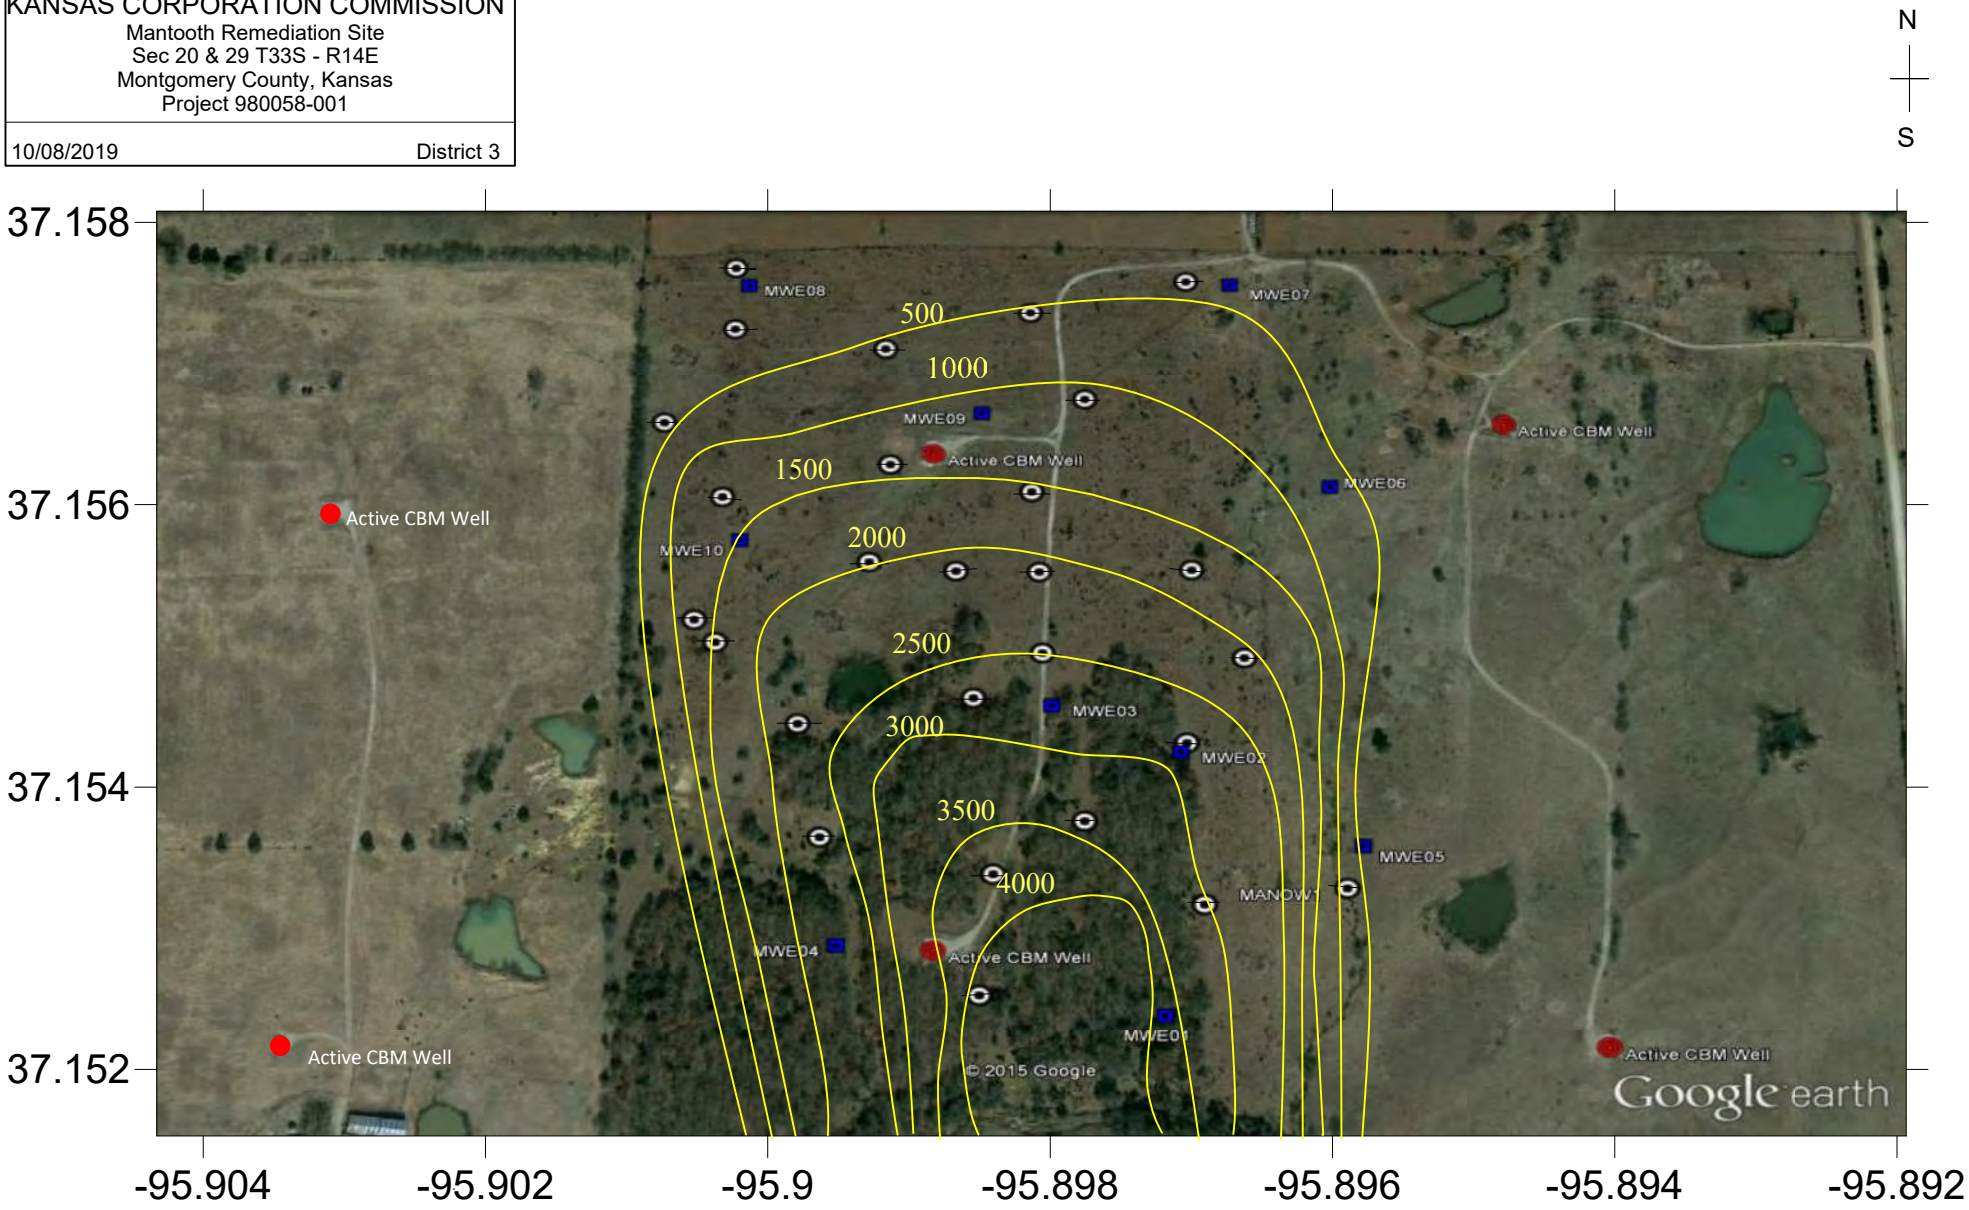
Contour Map Showing Cl- Concentrations of Mantooth Monitoring Wells

Site Description: The initial investigation began in May of 1996 by personnel from the Chanute Office, in response to a complaint of brine in Deer Creek. At that time the site consisted of an abandoned oil lease with as many as 41 abandoned well locations, some of which were leaking brine at or near the surface and effecting both surface water and groundwater resources. The site is situated immediately north of Deer Creek, a tributary of the Caney River in the Verdigris River Basin. In the spring of 1999 funds were approved for the excavation of abandoned well sites on this property. During that investigation 25 abandoned wells were confirmed and referenced by GPS.

Recommendation for Future Work: Continue monitoring in order to verify whether plugging of the existing abandoned wells eliminates the current source of saltwater contamination within the ground and surface water in the project area. Future work will be based upon the results of the sample analysis of the monitoring wells and Deer Creek. There have been 20 new CBM wells and associated SWD wells drilled in the last few years in sections 20 & 29. The new ability to download and overlay historic aerial imagery will be utilized to help identify undocumented well locations within and near the site boundary. Numerous possible well locations that are referenced on a recently discovered historical lease map of the site area will be investigated in the following year.

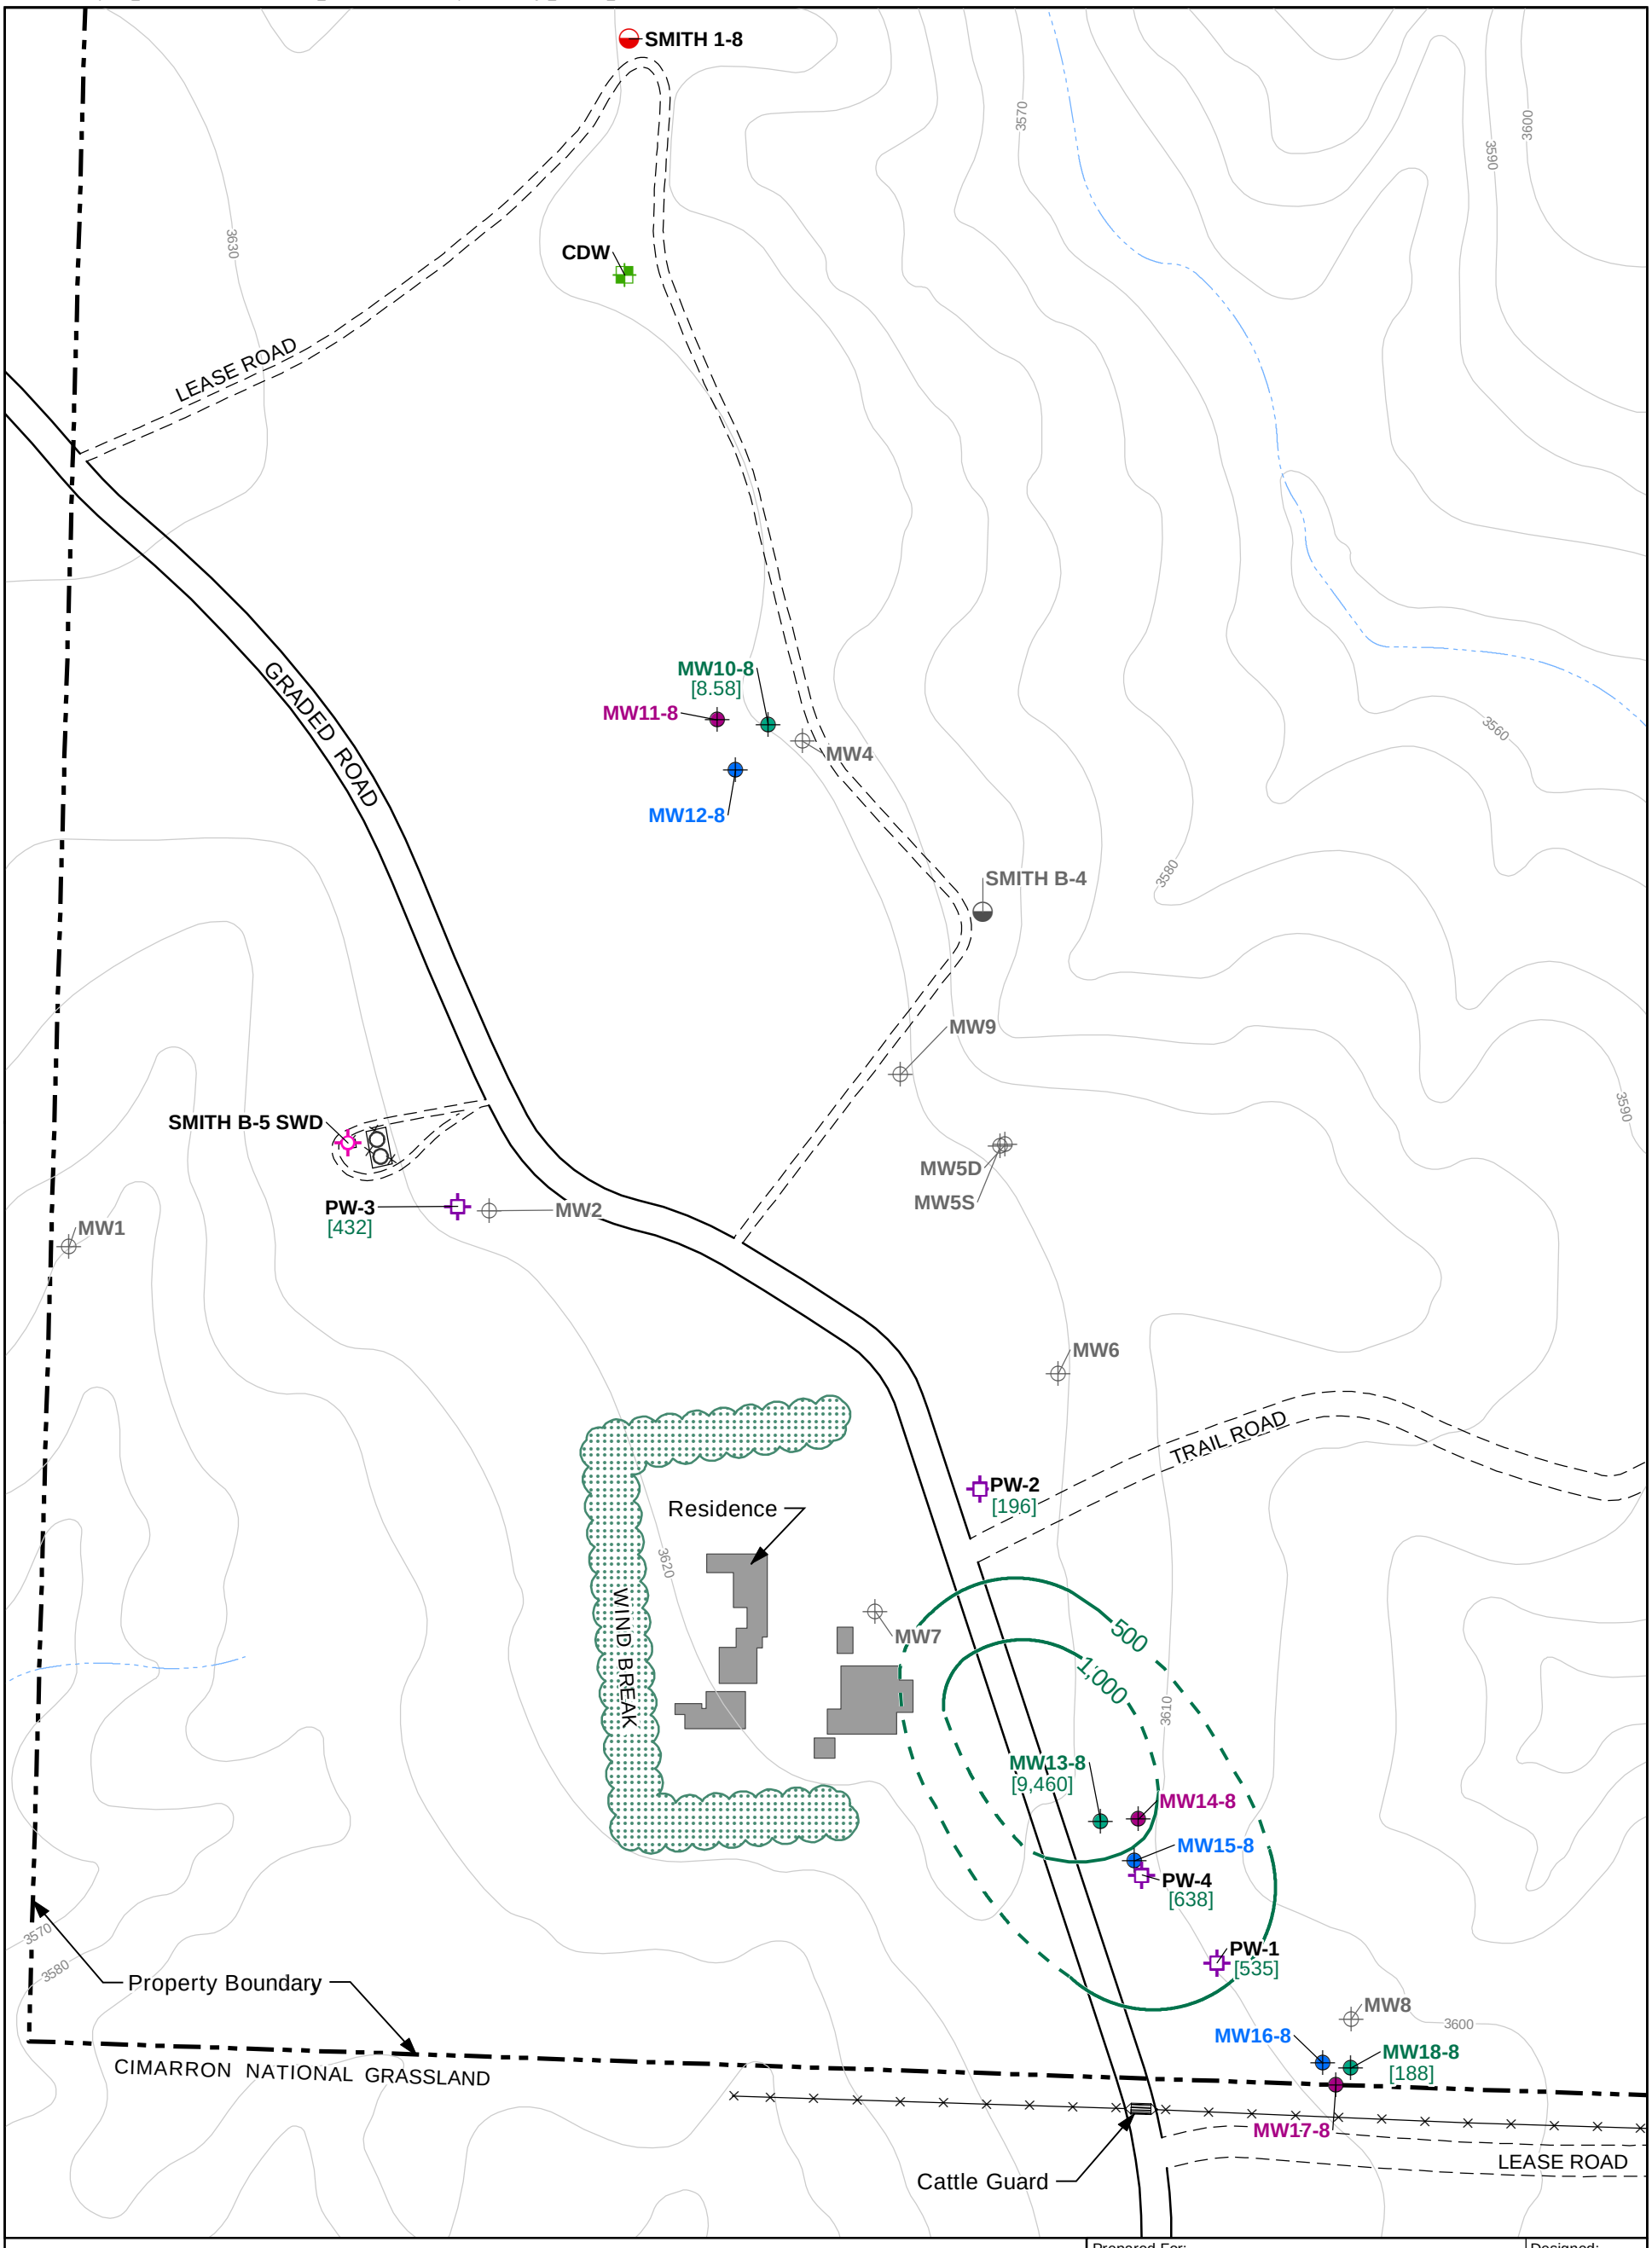
Prepared For: **Merit Energy Company**		Designed: **KM**
Title: **Chloride Isoconcentration Map for Shallow Wells May 2019** Smith Finn - Elkhart, Kansas		Drawn: **KK**
		Checked: **AH**
	Morton County, Kansas	Revised: **NA**
File: Q:\GC002026\ Fig7_Chloride_SZ.mxd	Date: **10/16/2019**	Figure: **7**

Status of Project: On June 25, 2019 the Smith disposal well failed MIT, this is the well that the recovered fluids are disposed in. The well is constructed in a way that makes it difficult to repair. Currently the site is shut down and RP will see how the site rebounds with recovery efforts being shut down for approximately four months.

Recommendation for Future Work: After the results of the rebound test, options will be explored between staff and RP to determine what the future will hold for this site. That meeting should be sometime in late 2019 or early 2020.

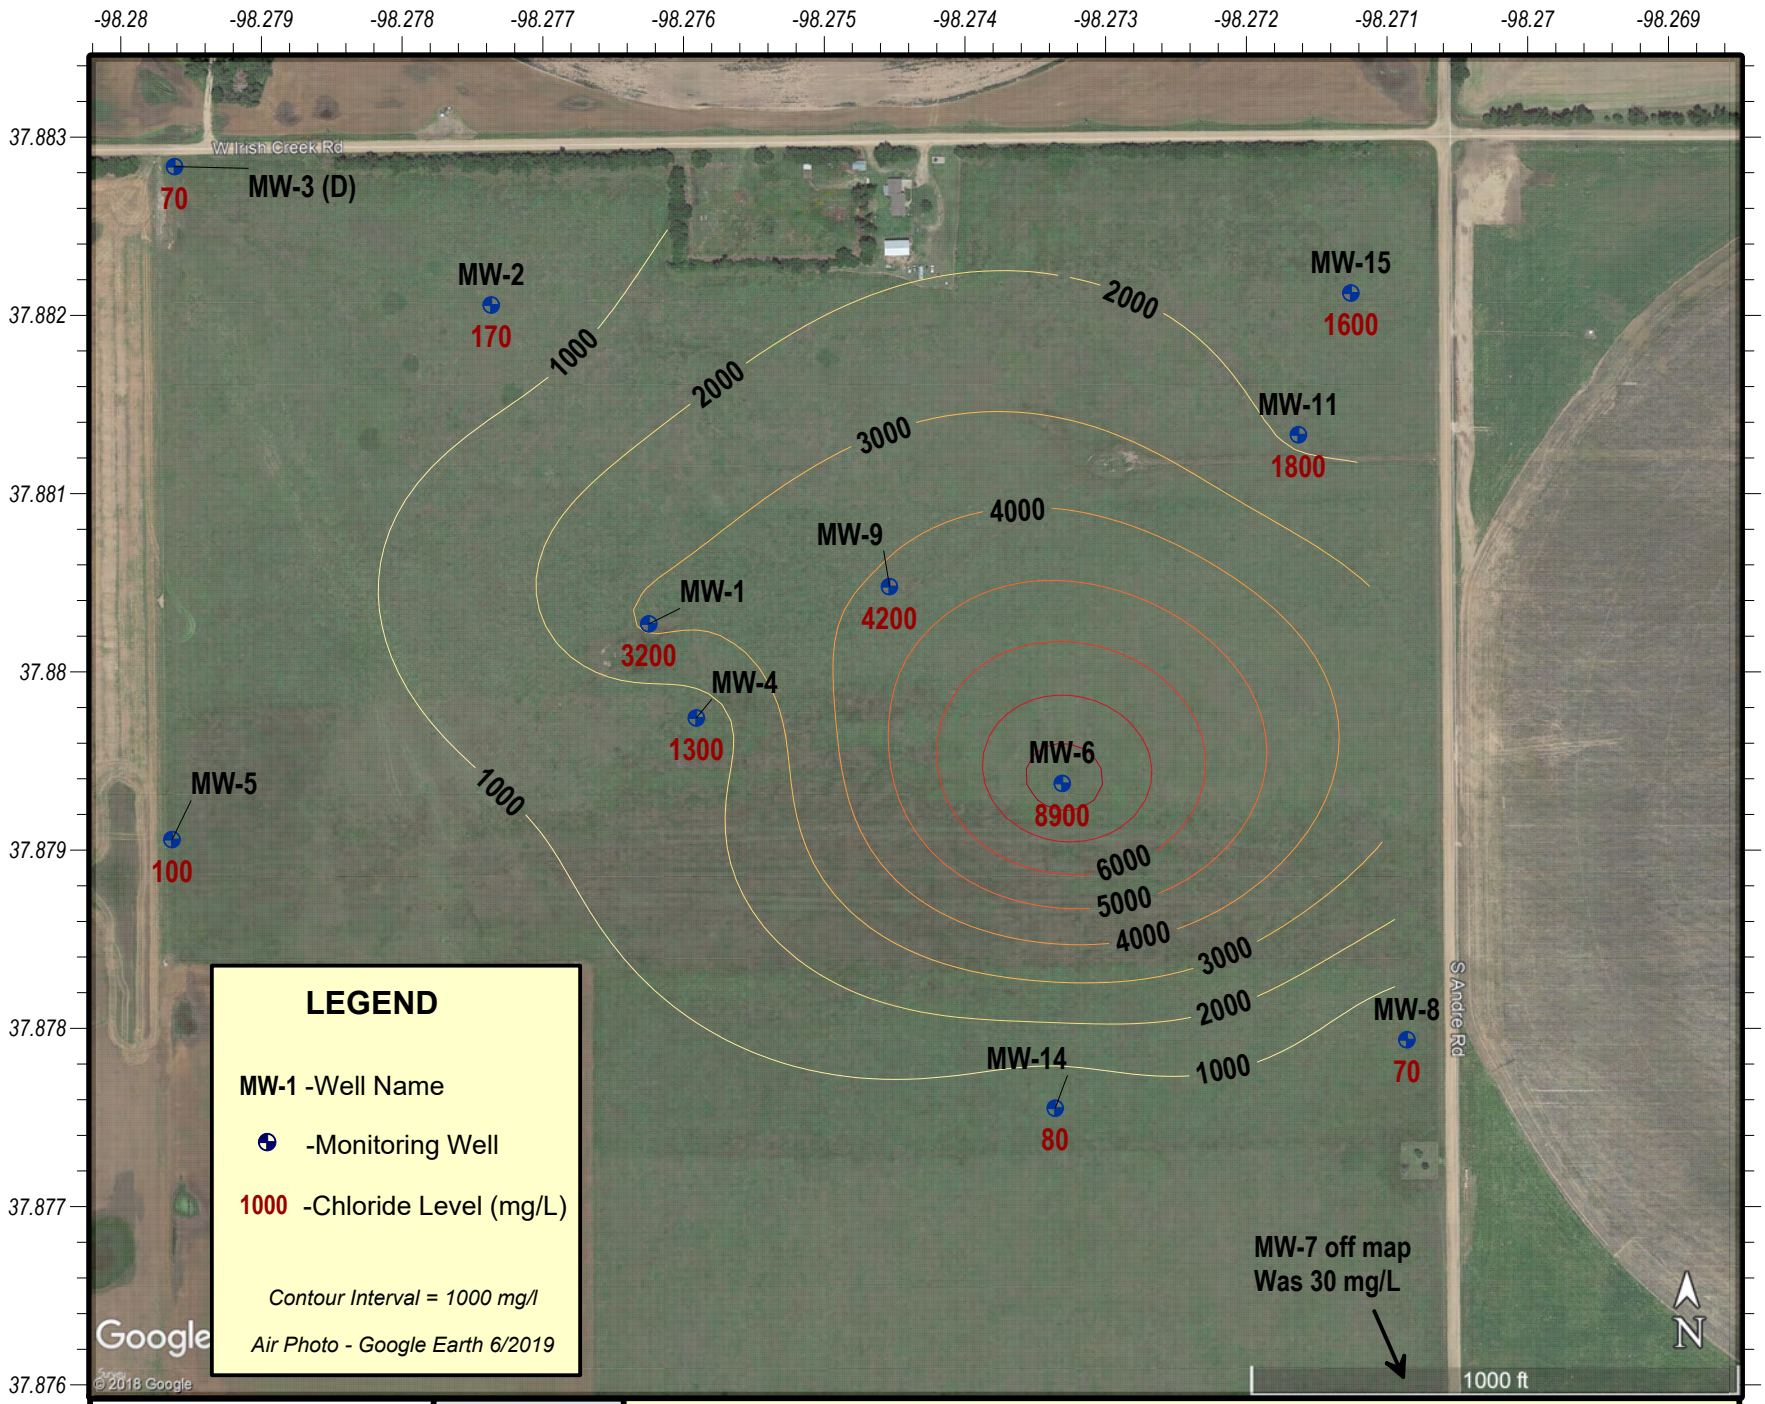
Impact/Immediacy: Impacts are to both soil and groundwater as a result of a large saltwater line leak from August 2000. Initially the spill impacted irrigation wells in the SE/4 of Section 11 and a domestic well on the lease in late 2001. The domestic well was abandoned and a new one was drilled, and the irrigation well was taken out of use for several seasons allowing the saltwater plume to migrate back to the southeast and be remediated in the NE/4 of Section 14. This site immediacy level should be classified as moderate.

Status of the Project: Rama had installed a pump and lines to RW-8 and ran that recovery well during the summers of 2014-15 after chloride levels were found to remain high. The last 5 years, Rama disposed of recovery water into their Banium 1-12 disposal well. A routine Mechanical Integrity Test on the Banium 1-12 failed in early 2019. The well was plugged on 4/8/2019. This left the Arlington site with no way of disposing recovery water, which shut down remedial efforts. The Arlington site is now in a long term monitoring status.

Current Contaminate Level: 8,900 mg/l in MW-6
