Distribution New Construction
St. Louis, Missouri April 20, 2010
Inspection findings related to Plastic Materials

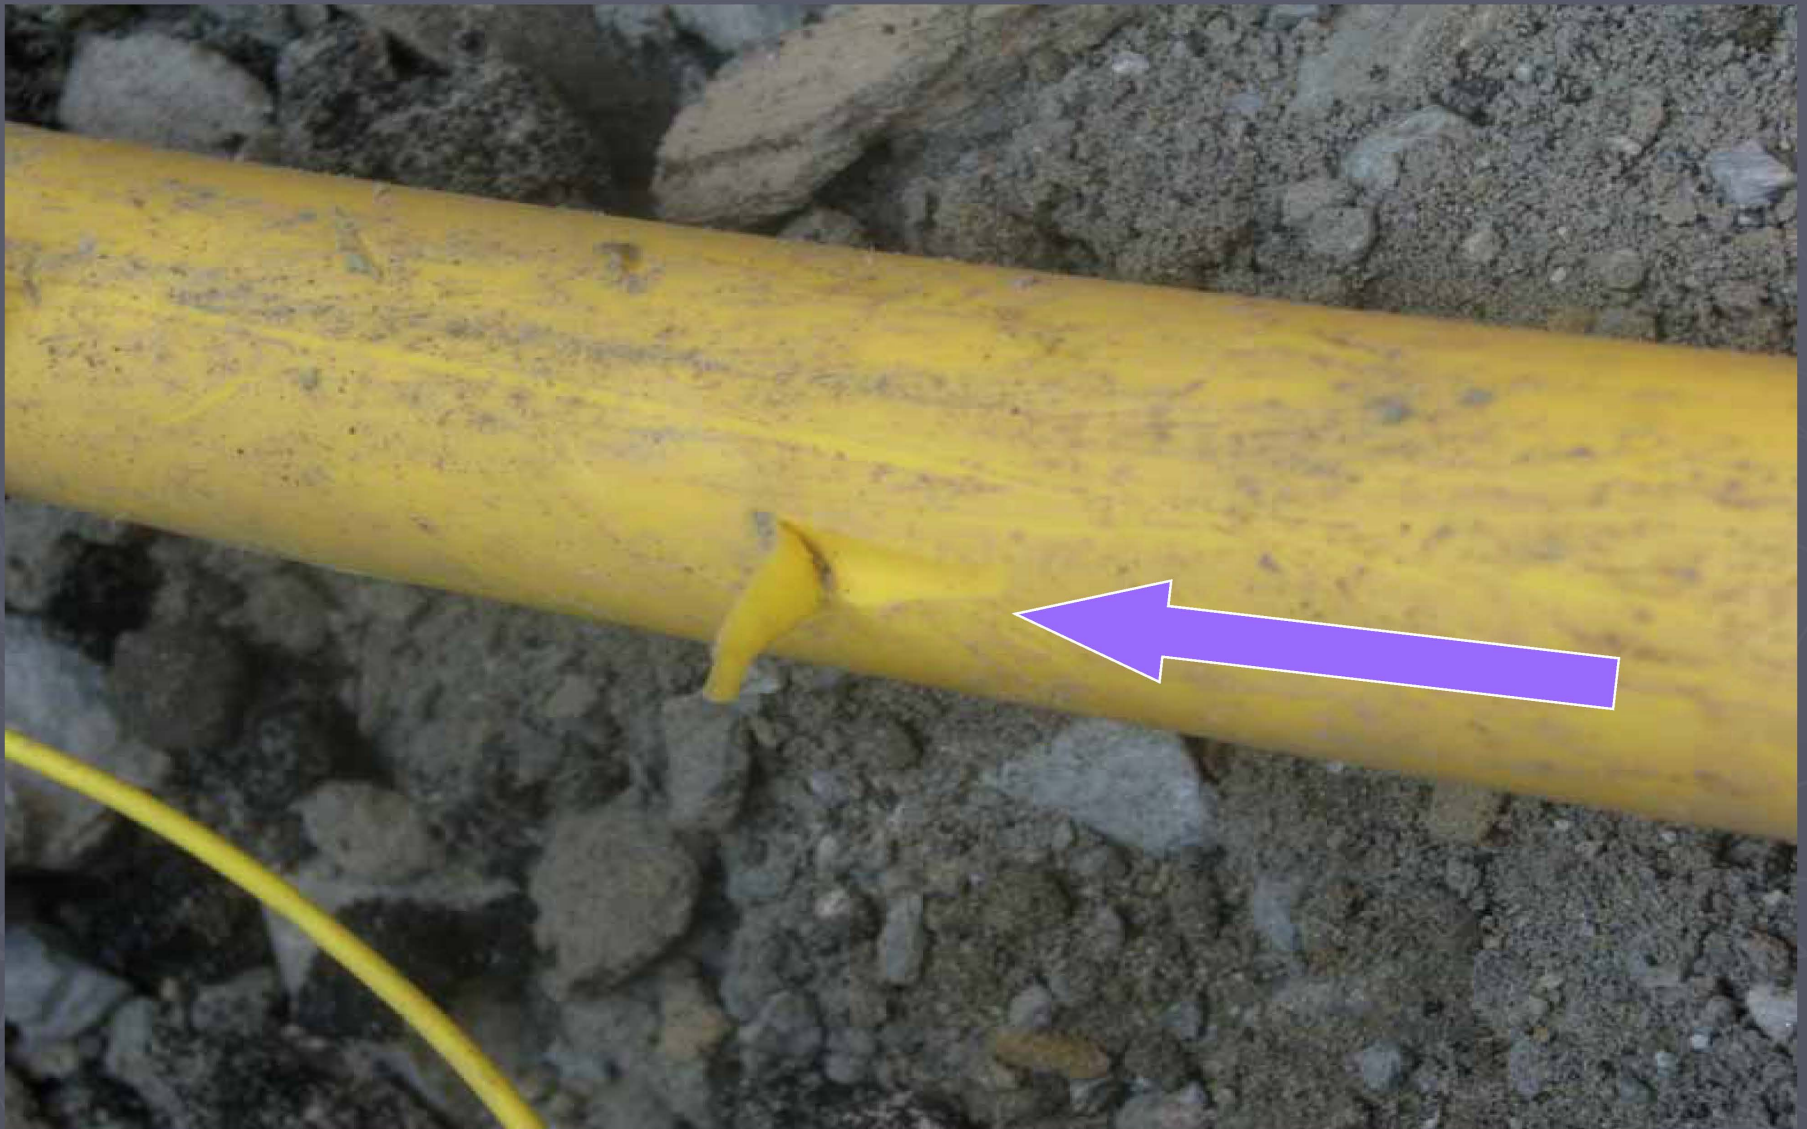
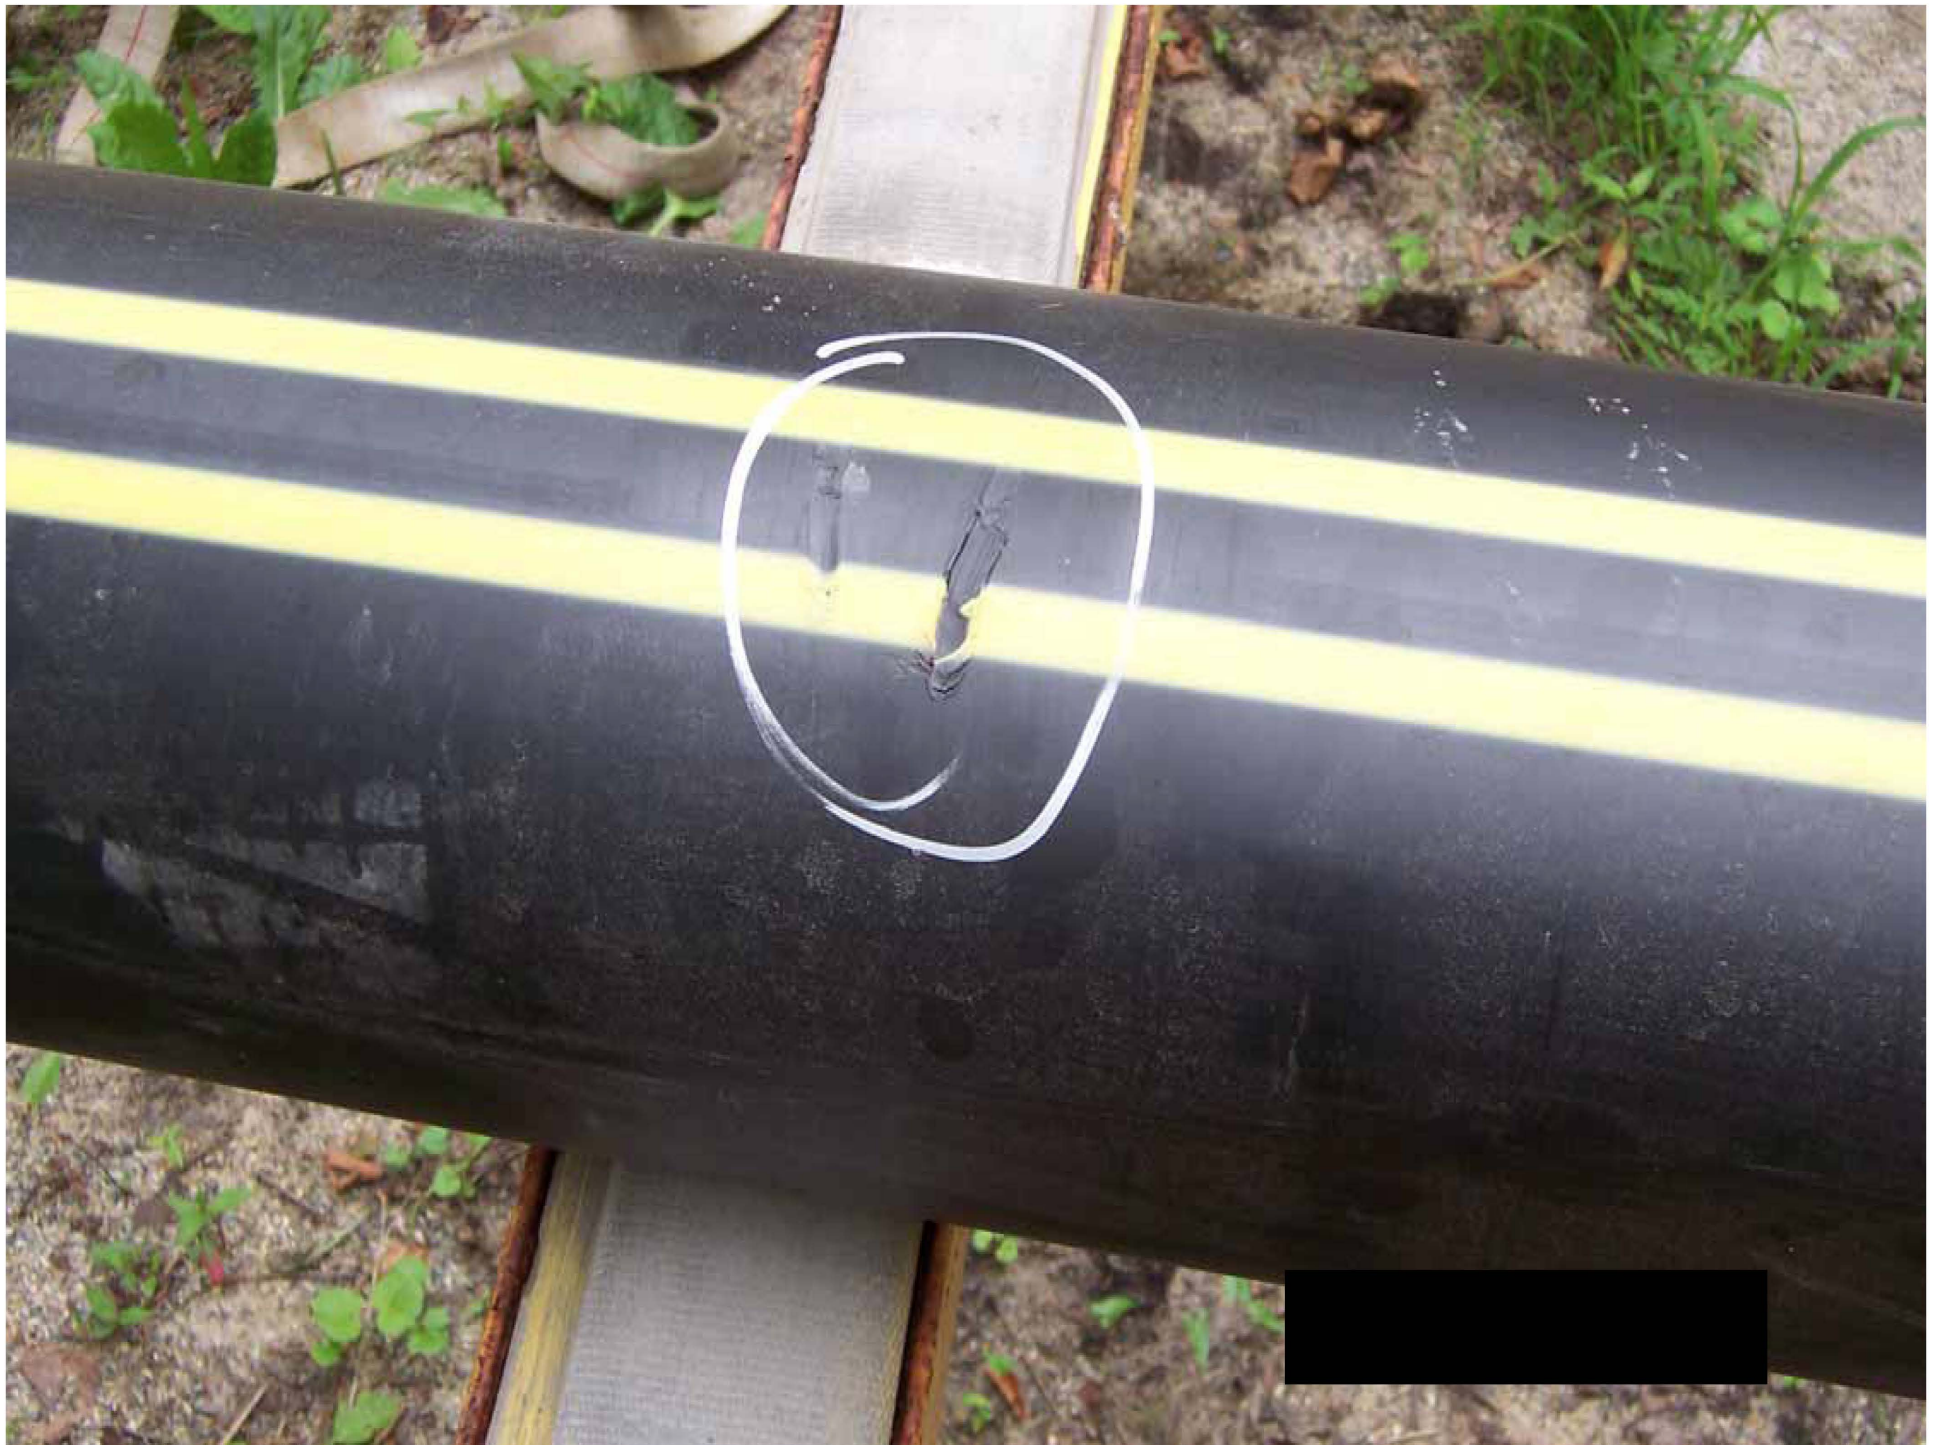
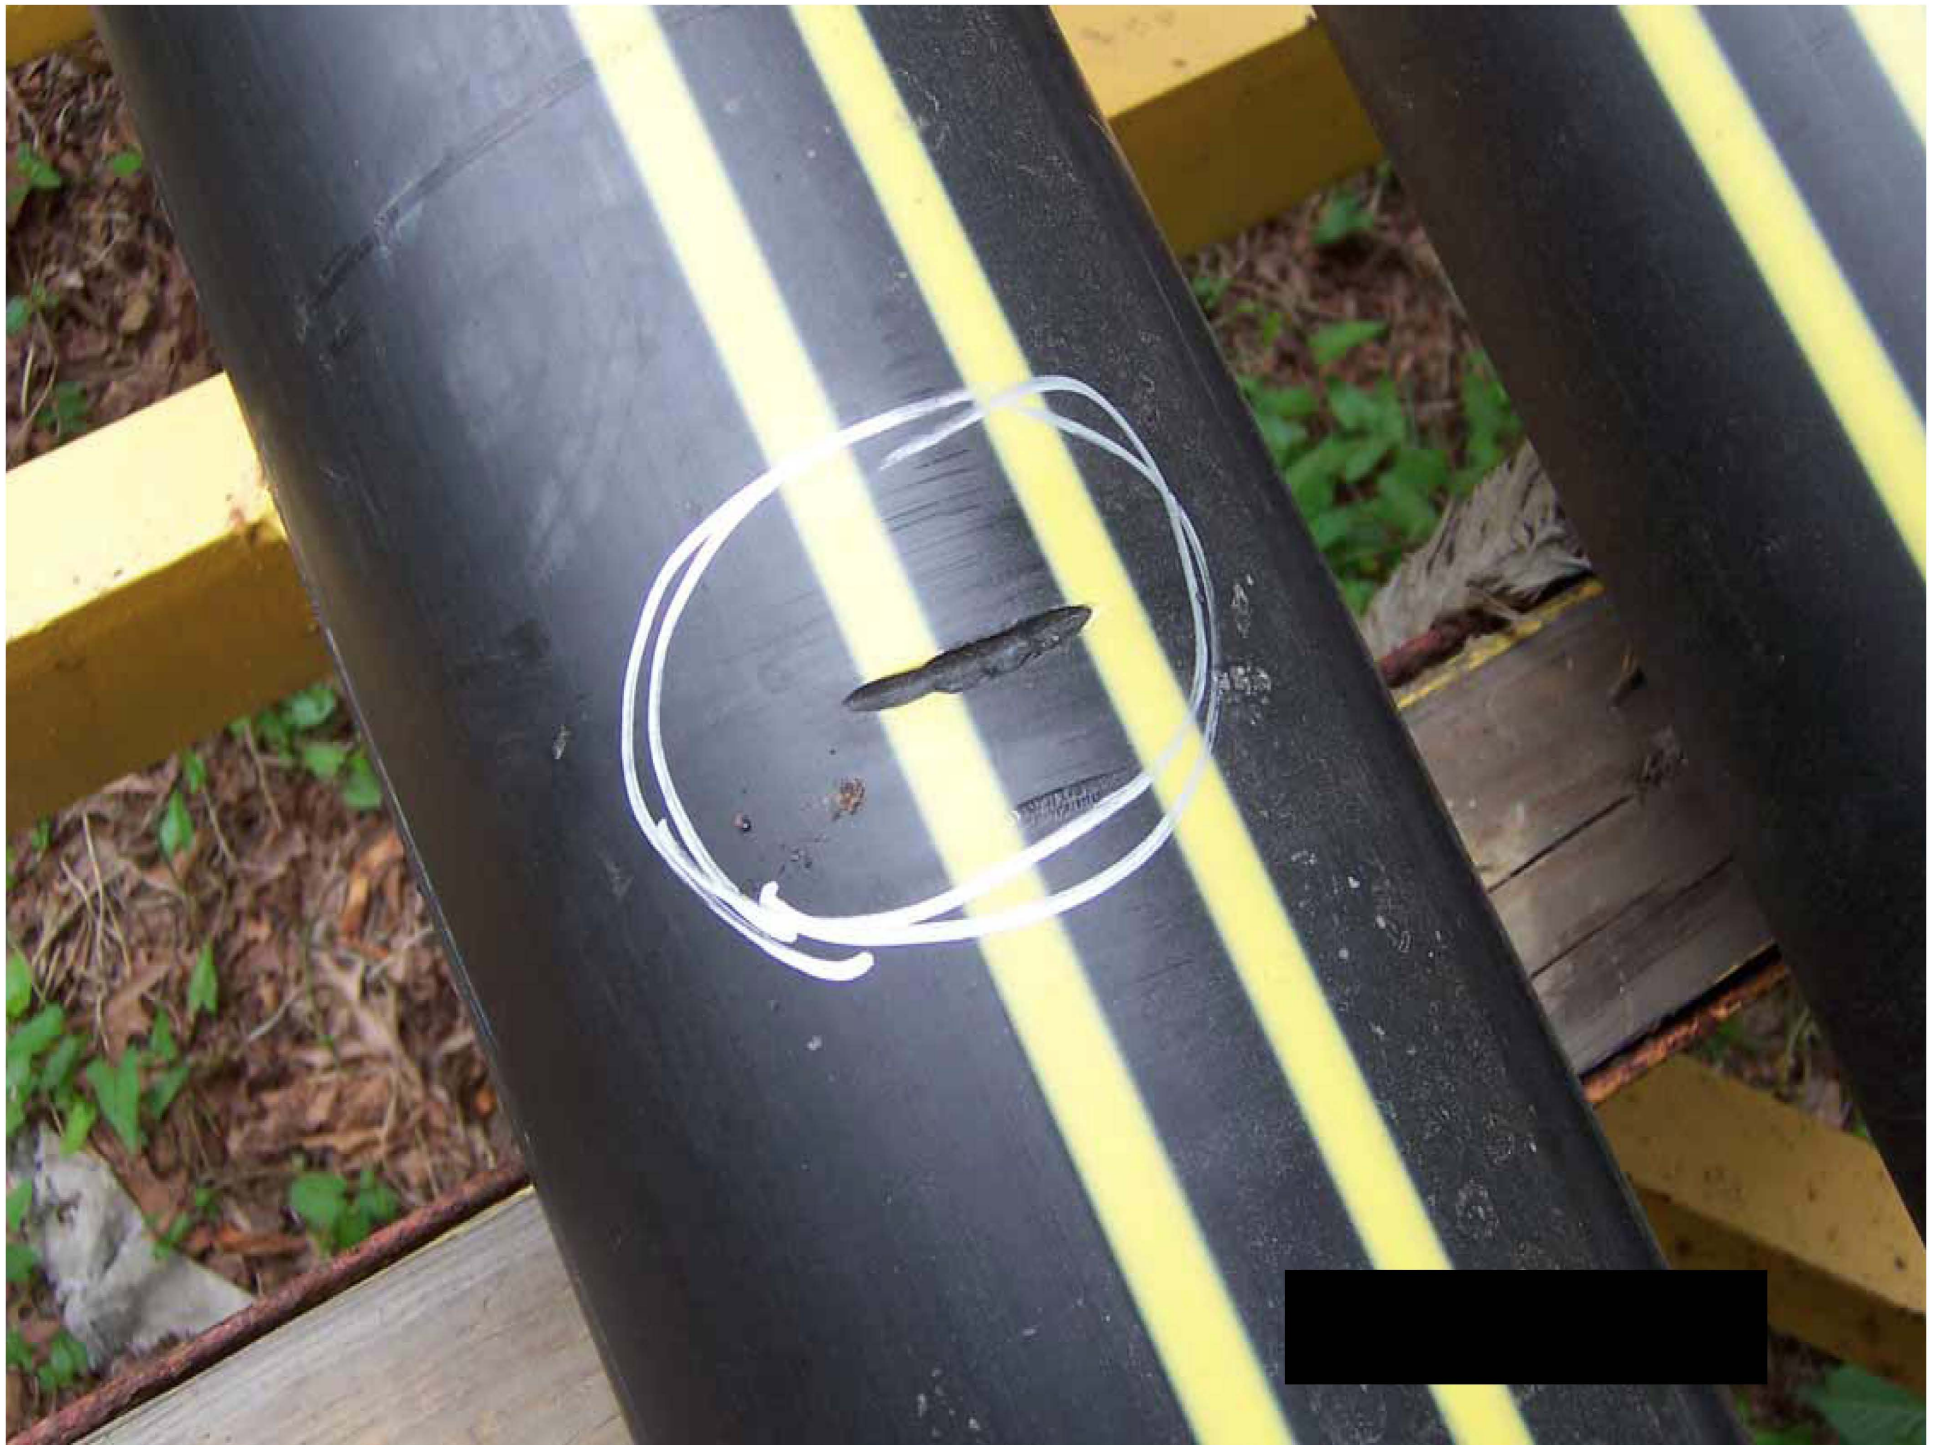
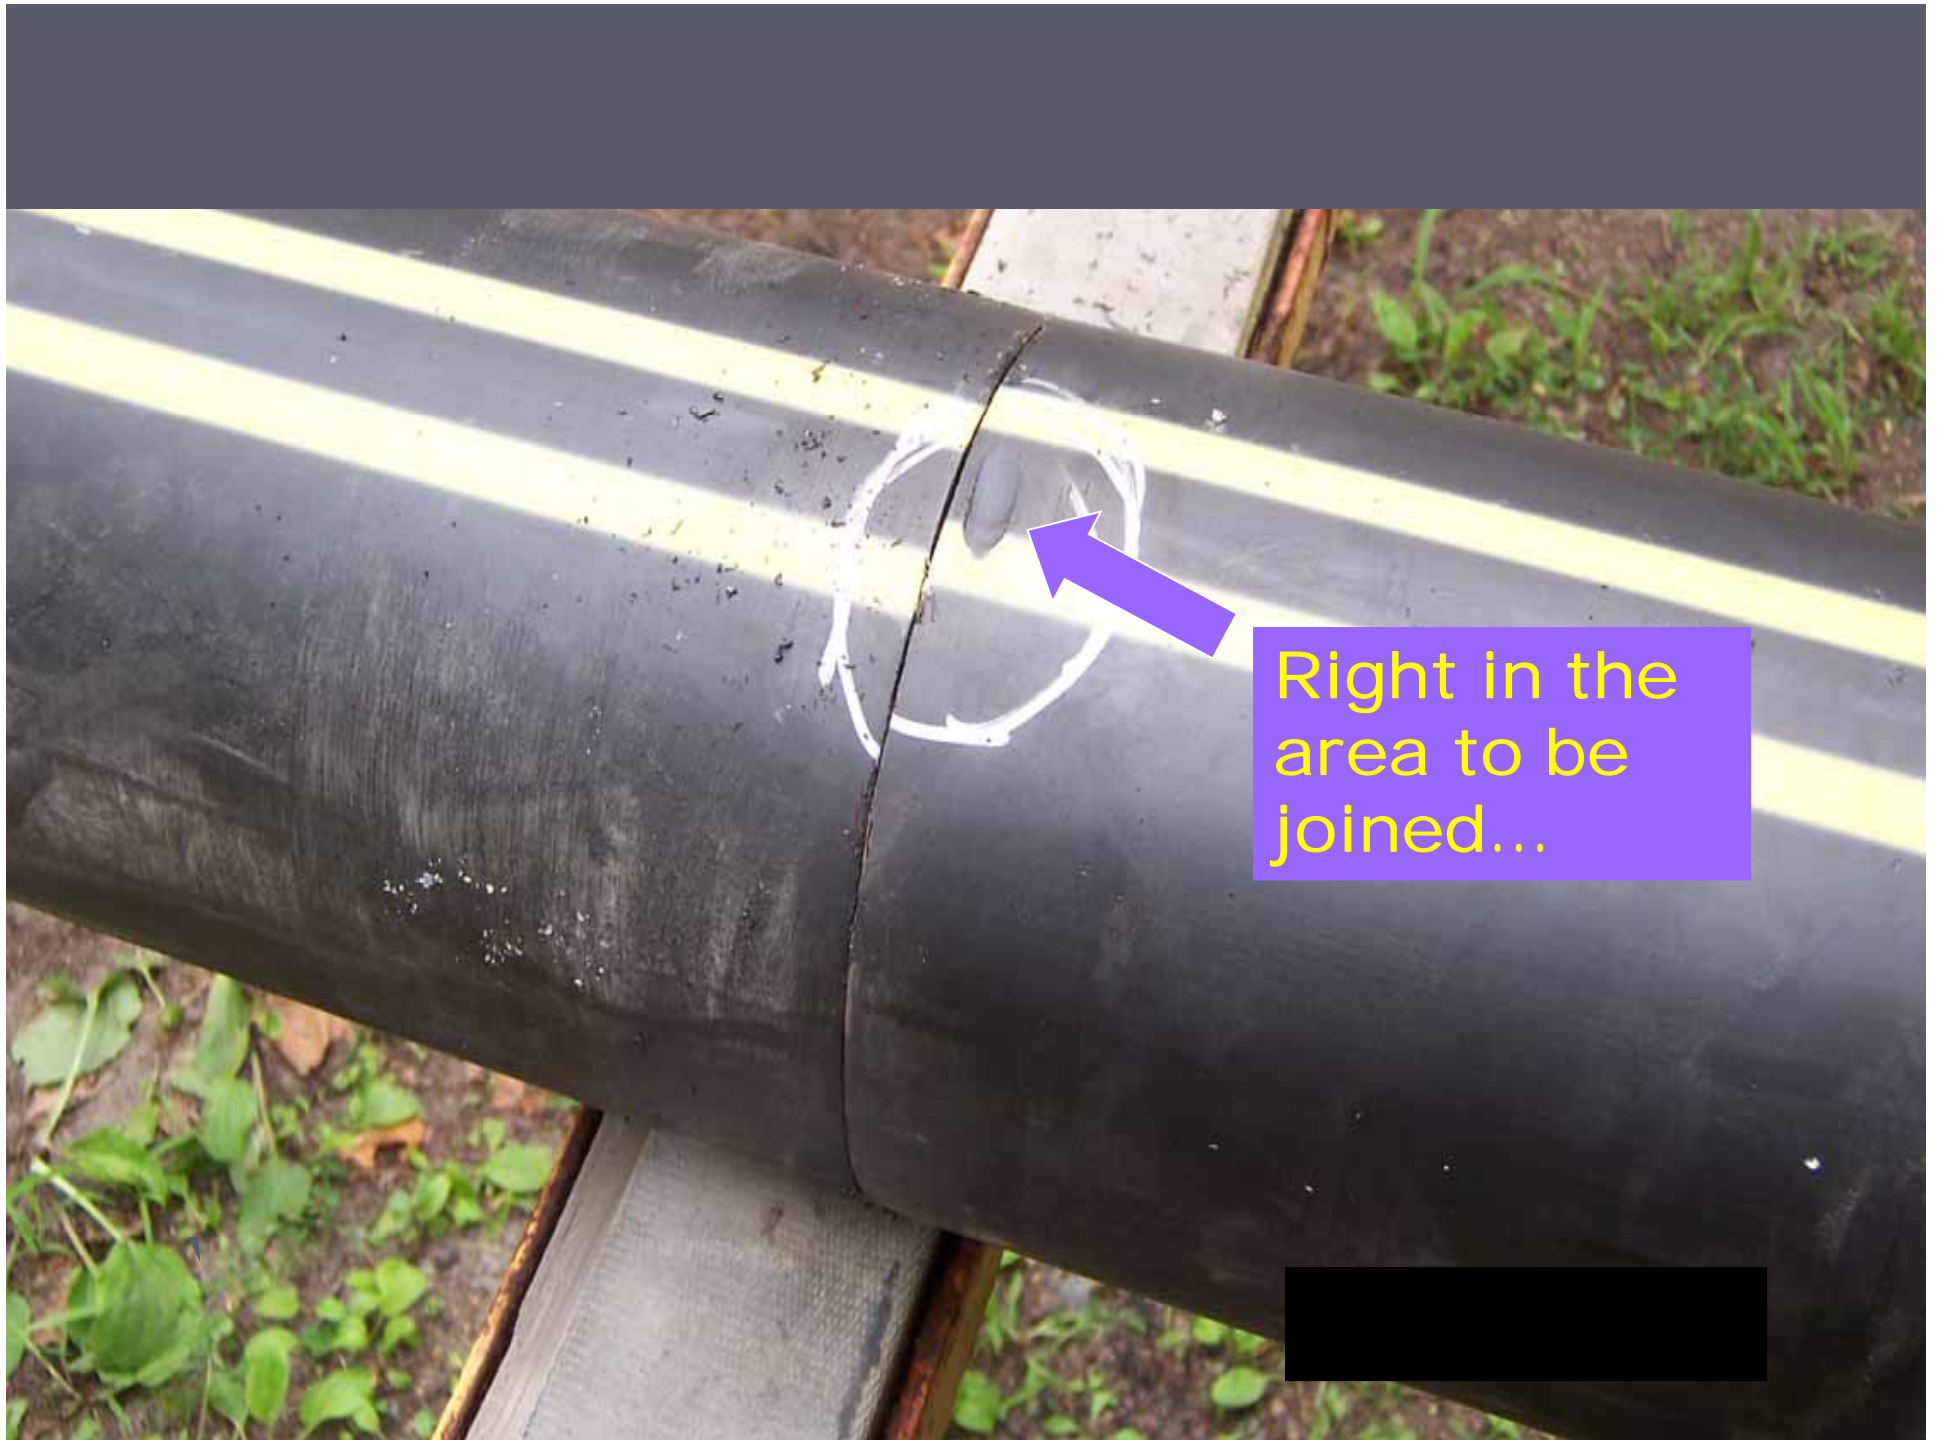
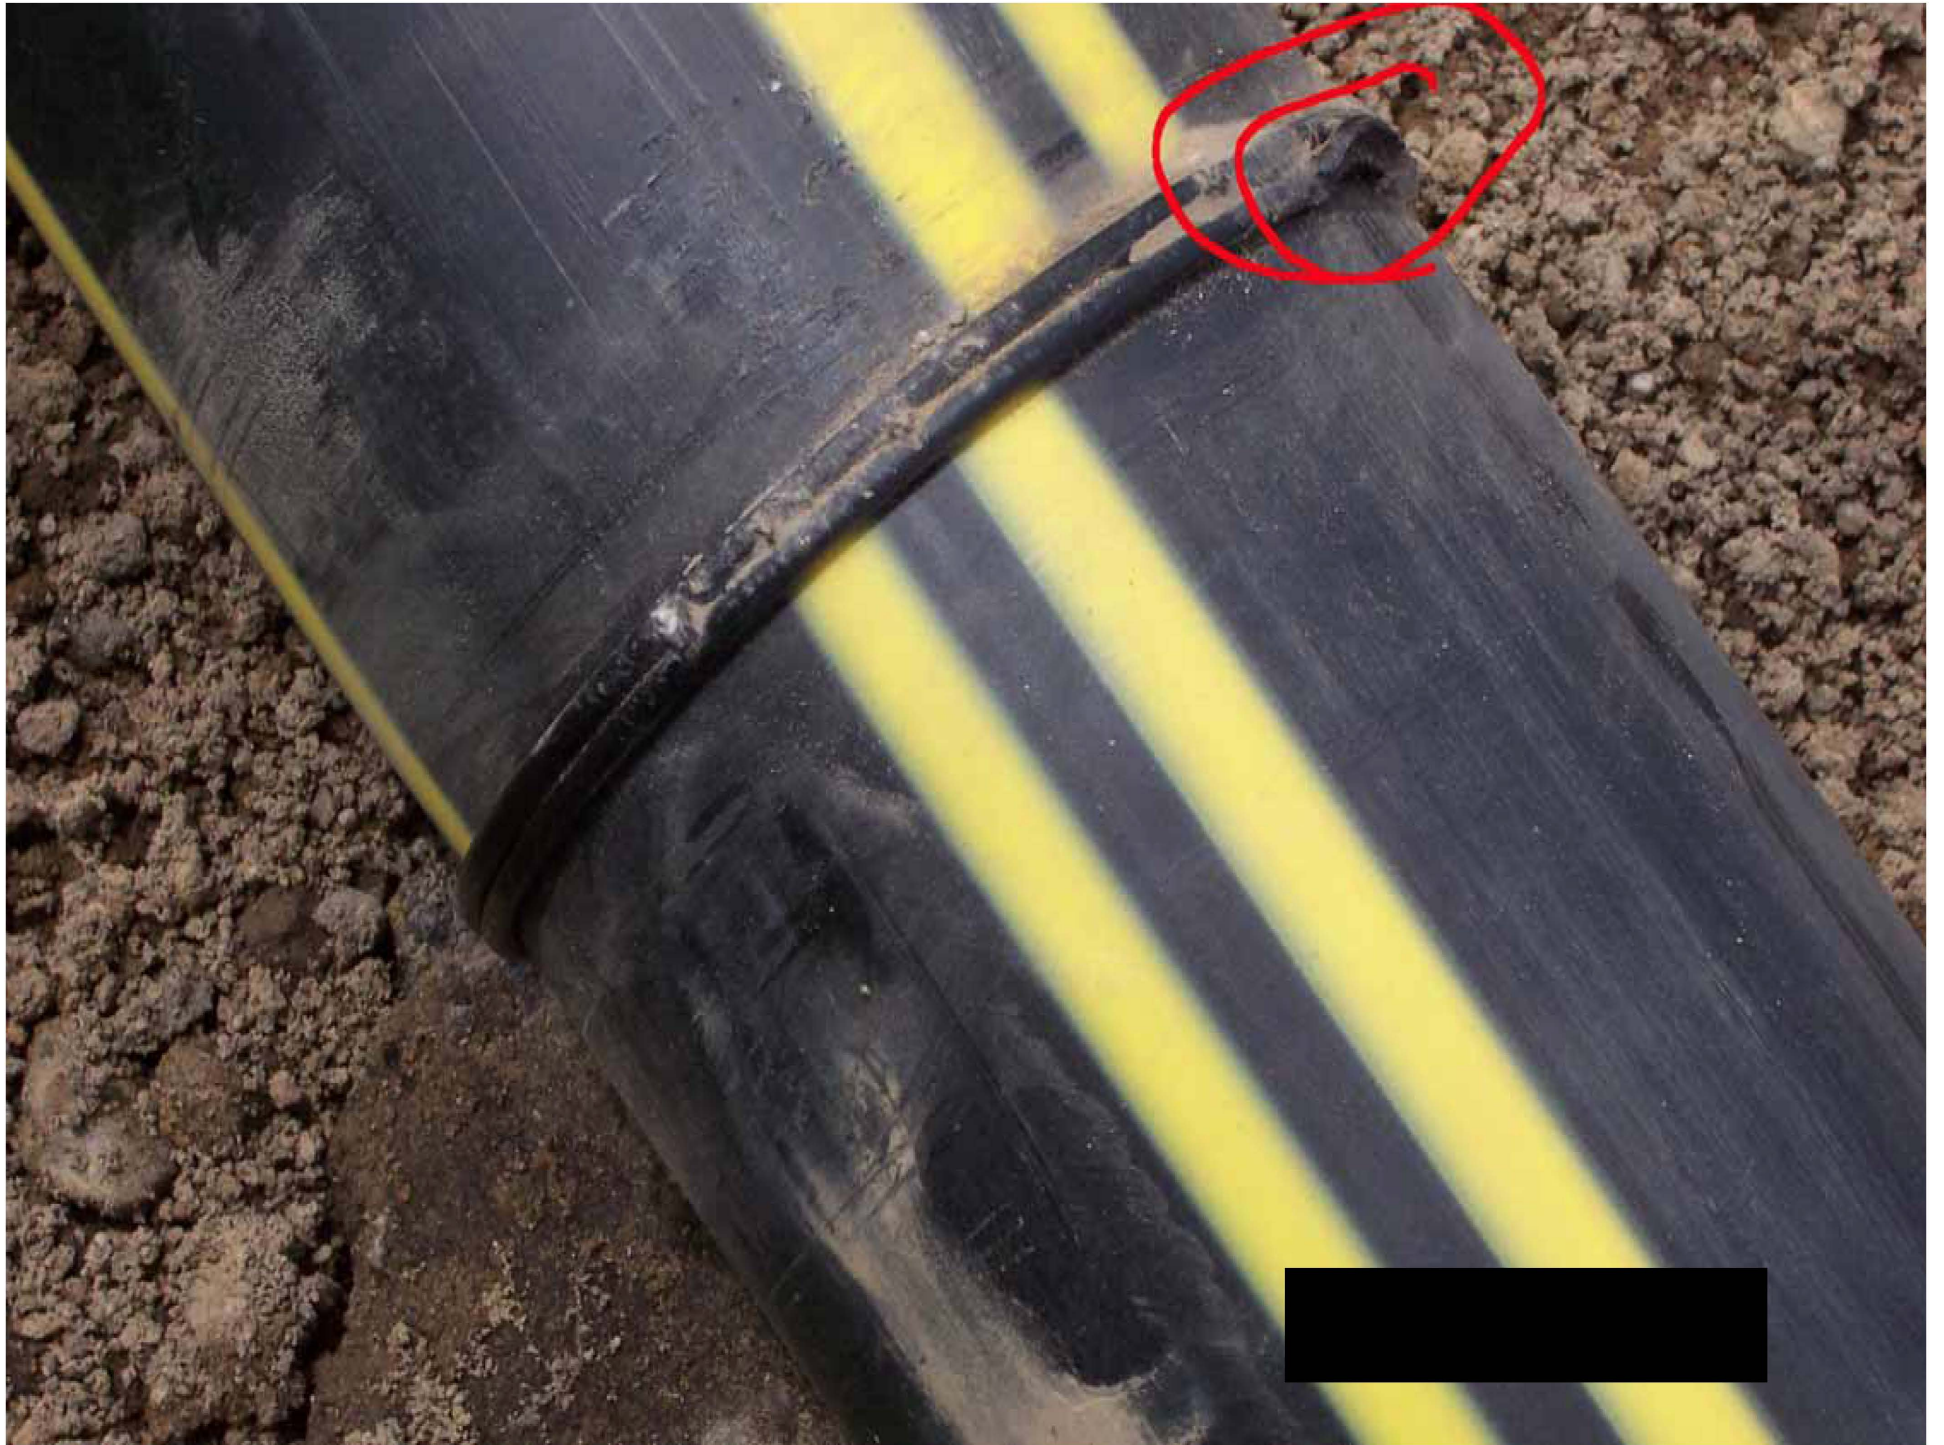
- The Operator installed a 2" ,lastic with a gouge greater than 10% wall loss, the Operator did not know how to measure the defect nor did he have any ,e ,ui, ment to measure the defect.

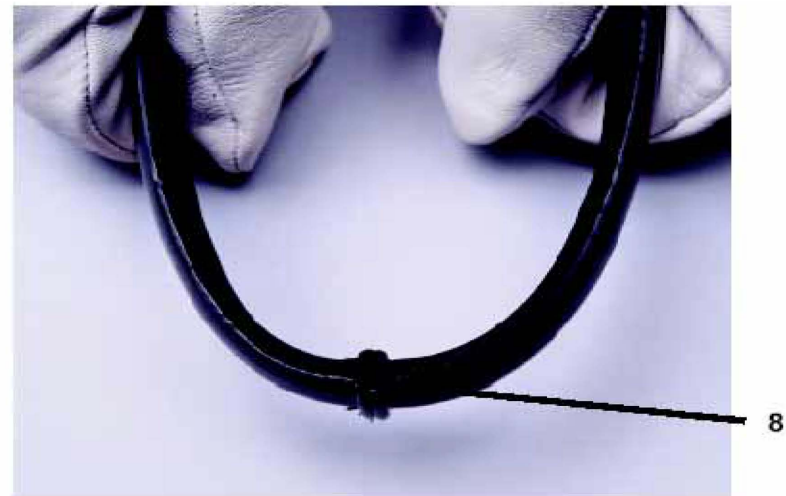
8. No gaps or voids when bent

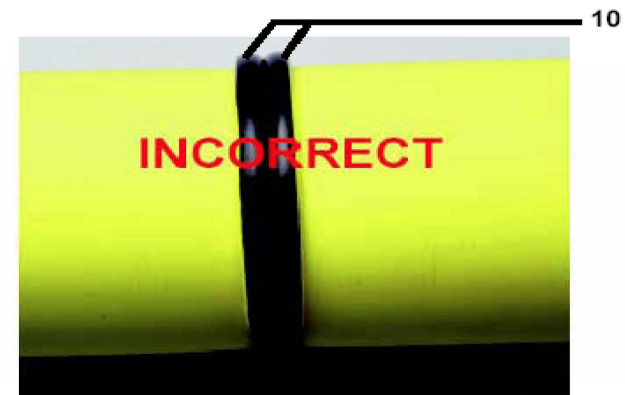
10. Excessive heat time or pressure applied during heating; melt bead too large

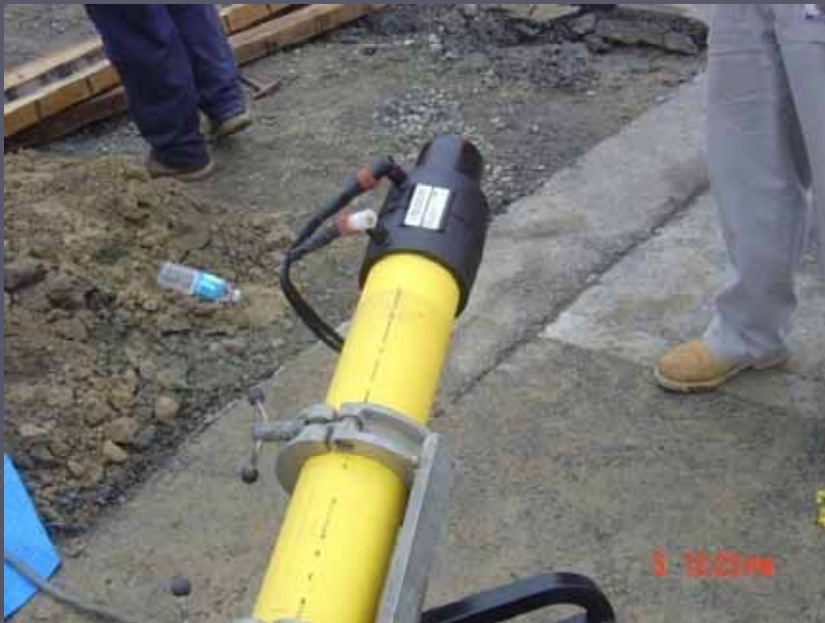
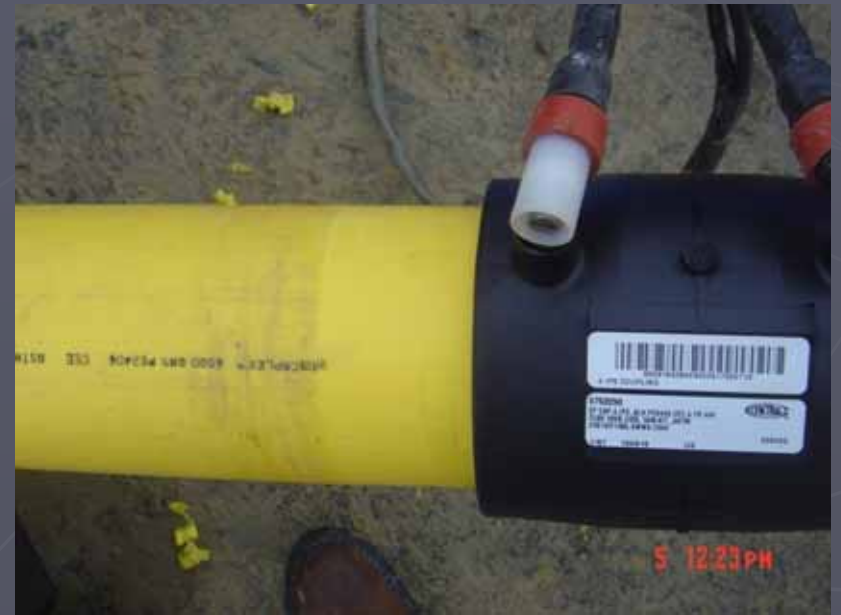
The Operator did not mark the proper stab depth before performing an electrotusion.

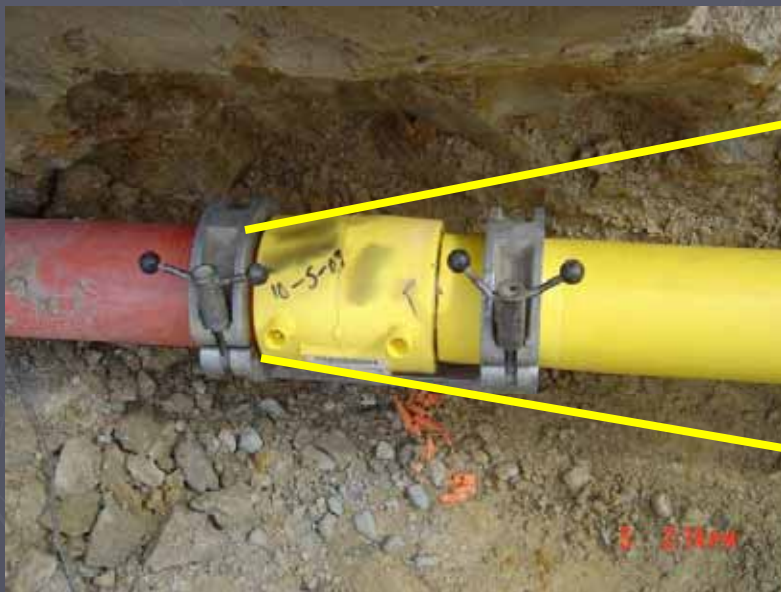
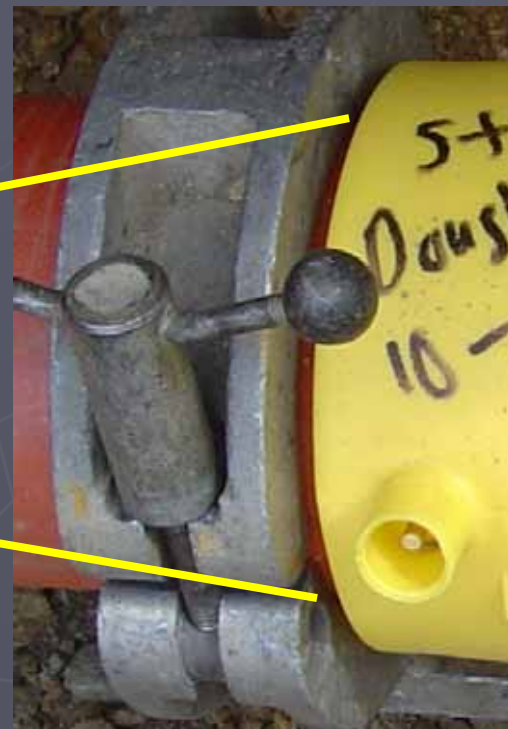
Another example of not marking the proper stab depth before performing an electrofusion.

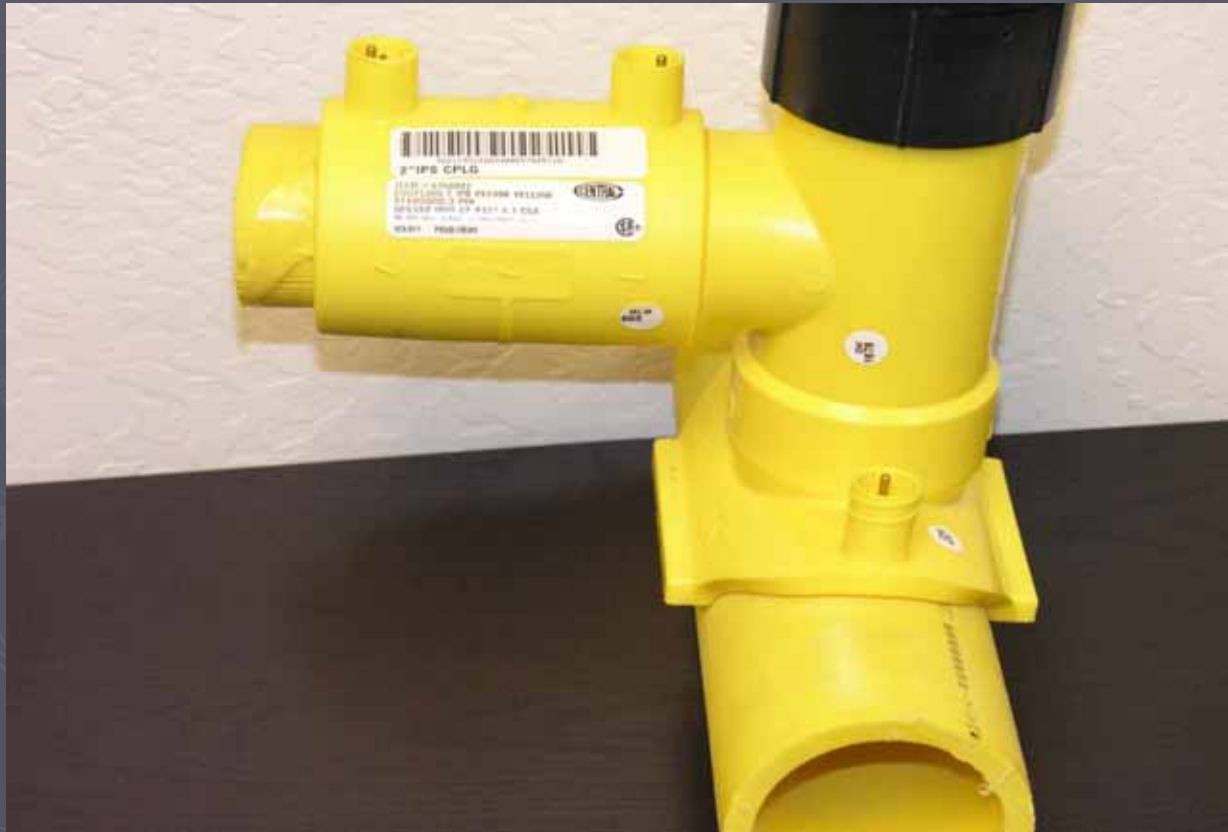
The Operator did not mark the proper stab depth before performing an electrofusion, and the Operator overrode the electrofusion safety protocols.

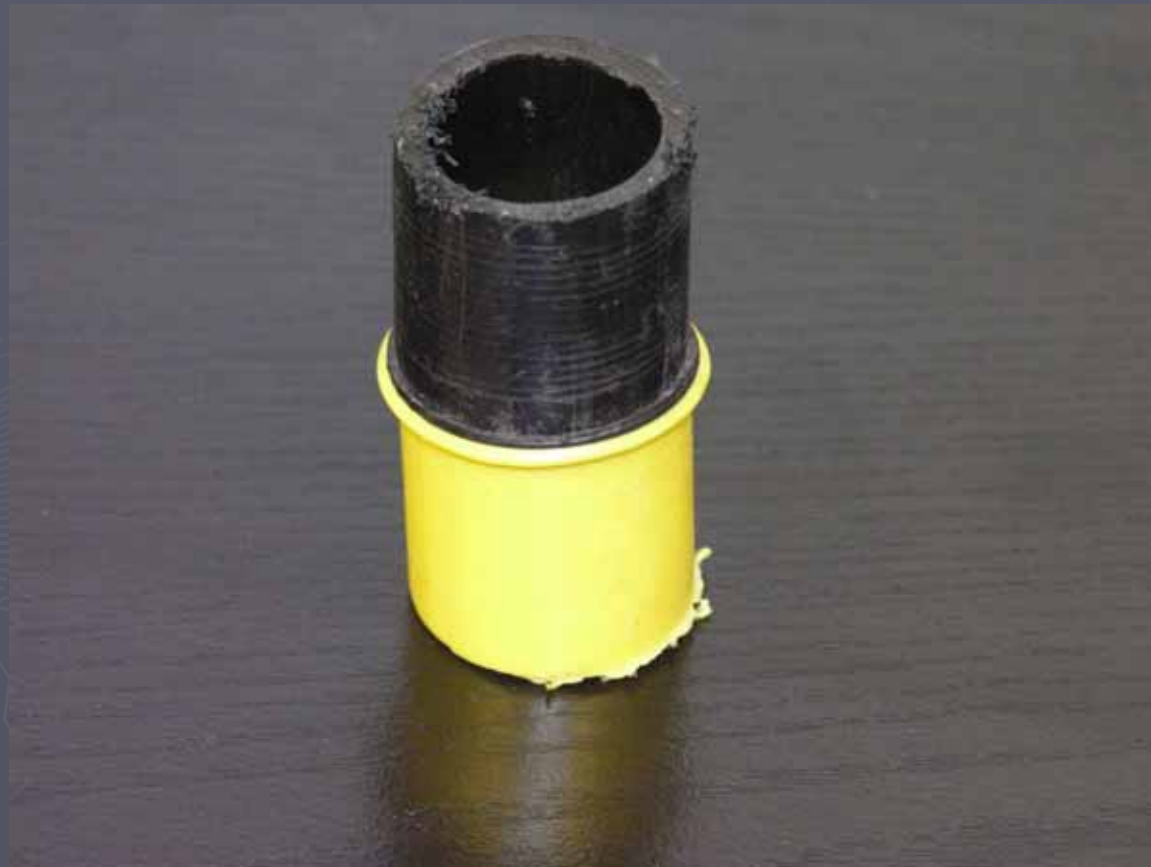
The Operator did not follow procedures.

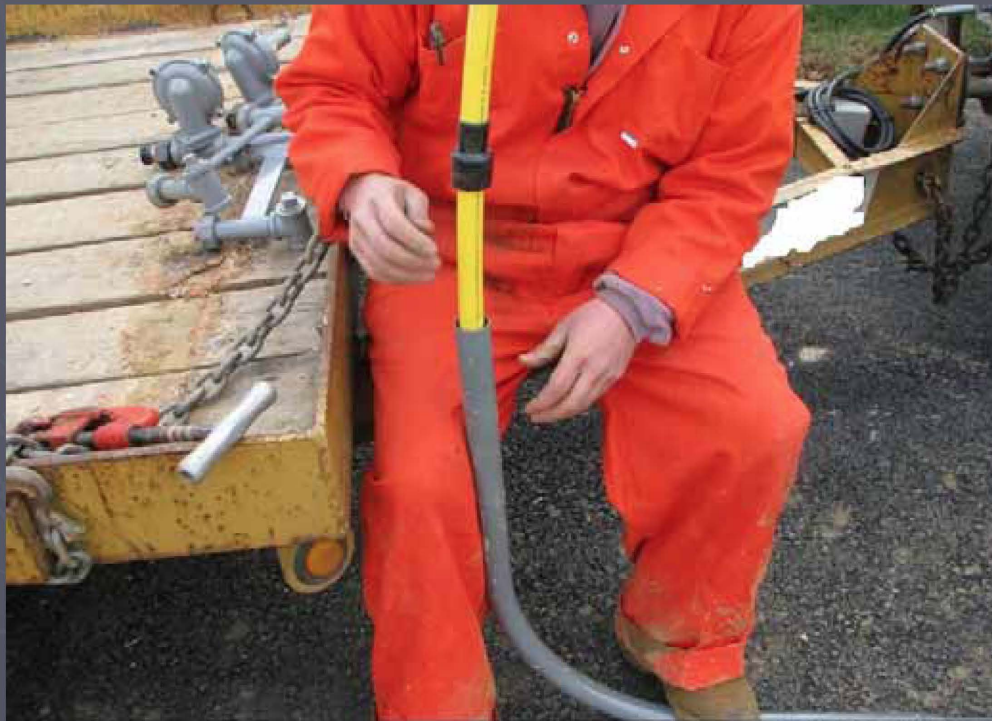
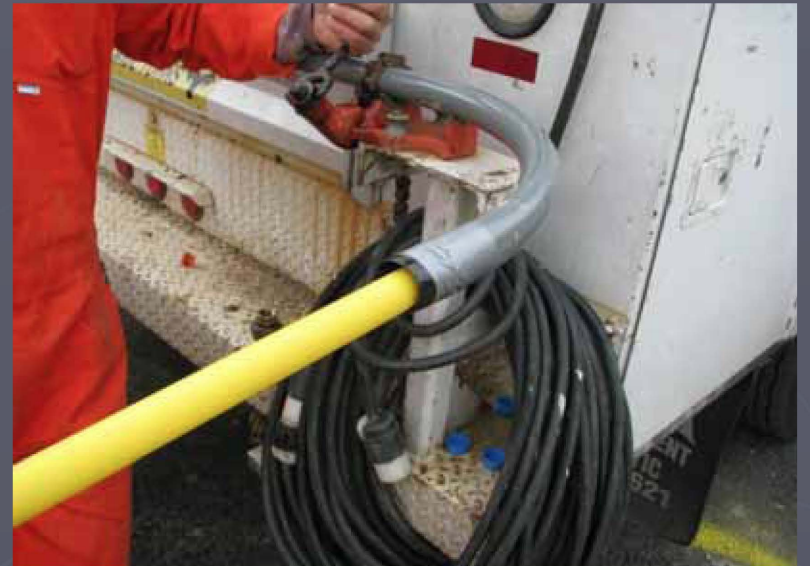
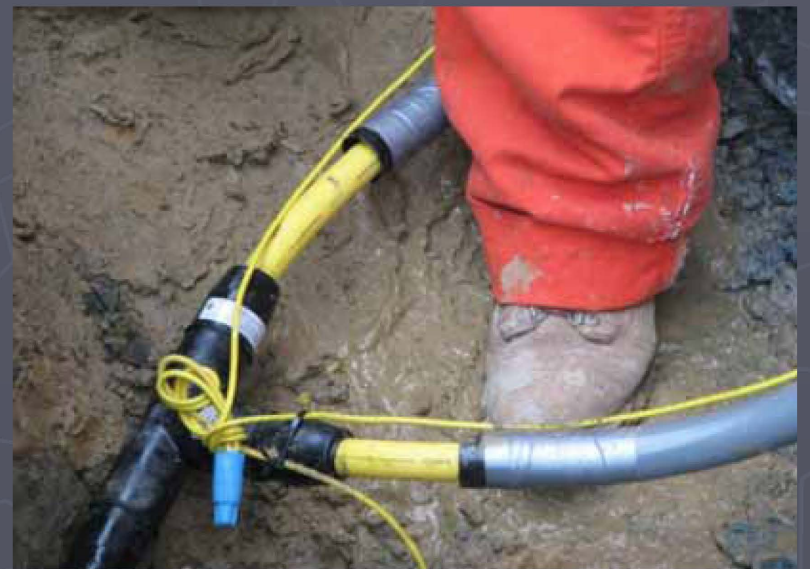
- ▶ The Operator's contractor , performing a branch service installation shortened two anodeless risers. There was no procedure for this activity.

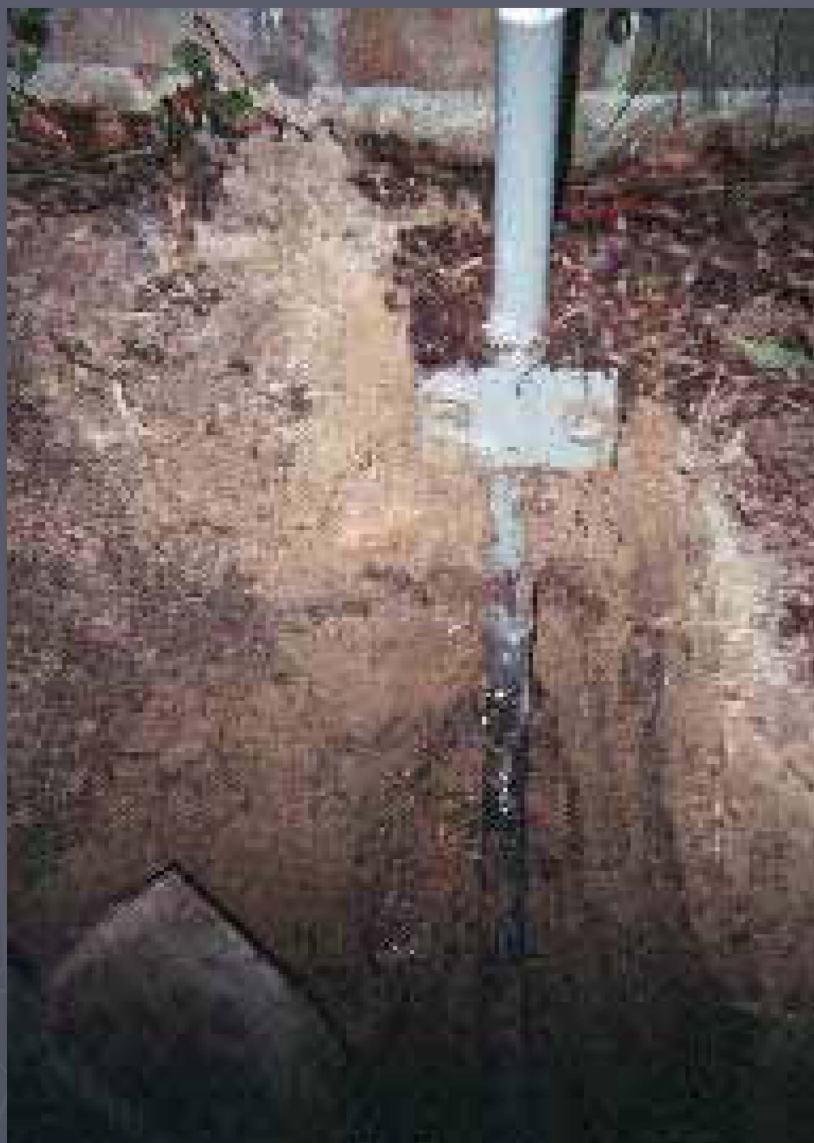
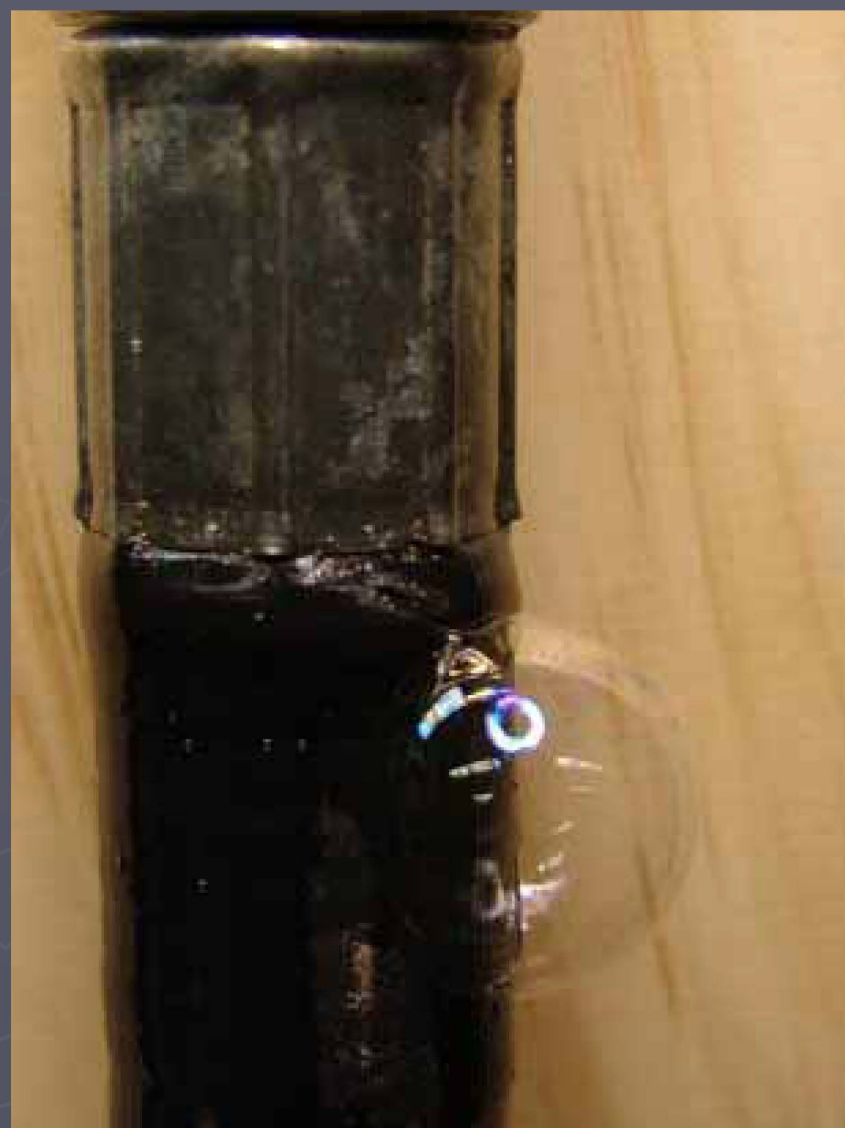
- This time the Operator had a written procedure to assemble anodeless risers but unfortunately the parts supplied were leading to on site failures.

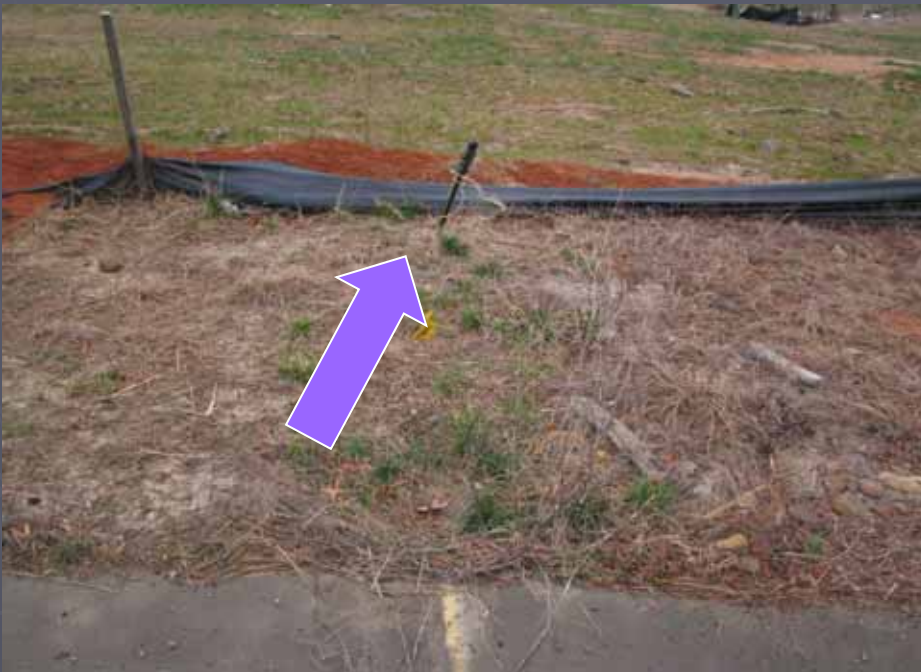
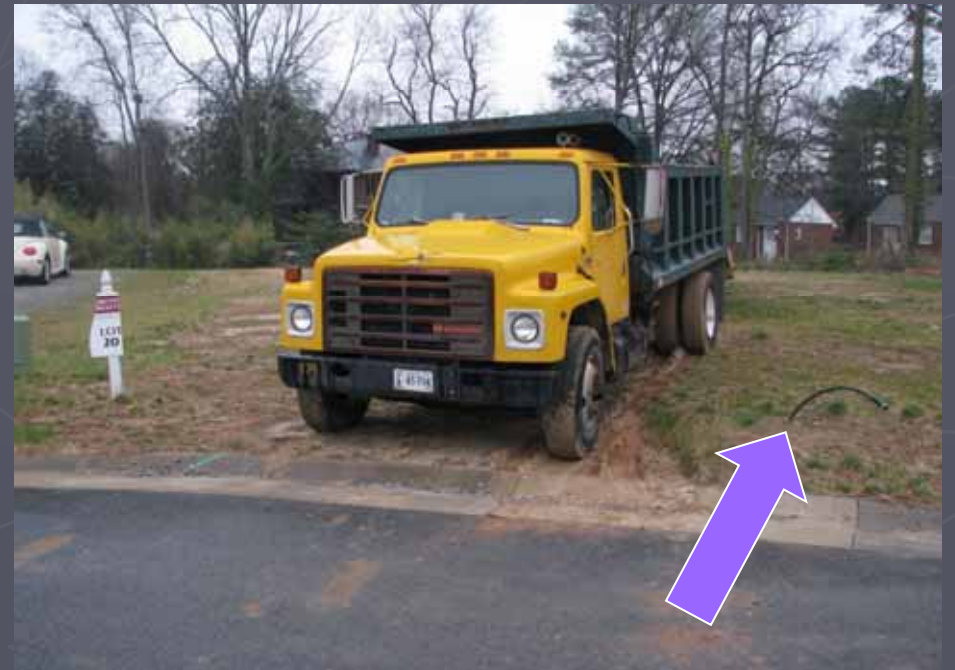
- The Operator's contractor installed service stubs above ground that were left above the ground for several years.

► The Operator installed a temporary gas service above ground over a garage.
