Distribution New Construction
St. Louis, Missouri April 20, 2010
Inspection findings related to Plastic Materials

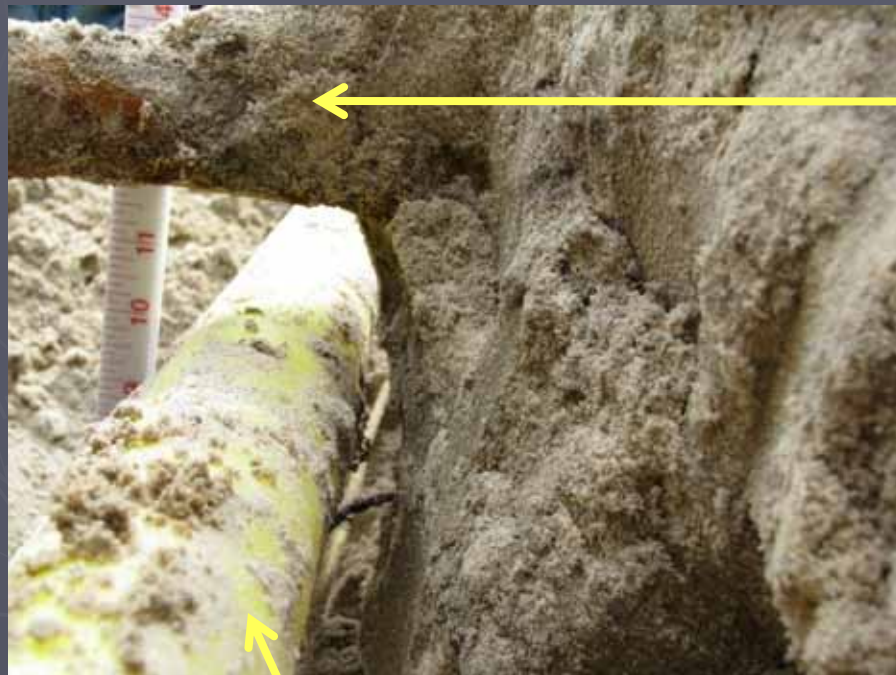
2" Plastic Gas Main

Electric Line

Sewer Line

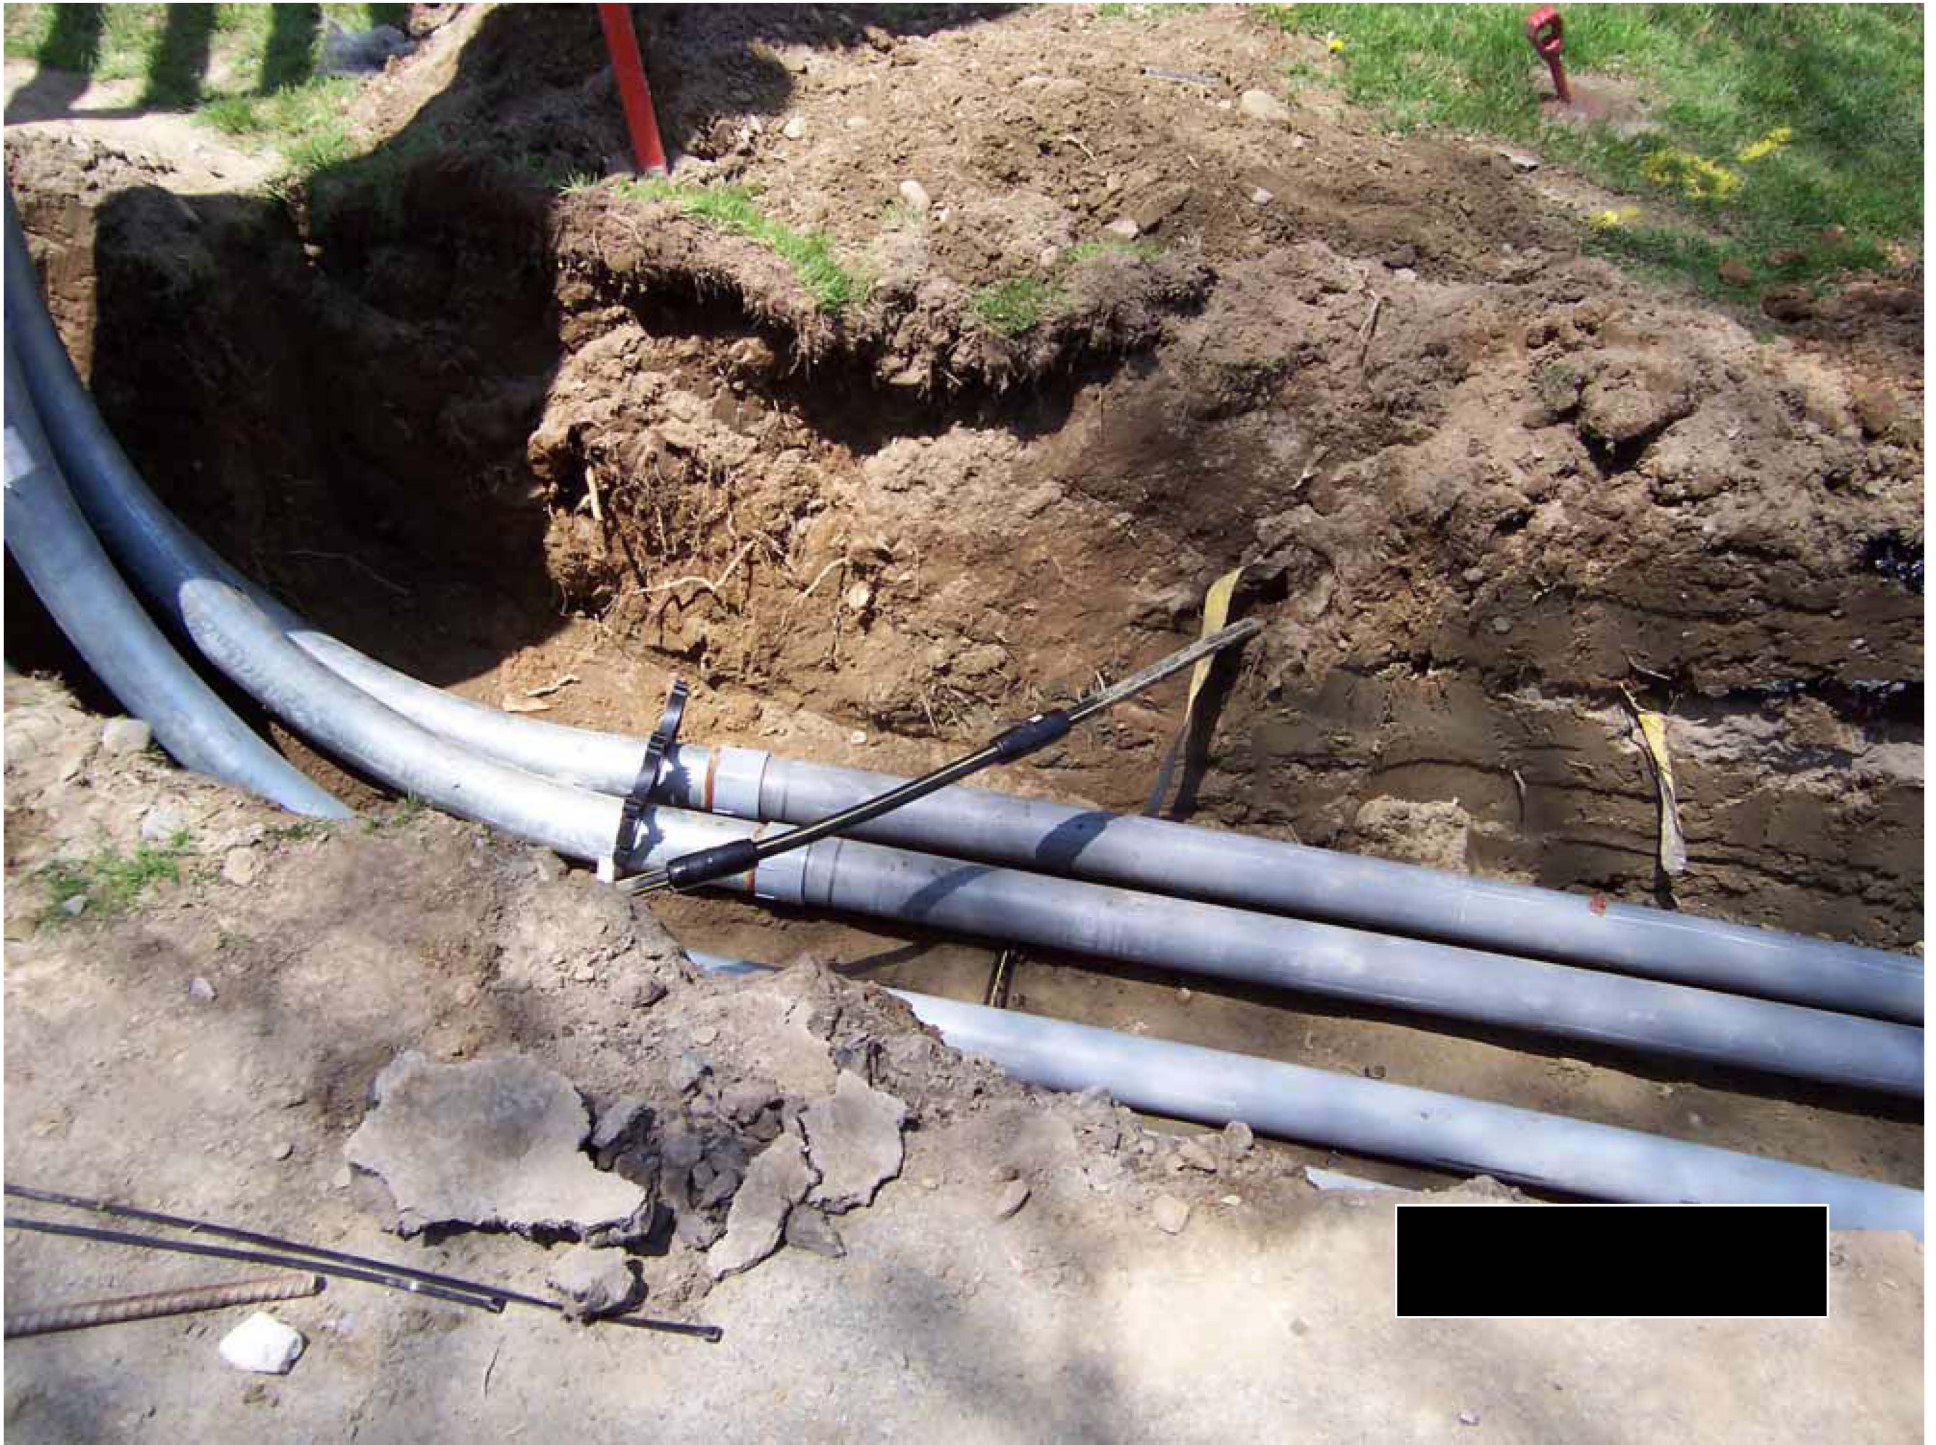
Grounding rod right next to the service

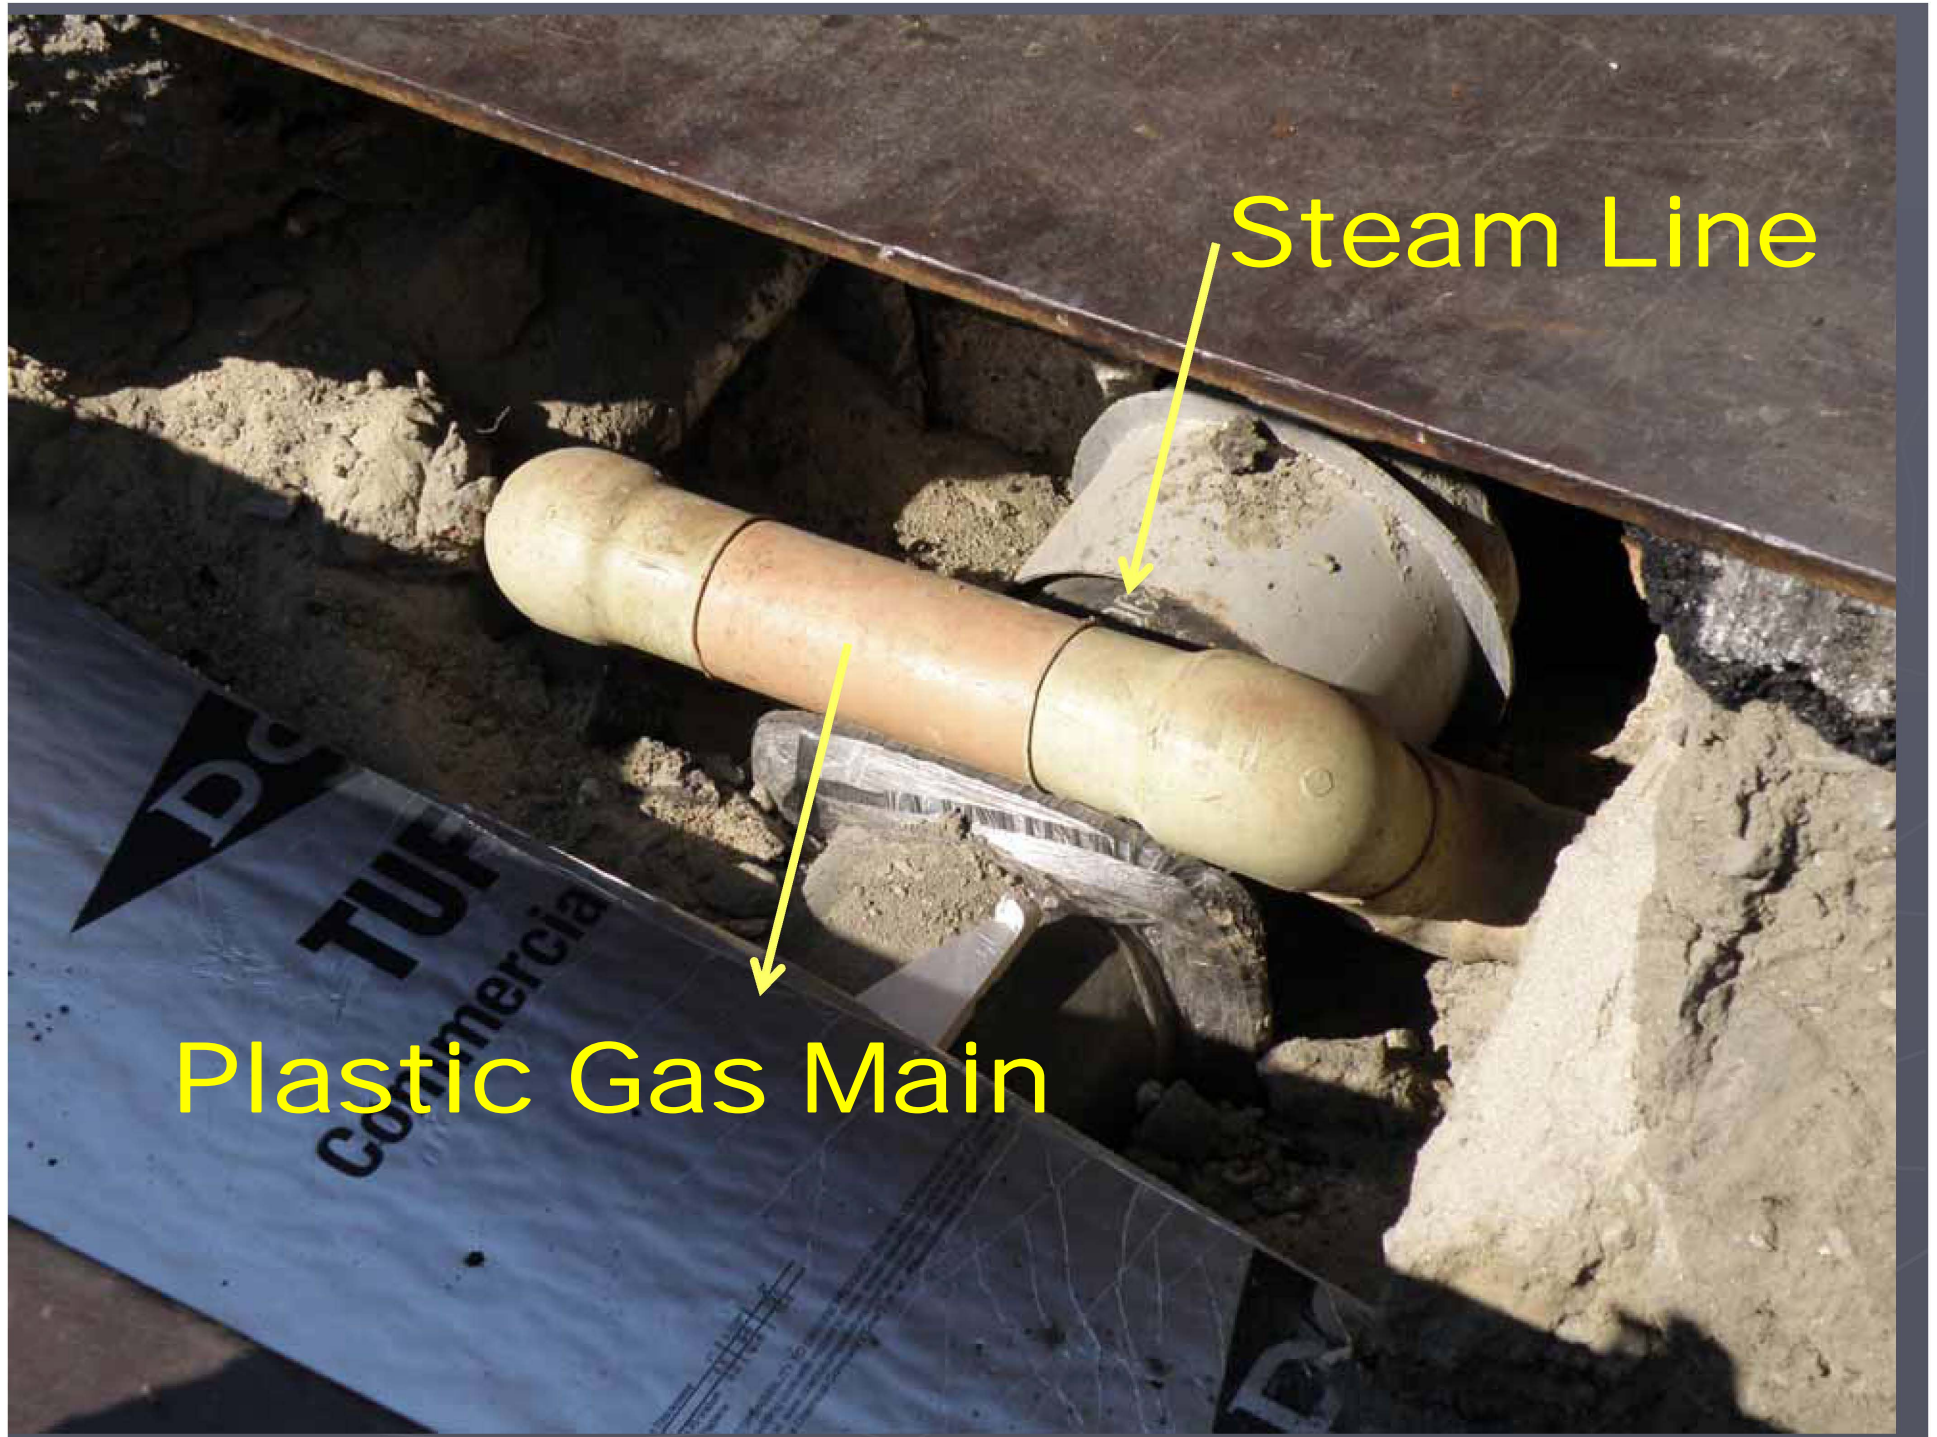
- The Operator's contractor installed a 4" plastic main with improper backfill material. About 2500' (about a ½ mile) of the newly installed 4" gas main was replaced and select backfill was brought in.

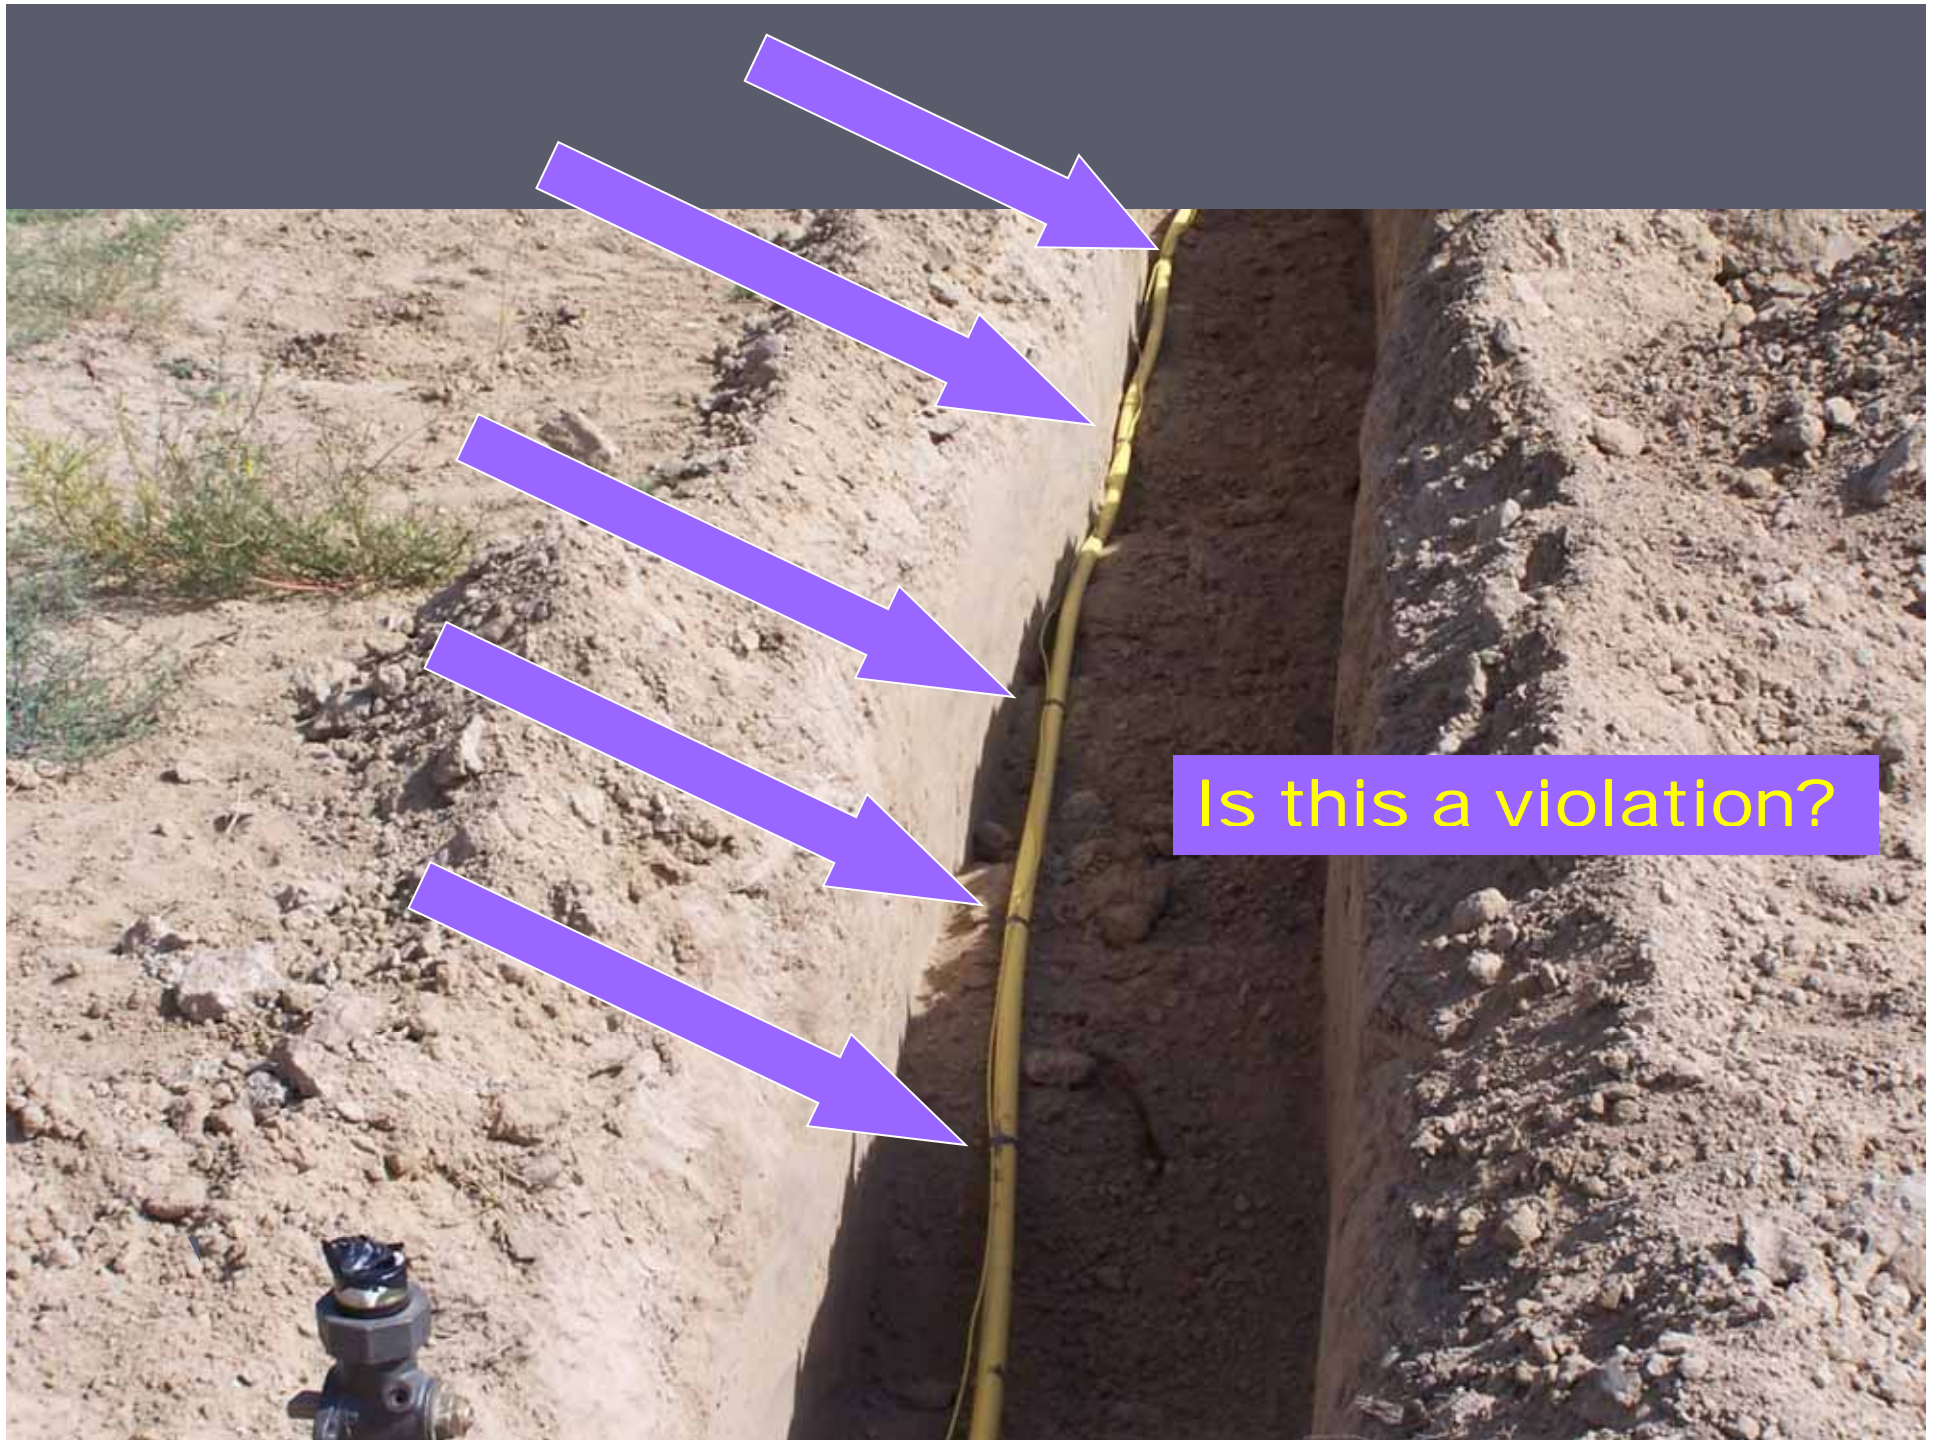
Is this a violation?

How is this line _oin_ to be marked?

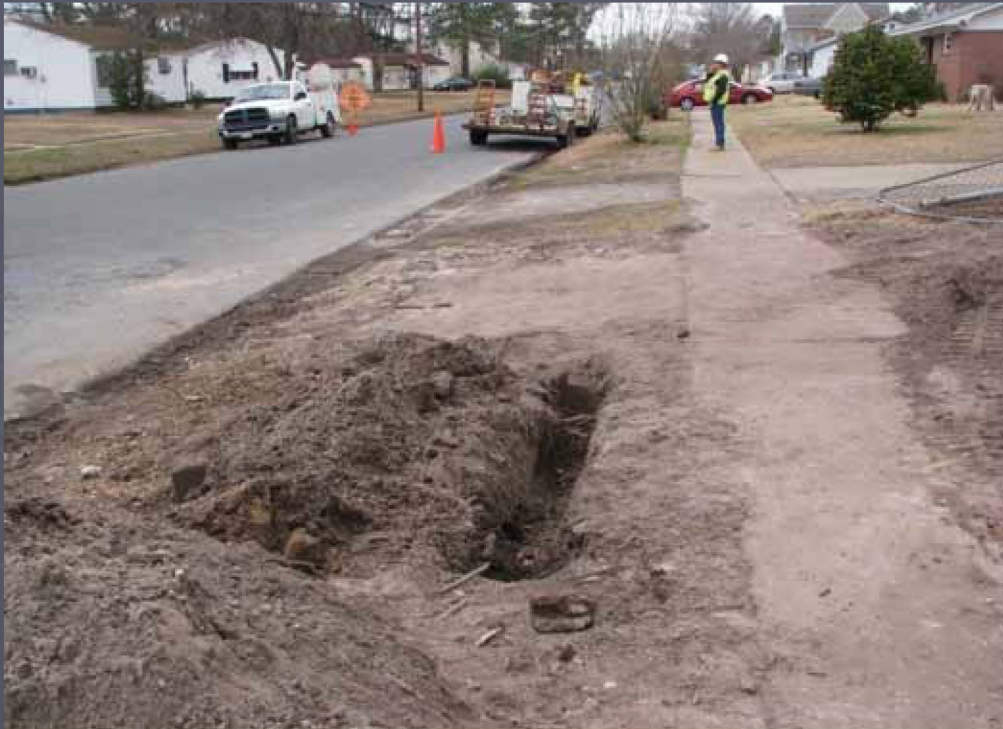
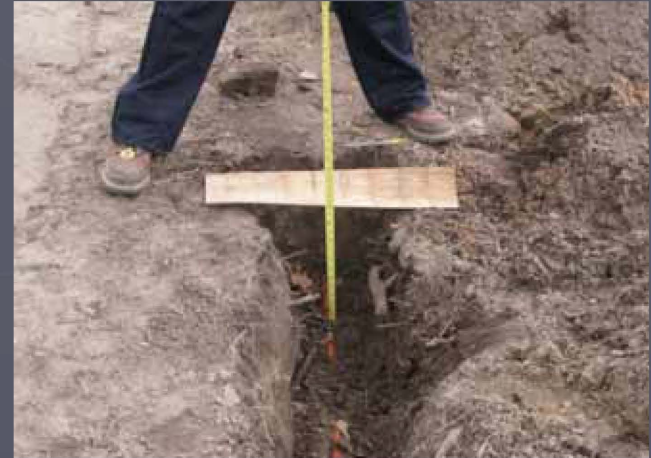
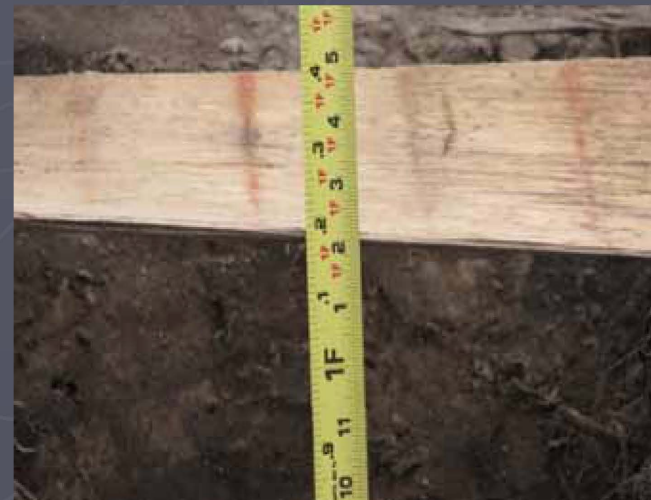
§192.327(b) - Failure to install a main with at least 24 inches of cover.

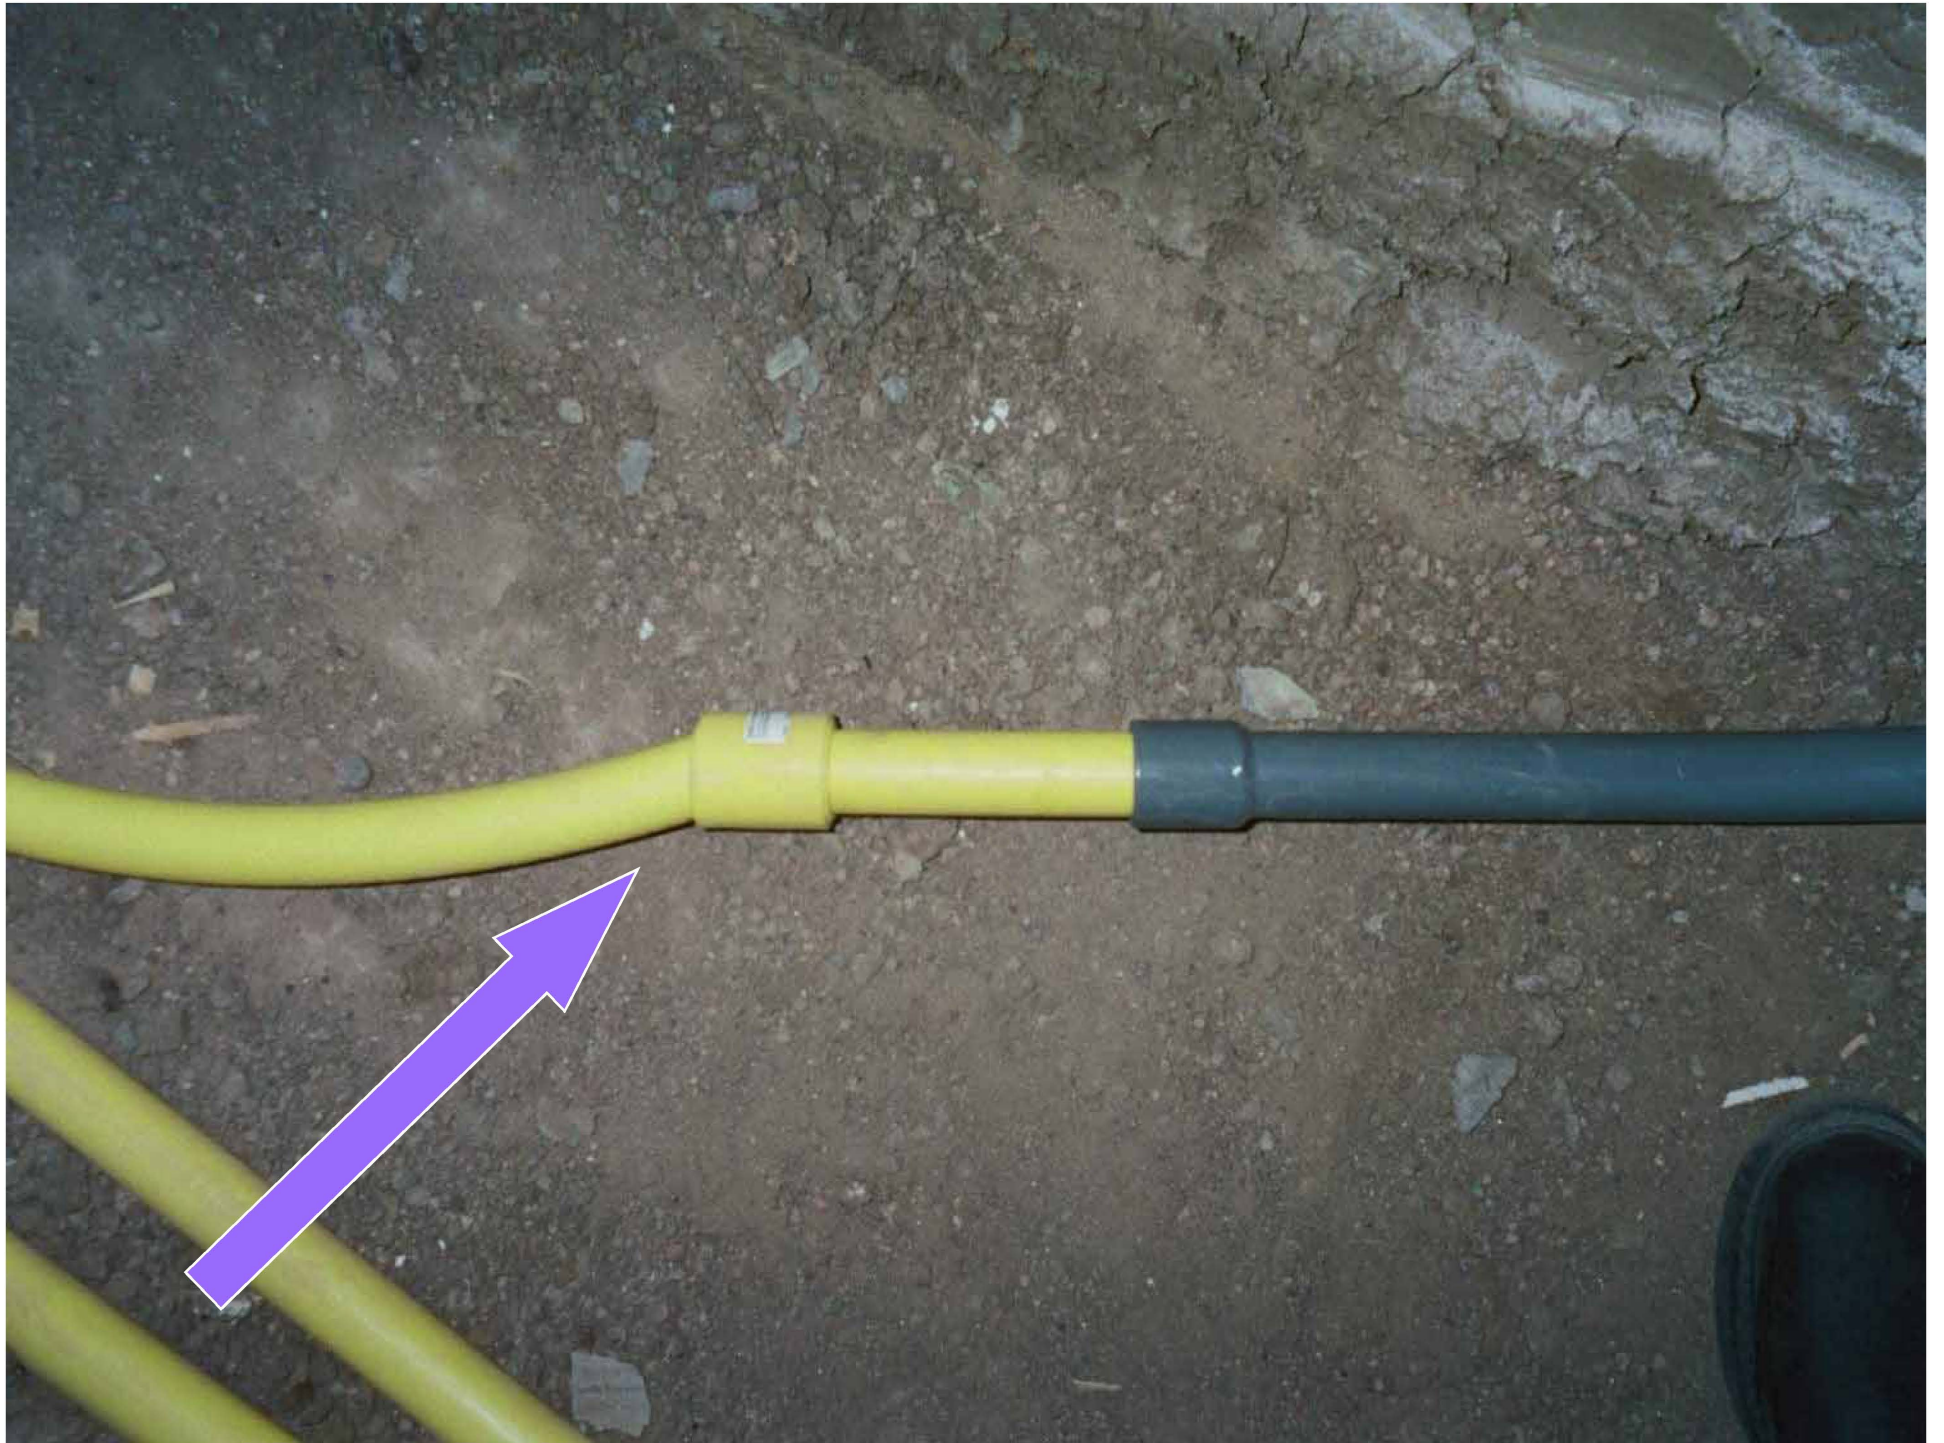
Rusty facing blades, your prone to failure.
